Hybrid 3z57 Traveler

April 28, 2000

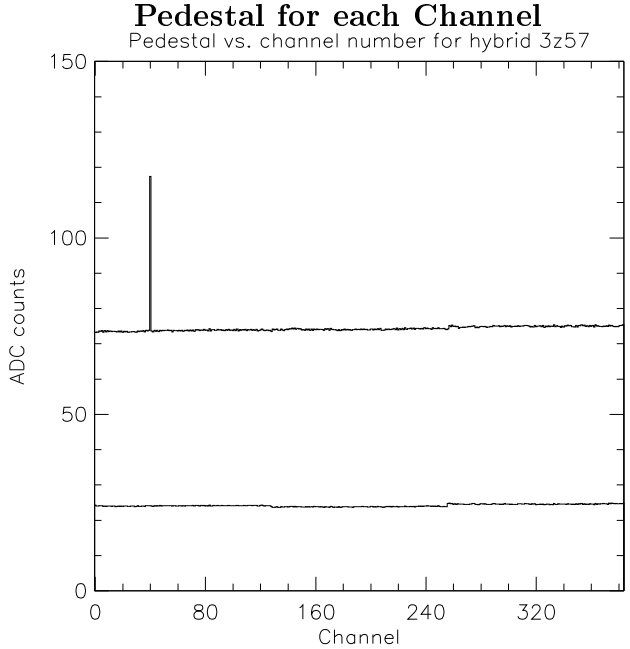
Pedestal for each Channel

The following plot shows the pedestals vs. channel number with and without charge injection:

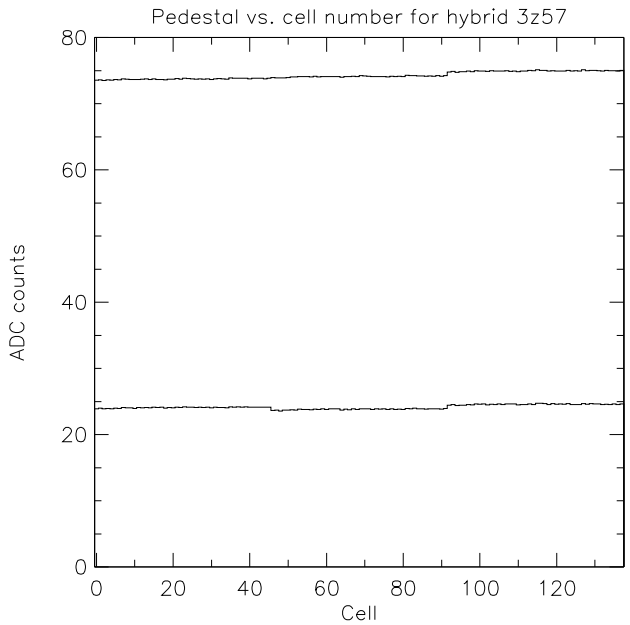
Pedestal vs. Pipeline Cell ID

The following plot shows the average pedestal vs. pipeline cell ID with and without charge injection. The x-axis is cell ID offset by 46 for each chip. Thus cell ID 5 for chip 1 is at x=5, chip 2 at x=51, chip 3 at x=97, etc.

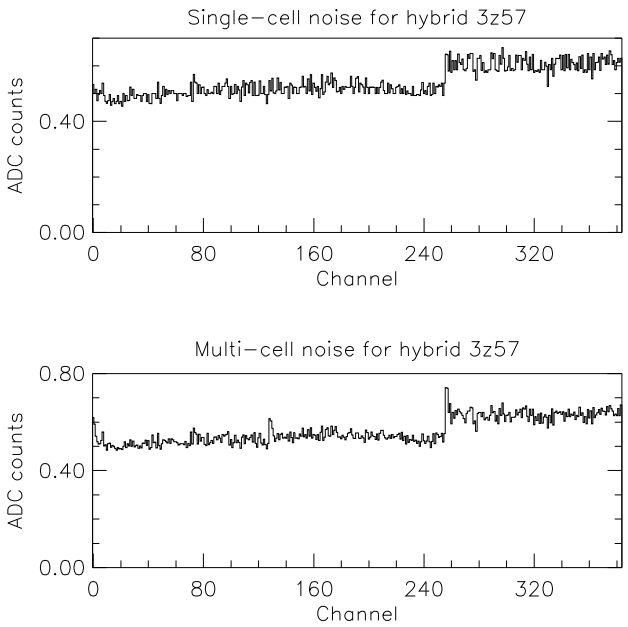
RMS Noise

The following plots show the single-cell and multi-cell RMS noise:

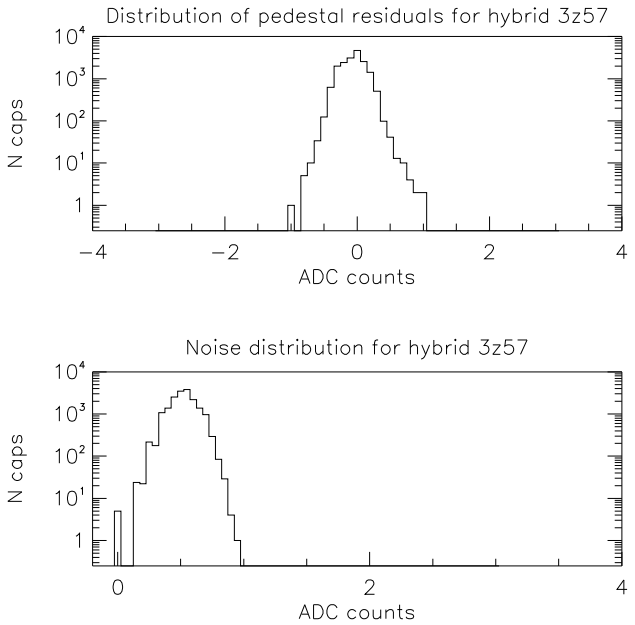
Distribution of Pedestals and Noise

The following are histograms of the pedestal of each pipeline capacitor relative to the chip average (top); and the RMS noise of each capacitor (bottom):

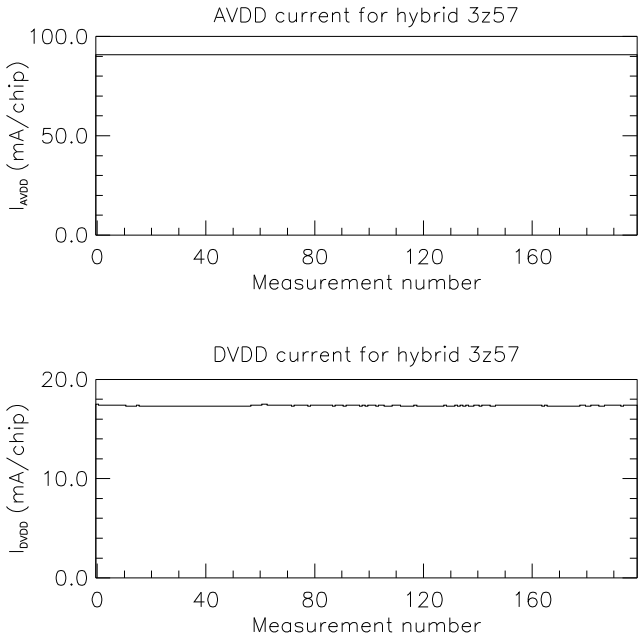
Supply Currents During Burn-in

The following plots show the supply currents per chip as a function of measurment number. Currents are measured approximately every 10 minutes:
