Hybrid 3z64 Traveler

December 10, 1999

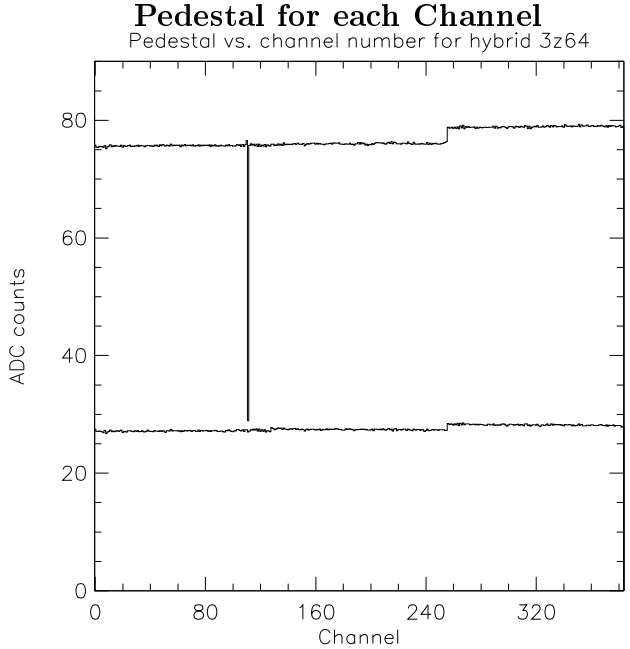
Pedestal for each Channel

The following plot shows the pedestals vs. channel number with and without charge injection:

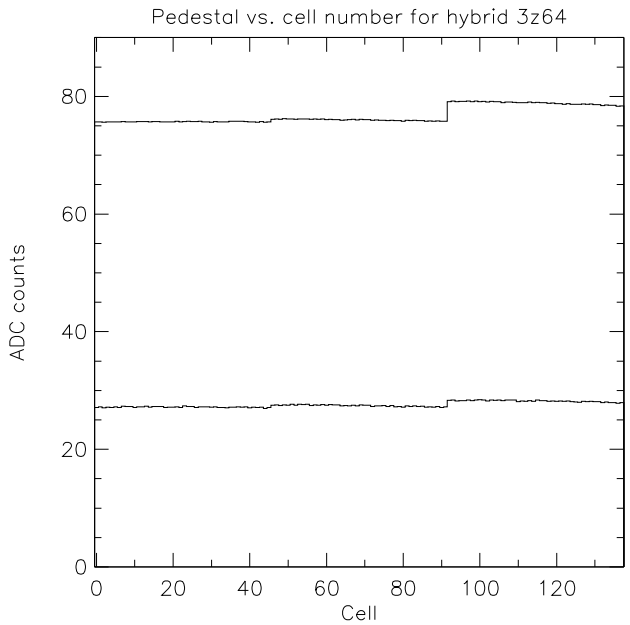
Pedestal vs. Pipeline Cell ID

The following plot shows the average pedestal vs. pipeline cell ID with and without charge injection. The x-axis is cell ID offset by 46 for each chip. Thus cell ID 5 for chip 1 is at x=5, chip 2 at x=51, chip 3 at x=97, etc.

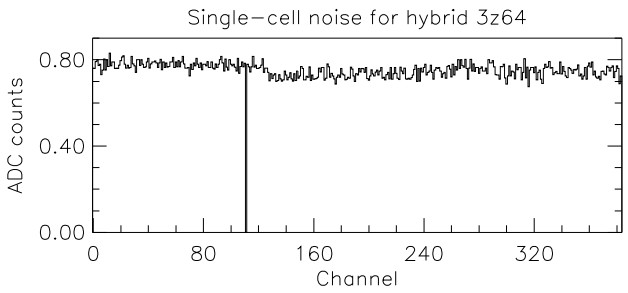
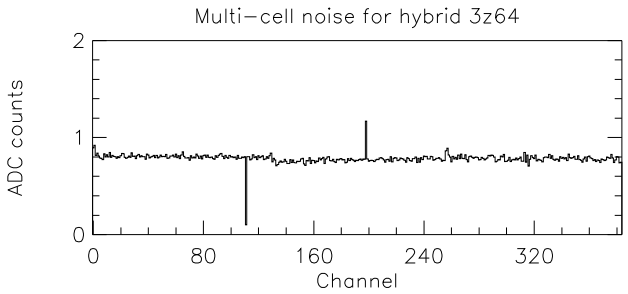
RMS Noise

The following plots show the single-cell and multi-cell RMS noise:

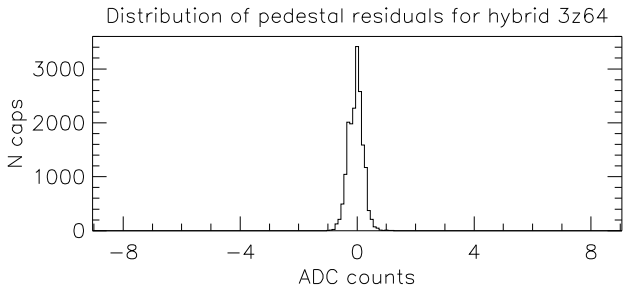
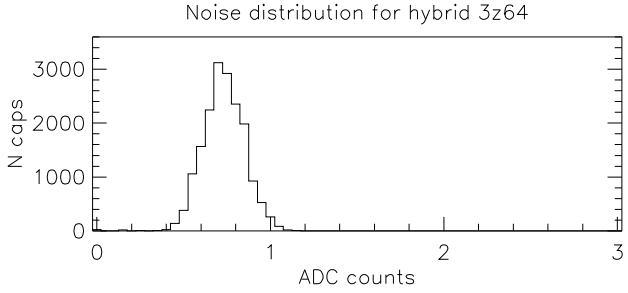
Distribution of Pedestals and Noise

The following are histograms of the pedestal of each pipeline capacitor relative to the chip average (top); and the RMS noise of each capacitor (bottom):

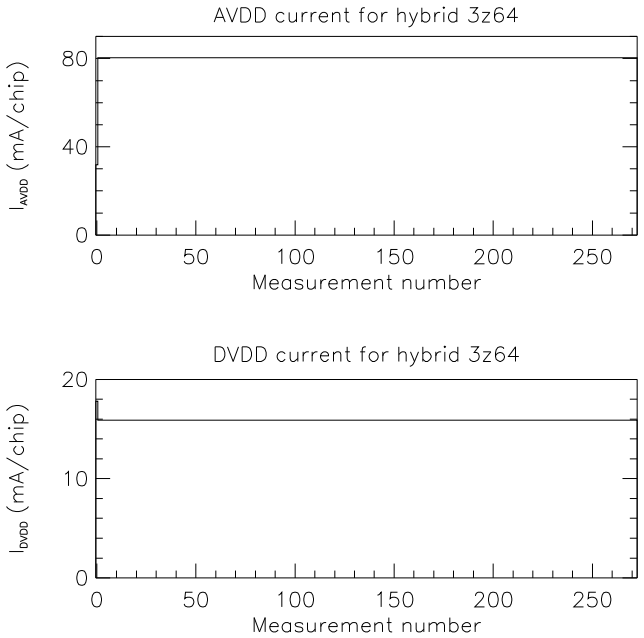
Supply Currents During Burn-in

The following plots show the supply currents per chip as a function of measurment number. Currents are measured approximately every 10 minutes:
