Hybrid 3z66 Traveler

February 3, 2000

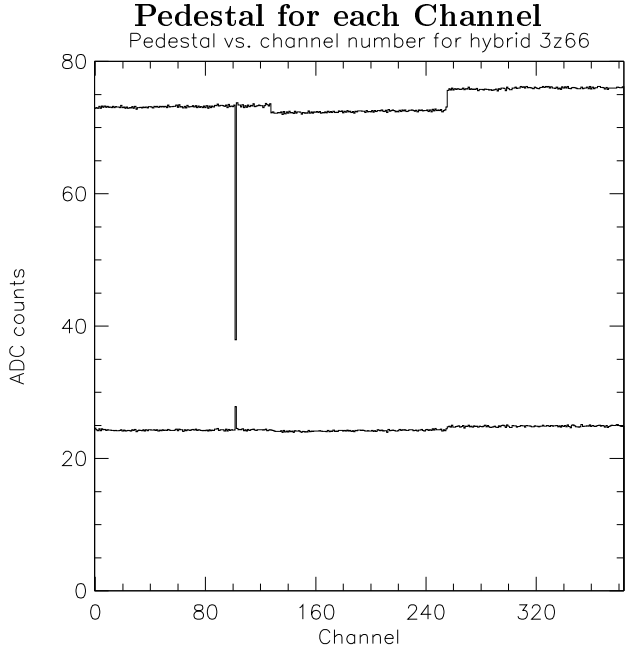
Pedestal for each Channel

The following plot shows the pedestals vs. channel number with and without charge injection:

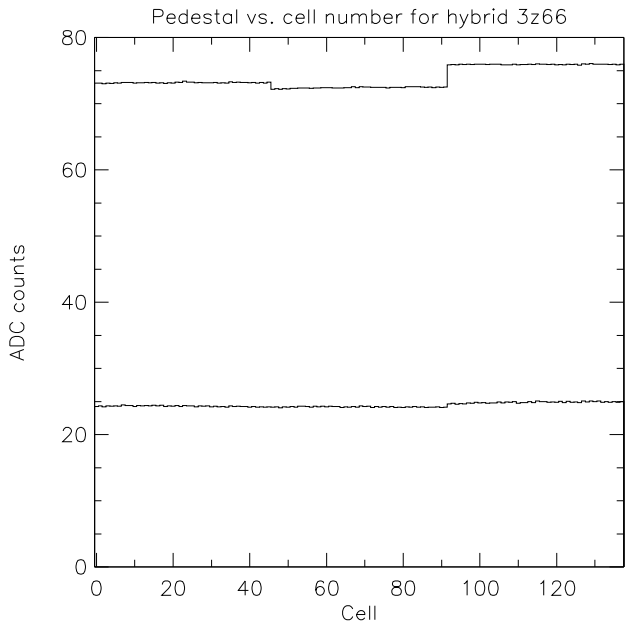
Pedestal vs. Pipeline Cell ID

The following plot shows the average pedestal vs. pipeline cell ID with and without charge injection. The x-axis is cell ID offset by 46 for each chip. Thus cell ID 5 for chip 1 is at x=5, chip 2 at x=51, chip 3 at x=97, etc.

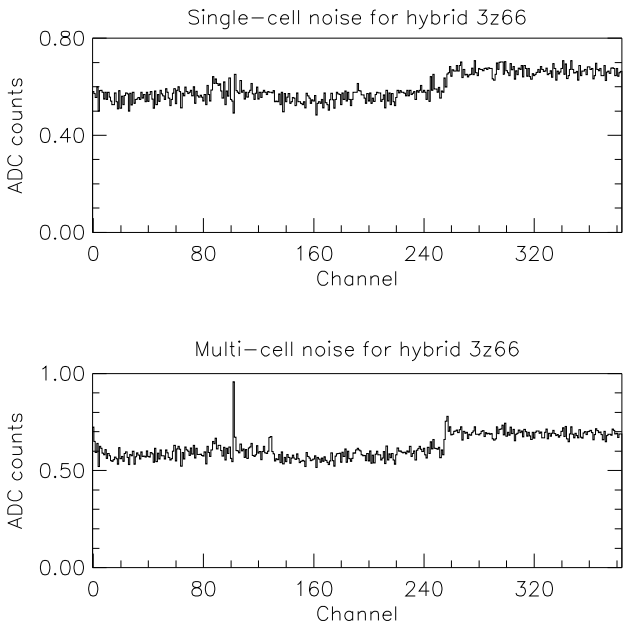
RMS Noise

The following plots show the single-cell and multi-cell RMS noise:

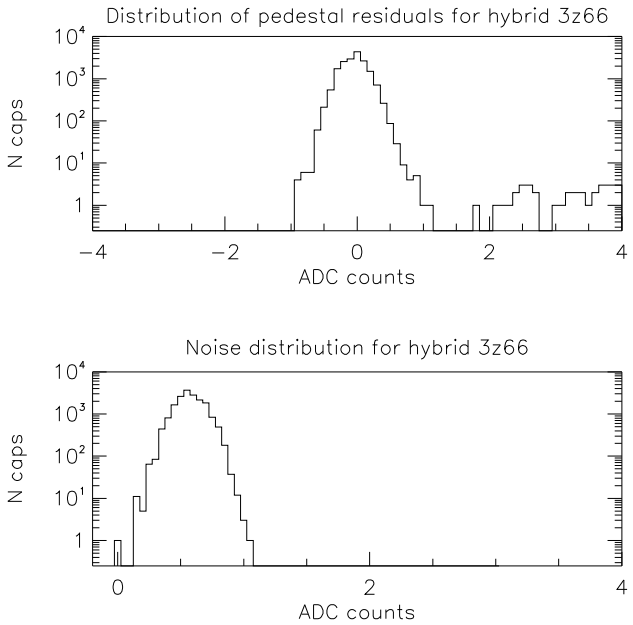
Distribution of Pedestals and Noise

The following are histograms of the pedestal of each pipeline capacitor relative to the chip average (top); and the RMS noise of each capacitor (bottom):

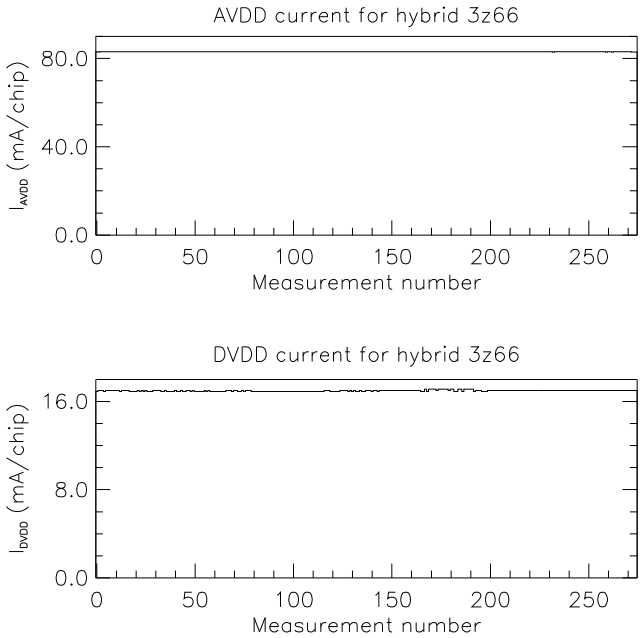
Supply Currents During Burn-in

The following plots show the supply currents per chip as a function of measurment number. Currents are measured approximately every 10 minutes:
