Hybrid 3z72 Traveler

March 10, 2000

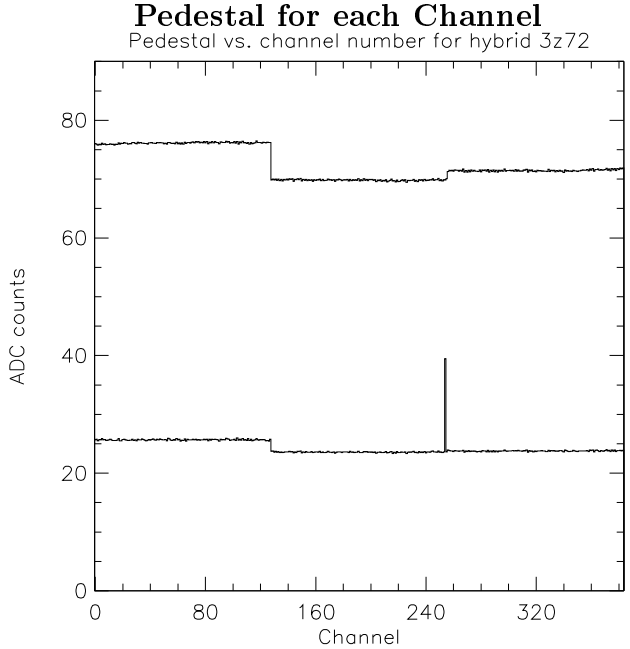
Pedestal for each Channel

The following plot shows the pedestals vs. channel number with and without charge injection:

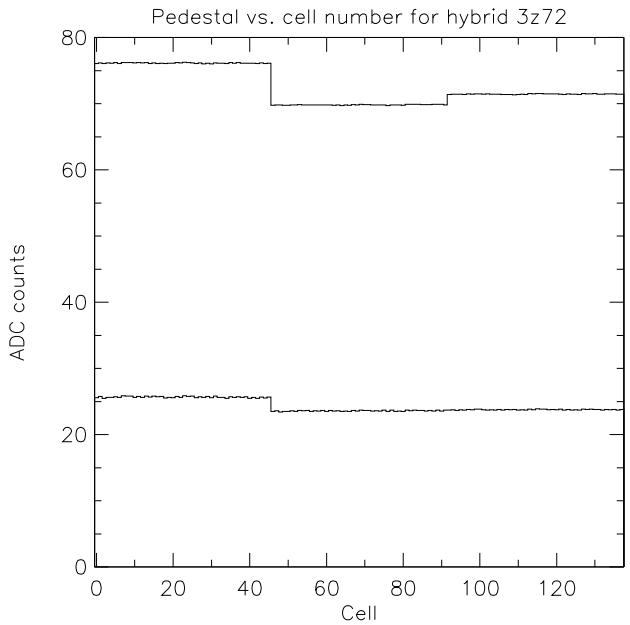
Pedestal vs. Pipeline Cell ID

The following plot shows the average pedestal vs. pipeline cell ID with and without charge injection. The x-axis is cell ID offset by 46 for each chip. Thus cell ID 5 for chip 1 is at x=5, chip 2 at x=51, chip 3 at x=97, etc.

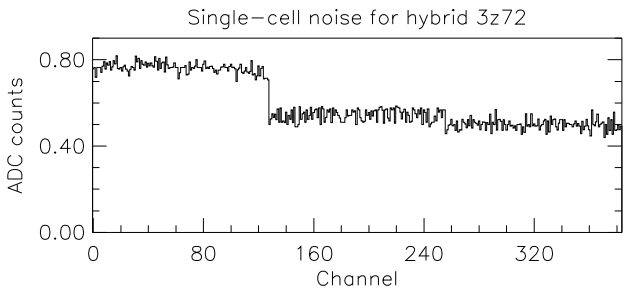
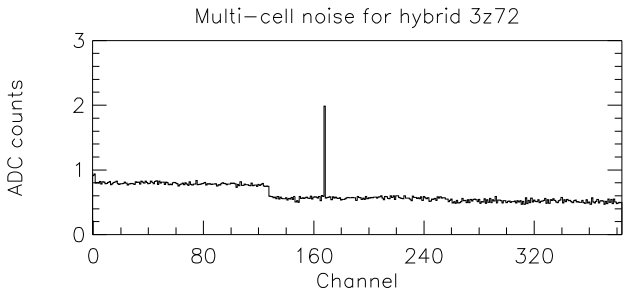
RMS Noise

The following plots show the single-cell and multi-cell RMS noise:

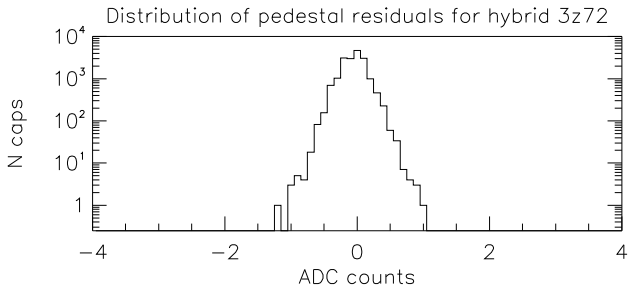
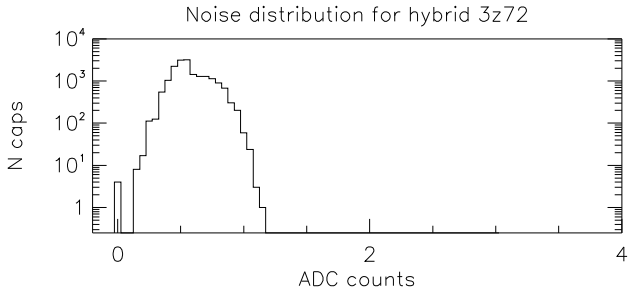
Distribution of Pedestals and Noise

The following are histograms of the pedestal of each pipeline capacitor relative to the chip average (top); and the RMS noise of each capacitor (bottom):

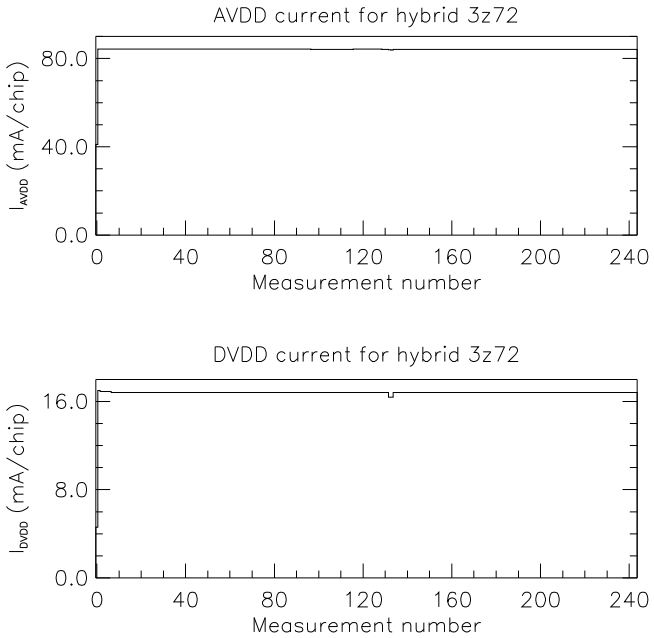
Supply Currents During Burn-in

The following plots show the supply currents per chip as a function of measurment number. Currents are measured approximately every 10 minutes:
