Hybrid 3z74 Traveler

December 17, 1999

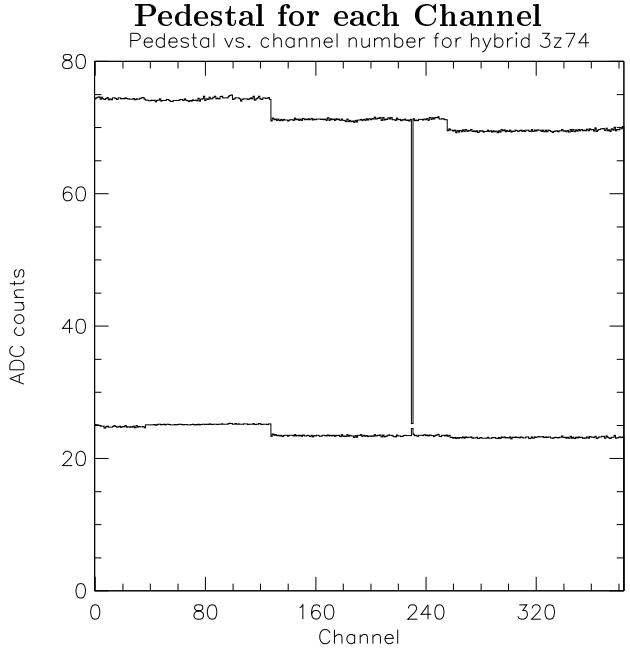
Pedestal for each Channel

The following plot shows the pedestals vs. channel number with and without charge injection:

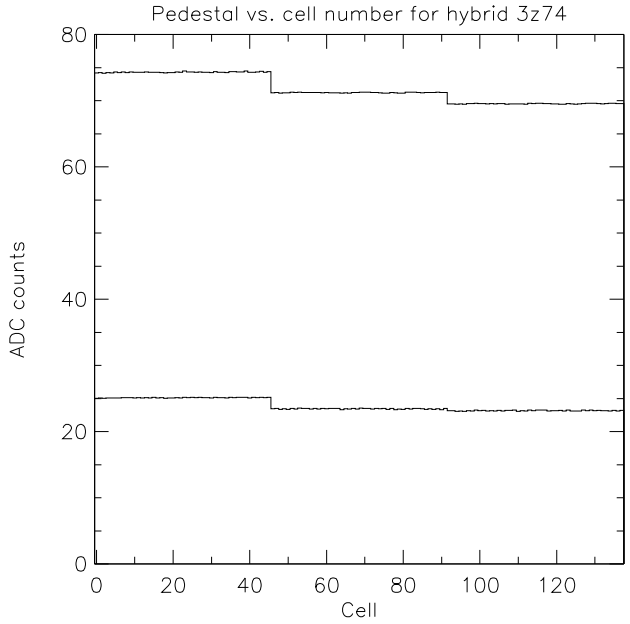
Pedestal vs. Pipeline Cell ID

The following plot shows the average pedestal vs. pipeline cell ID with and without charge injection. The x-axis is cell ID offset by 46 for each chip. Thus cell ID 5 for chip 1 is at x=5, chip 2 at x=51, chip 3 at x=97, etc.

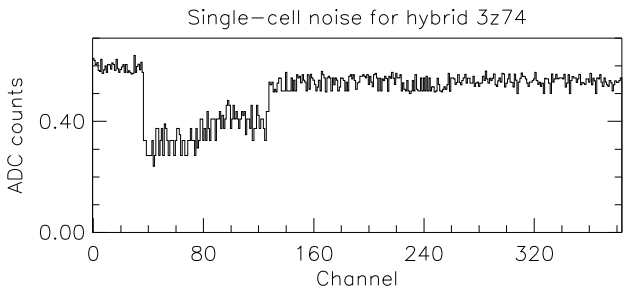
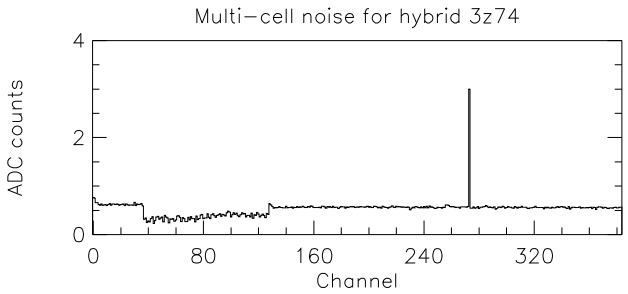
RMS Noise

The following plots show the single-cell and multi-cell RMS noise:

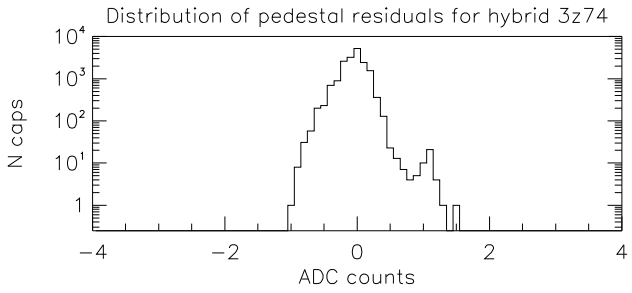
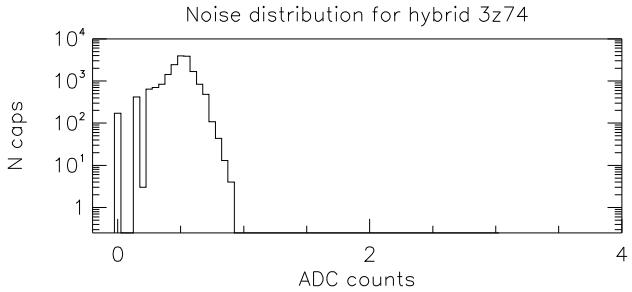
Distribution of Pedestals and Noise

The following are histograms of the pedestal of each pipeline capacitor relative to the chip average (top); and the RMS noise of each capacitor (bottom):

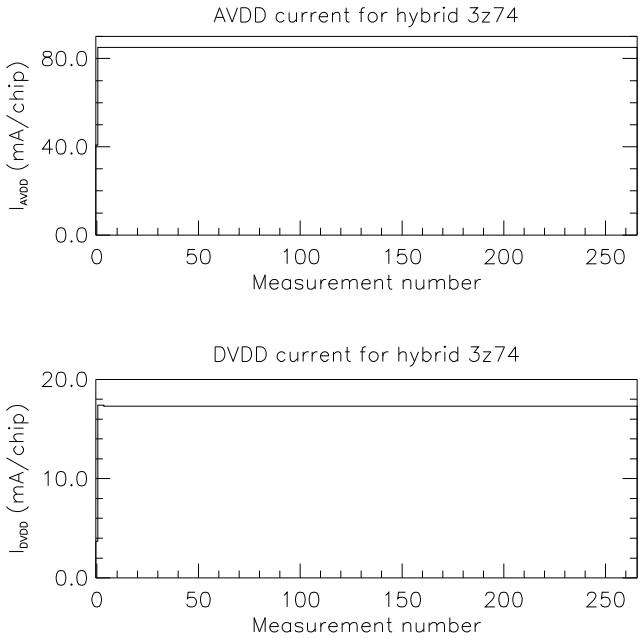
Supply Currents During Burn-in

The following plots show the supply currents per chip as a function of measurment number. Currents are measured approximately every 10 minutes:
