Hybrid 3z80 Traveler

January 14, 2000

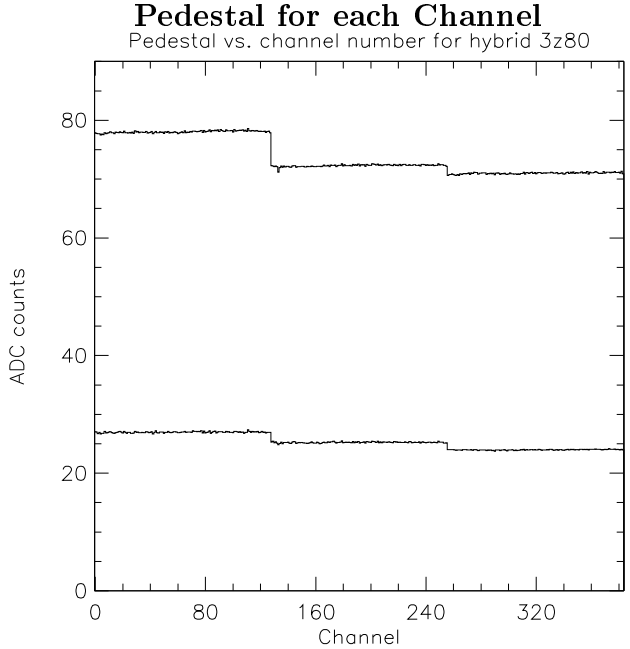
Pedestal for each Channel

The following plot shows the pedestals vs. channel number with and without charge injection:

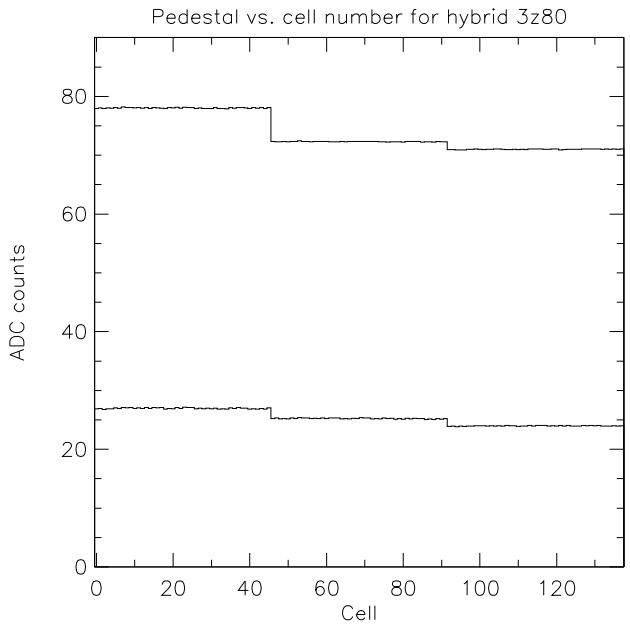
Pedestal vs. Pipeline Cell ID

The following plot shows the average pedestal vs. pipeline cell ID with and without charge injection. The x-axis is cell ID offset by 46 for each chip. Thus cell ID 5 for chip 1 is at x=5, chip 2 at x=51, chip 3 at x=97, etc.

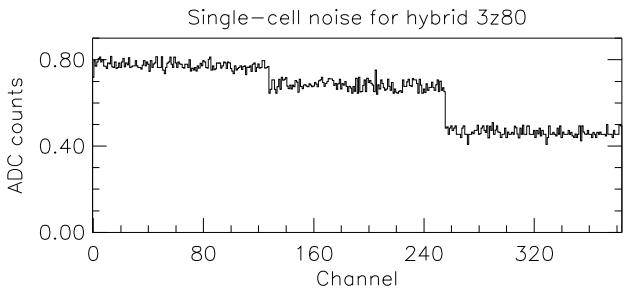
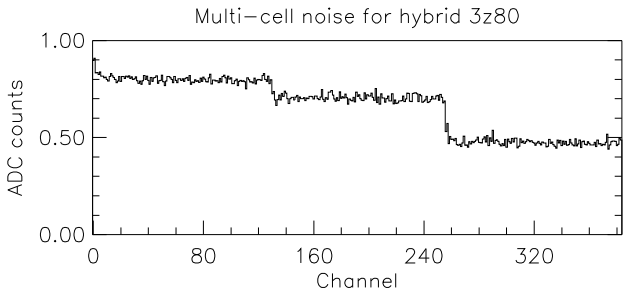
RMS Noise

The following plots show the single-cell and multi-cell RMS noise:

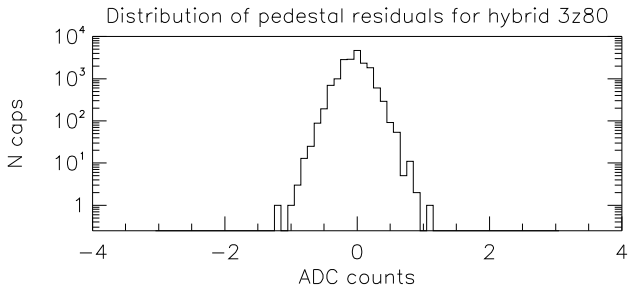
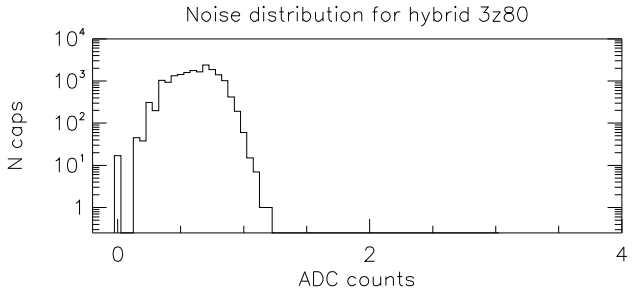
Distribution of Pedestals and Noise

The following are histograms of the pedestal of each pipeline capacitor relative to the chip average (top); and the RMS noise of each capacitor (bottom):

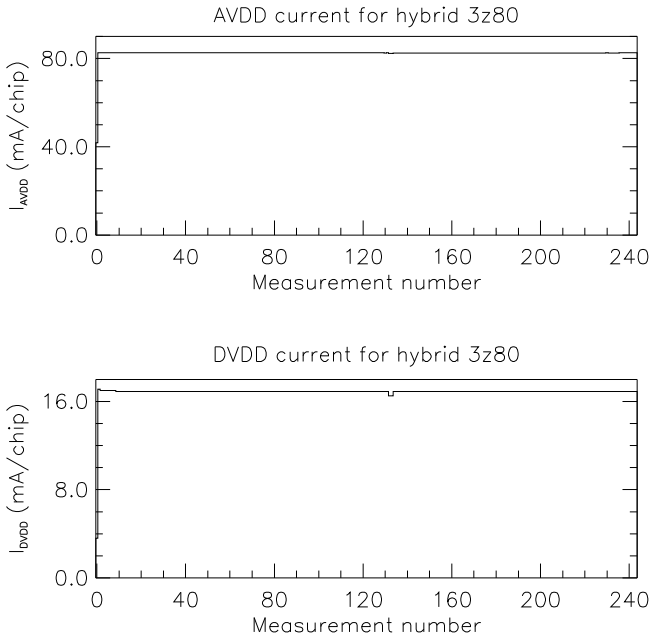
Supply Currents During Burn-in

The following plots show the supply currents per chip as a function of measurment number. Currents are measured approximately every 10 minutes:
