Hybrid 3z81 Traveler

February 1, 2000

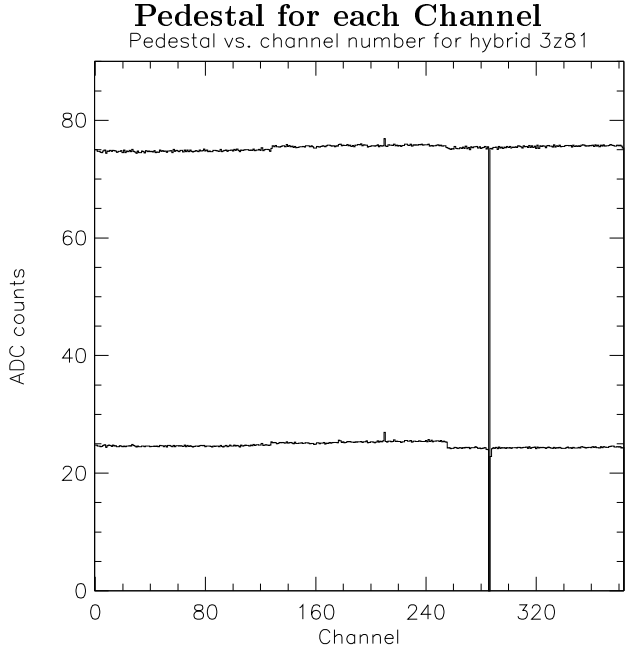
Pedestal for each Channel

The following plot shows the pedestals vs. channel number with and without charge injection:

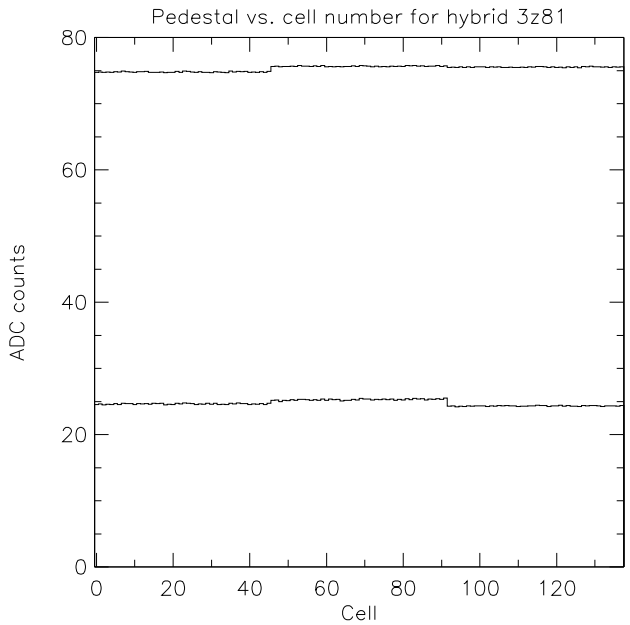
Pedestal vs. Pipeline Cell ID

The following plot shows the average pedestal vs. pipeline cell ID with and without charge injection. The x-axis is cell ID offset by 46 for each chip. Thus cell ID 5 for chip 1 is at x=5, chip 2 at x=51, chip 3 at x=97, etc.

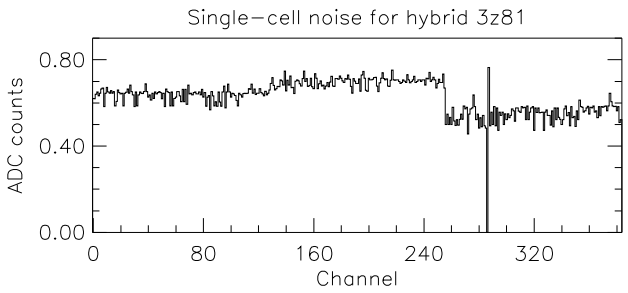
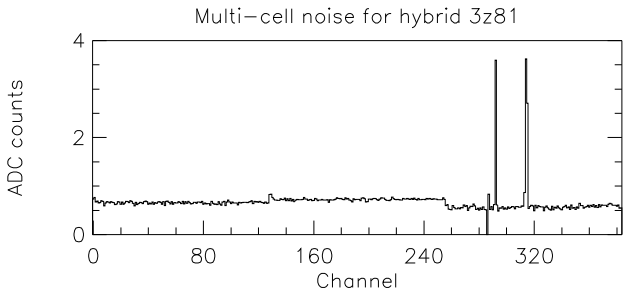
RMS Noise

The following plots show the single-cell and multi-cell RMS noise:

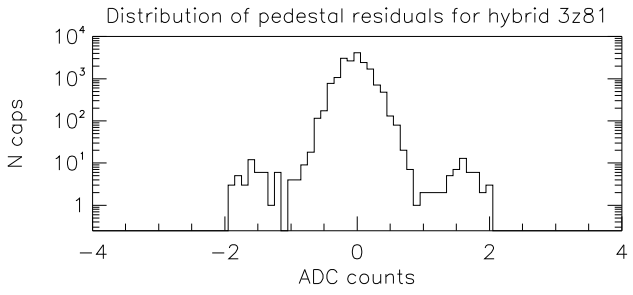
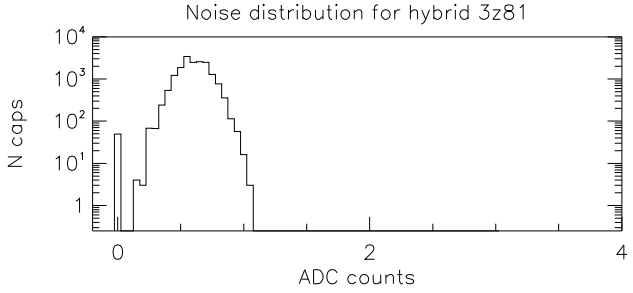
Distribution of Pedestals and Noise

The following are histograms of the pedestal of each pipeline capacitor relative to the chip average (top); and the RMS noise of each capacitor (bottom):

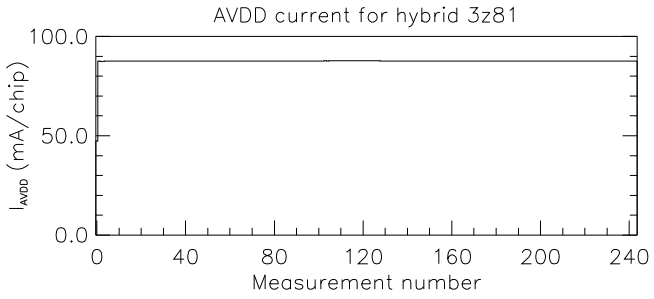
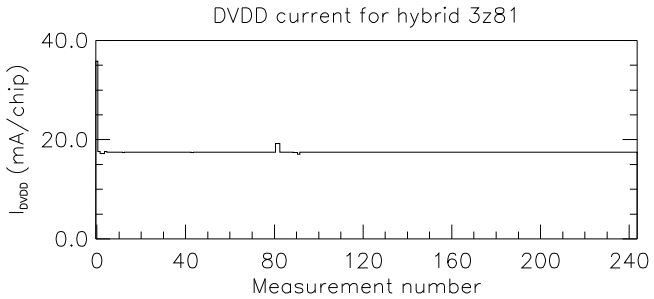
Supply Currents During Burn-in

The following plots show the supply currents per chip as a function of measurment number. Currents are measured approximately every 10 minutes:
