Hybrid 3z83 Traveler

April 25, 2000

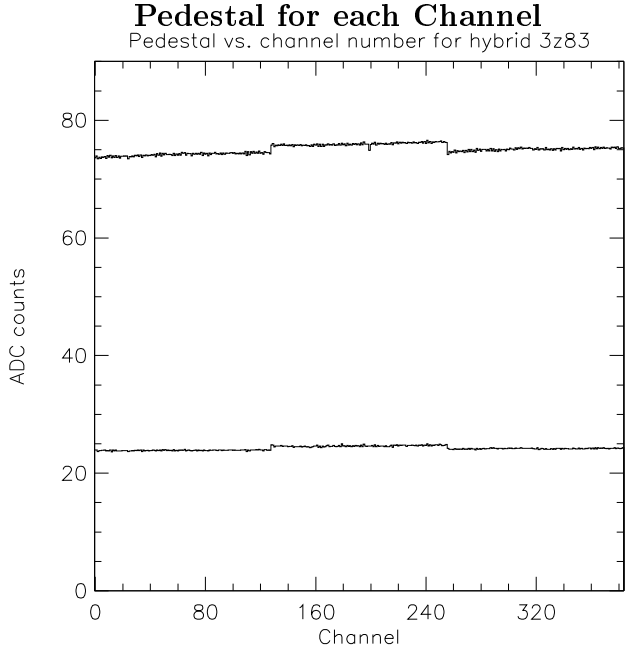
Pedestal for each Channel

Hybrid 3z83 quality: fair
Chip classification: good fair good
Bad channels (chip-channel): 1-71
Bad cells: none
Random bad capacitors: none
Channels at pedestal needed for DCMS: 33.7 35.7 33.6
```
