Hybrid 4z117 Traveler

January 12, 2000

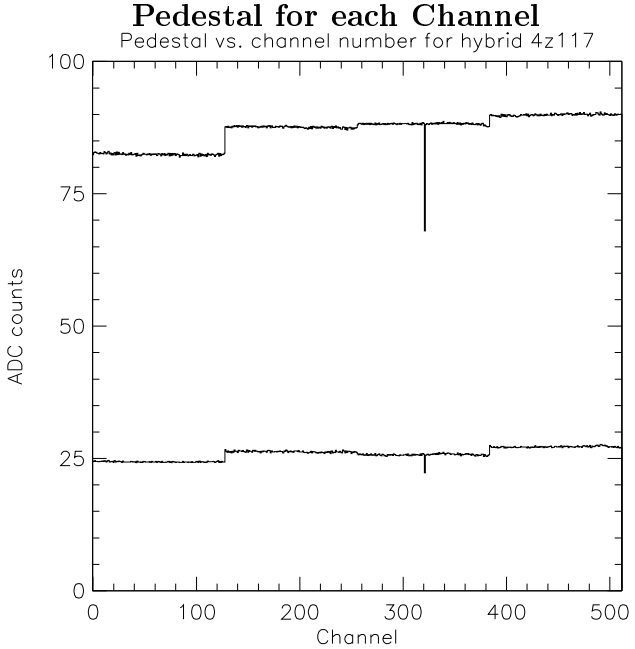
Pedestal for each Channel

The following plot shows the pedestals vs. channel number with and without charge injection:

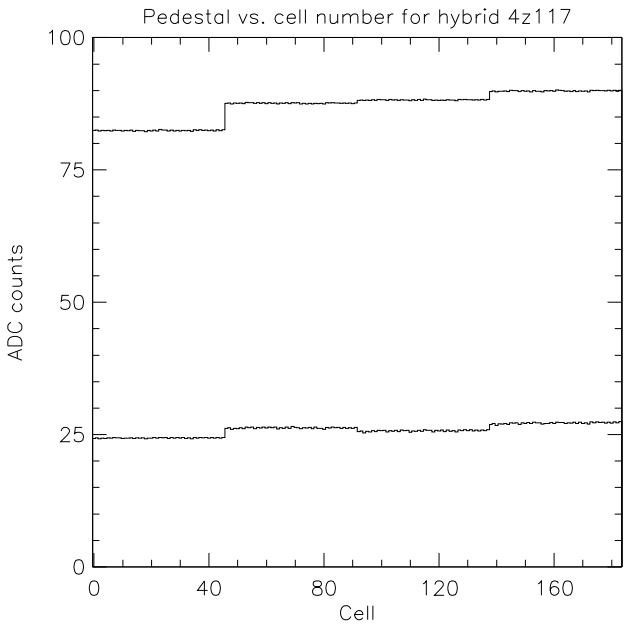
Pedestal vs. Pipeline Cell ID

The following plot shows the average pedestal vs. pipeline cell ID with and without charge injection. The x-axis is cell ID offset by 46 for each chip. Thus cell ID 5 for chip 1 is at x=5, chip 2 at x=51, chip 3 at x=97, etc.

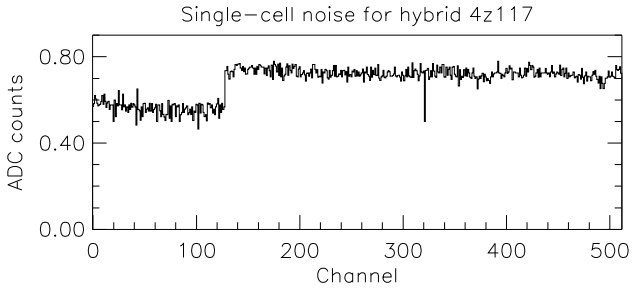
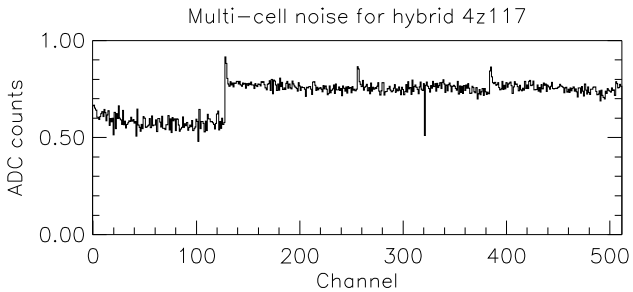
RMS Noise

The following plots show the single-cell and multi-cell RMS noise:

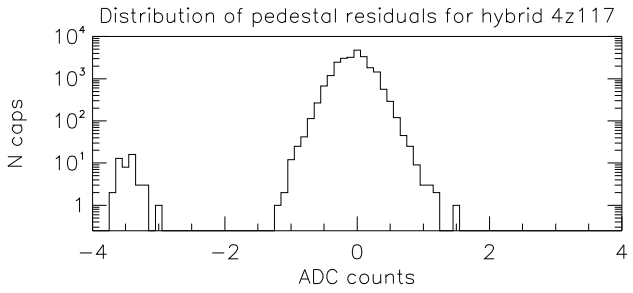
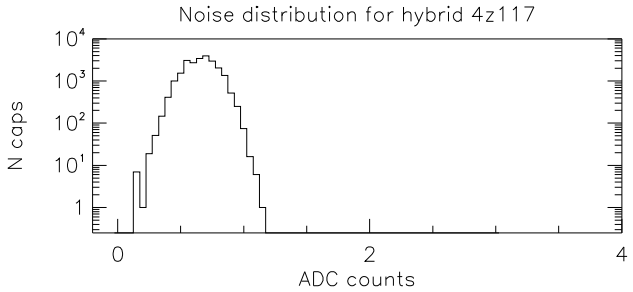
Distribution of Pedestals and Noise

The following are histograms of the pedestal of each pipeline capacitor relative to the chip average (top); and the RMS noise of each capacitor (bottom):

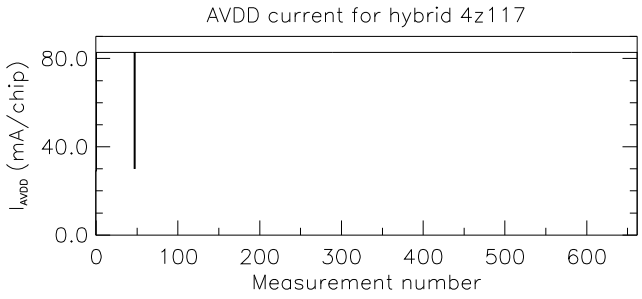
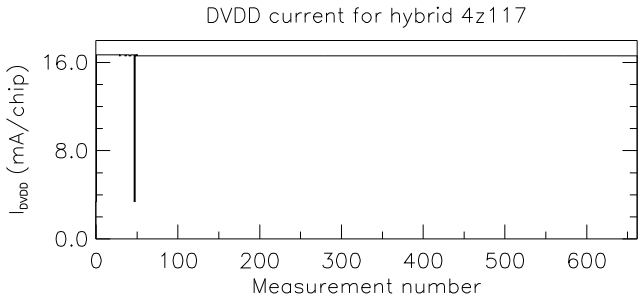
Supply Currents During Burn-in

The following plots show the supply currents per chip as a function of measurment number. Currents are measured approximately every 10 minutes:
