Hybrid 4z127 Traveler

September 8, 1999

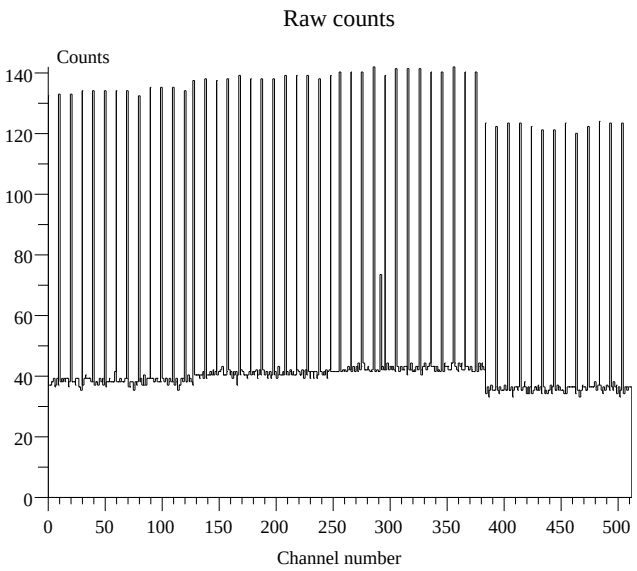
Pedestal

The following channels were bad or exceedingly noisy:
65, 292 are bad. 128 has dead pipeline cell.

The following plot shows the pedestals vs. channel number

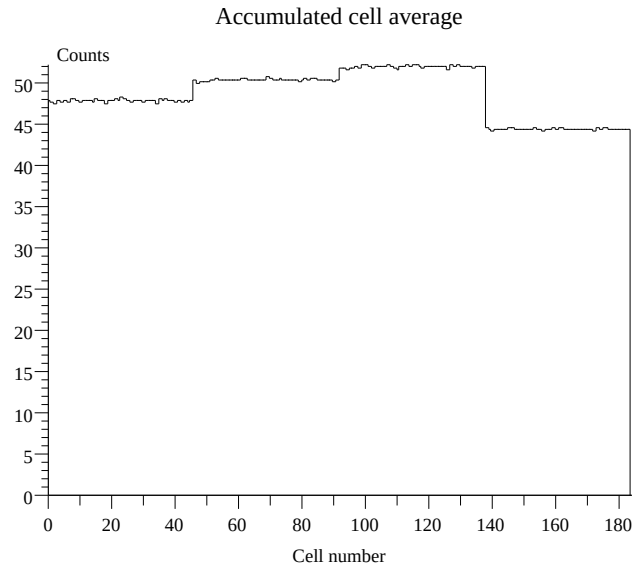
Pedestal vs. Pipeline Cell ID

The following plot shows the average pedestal vs. pipeline cell ID. The x-axis is cell ID offset by 46 for each chip. Thus cell ID 5 on chip 1 ia at x=5, chip 2 at x=49, chip 3 at x=97, etc.

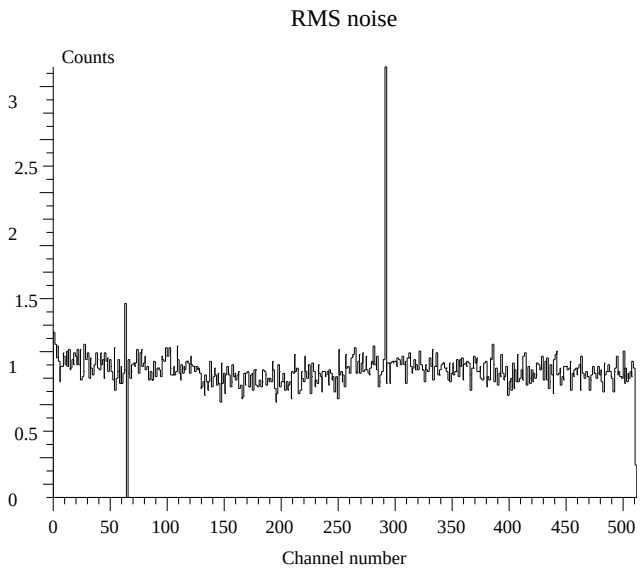
RMS Noise

The following plot shows the single cell RMS noise:

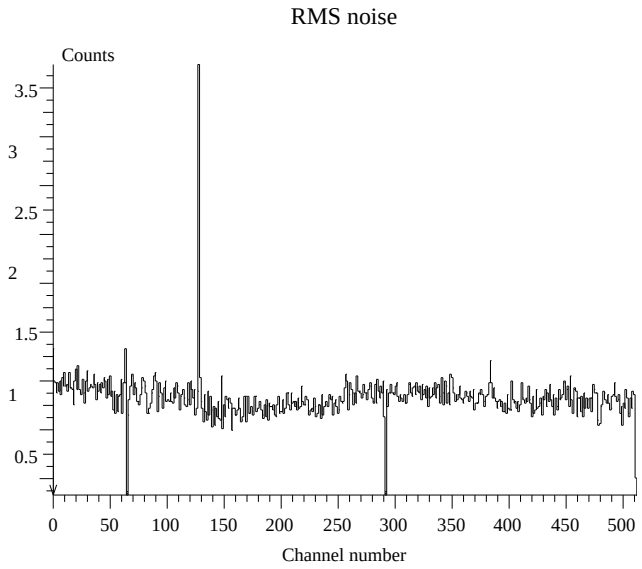
Multi-Cell Noise

The following plot show the multi-cell RMS noise:

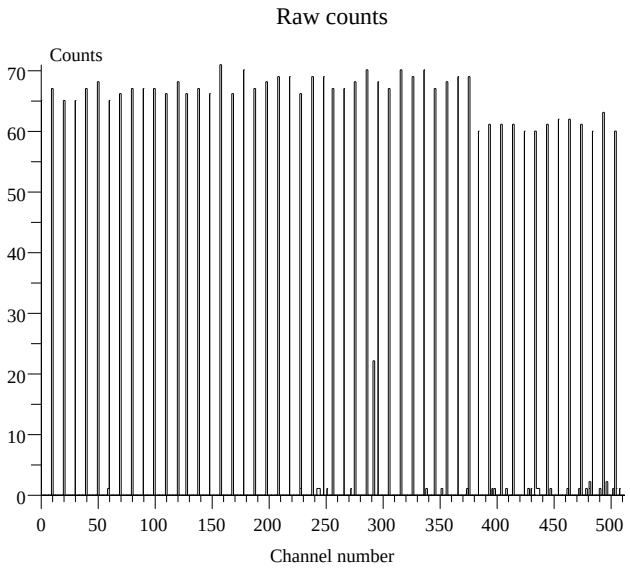
Dynamic Threshold Subtraction

The following plot shows the readout of channels with charge injection with the dynamic threshold subtraction turned on:
