Hybrid 4z18 Traveler

September 29, 1999

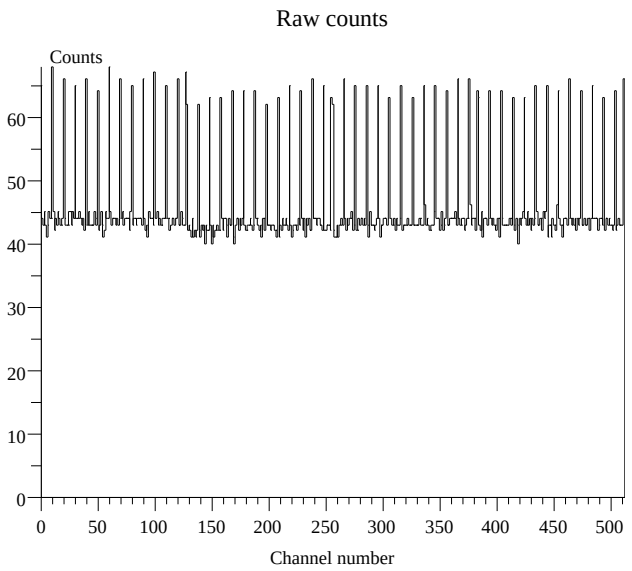
Pedestal

The following plot shows the pedestals vs. channel number

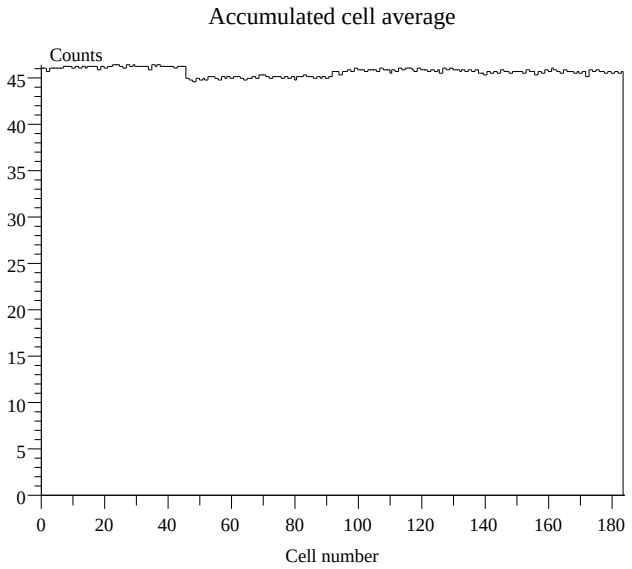
Pedestal vs. Pipeline Cell ID

The following plot shows the average pedestal vs. pipeline cell ID. The x-axis is cell ID offset by 46 for each chip. Thus cell ID 5 on chip 1 ia at x=5, chip 2 at x=49, chip 3 at x=97, etc.

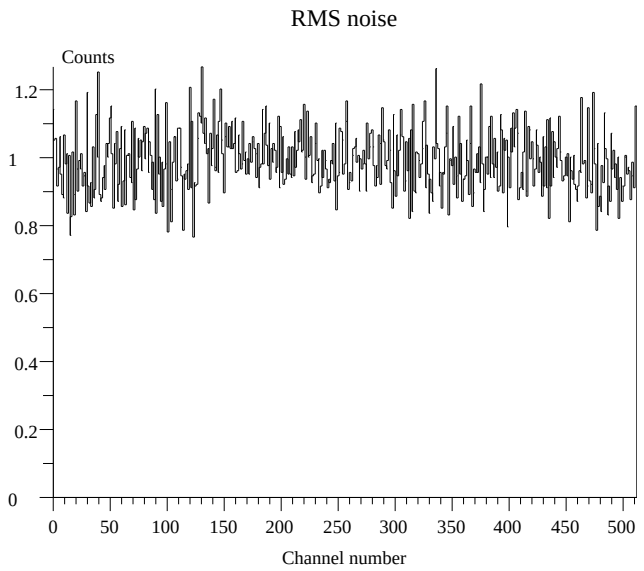
RMS Noise

The following plot shows the single cell RMS noise:

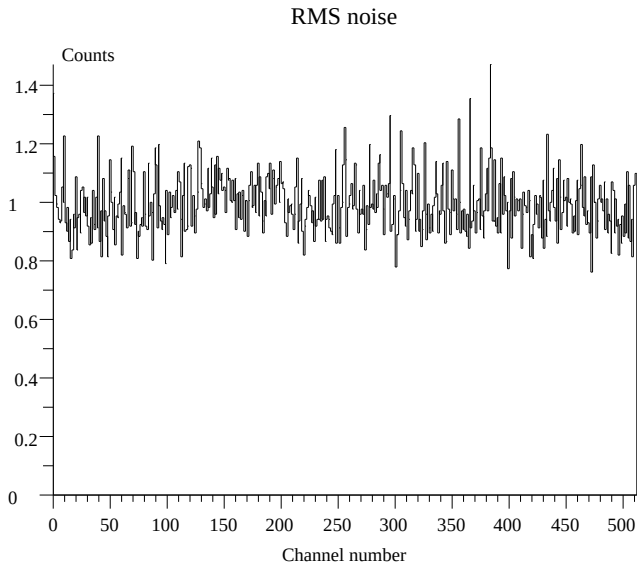
Multi-Cell Noise

The following plot show the multi-cell RMS noise:

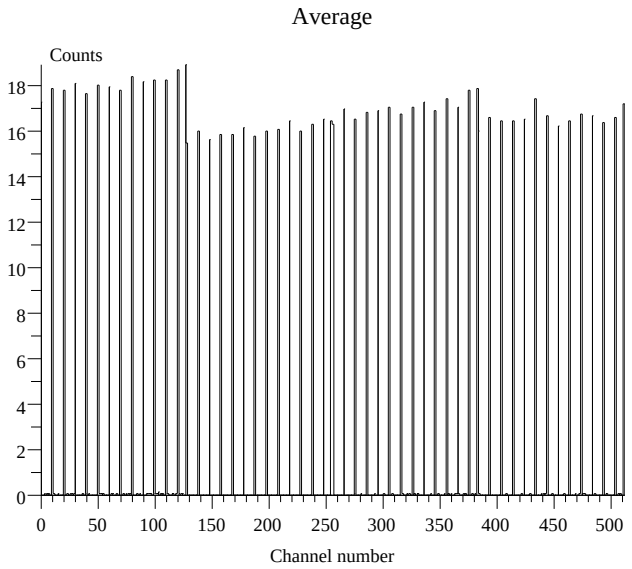
Dynamic Threshold Subtraction

The following plot shows the readout of channels with charge injection with the dynamic threshold subtraction turned on:
