Hybrid 4z34 Traveler

September 8, 1999

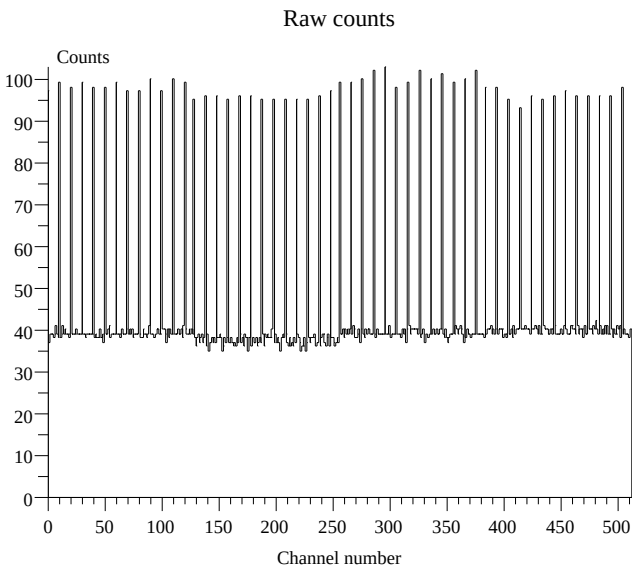
Pedestal

The following plot shows the pedestals vs. channel number

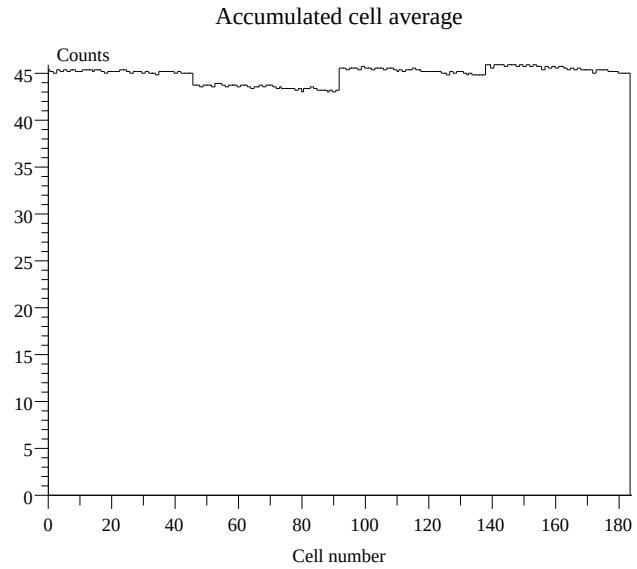
Pedestal vs. Pipeline Cell ID

The following plot shows the average pedestal vs. pipeline cell ID. The x-axis is cell ID offset by 46 for each chip. Thus cell ID 5 on chip 1 ia at x=5, chip 2 at x=49, chip 3 at x=97, etc.

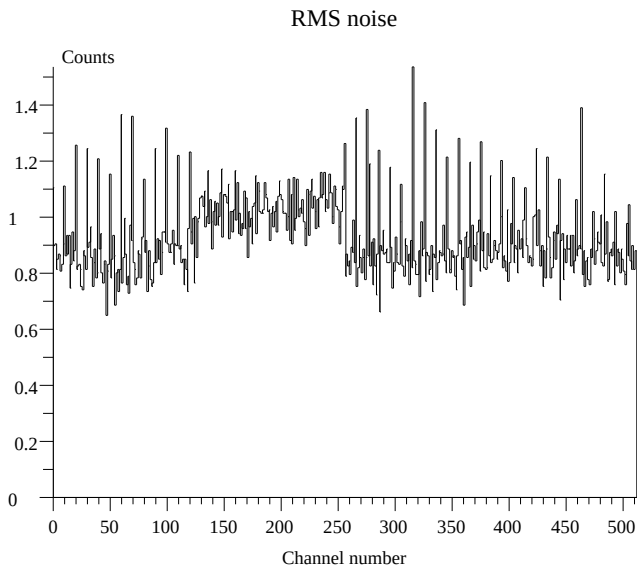
RMS Noise

The following plot shows the single cell RMS noise:

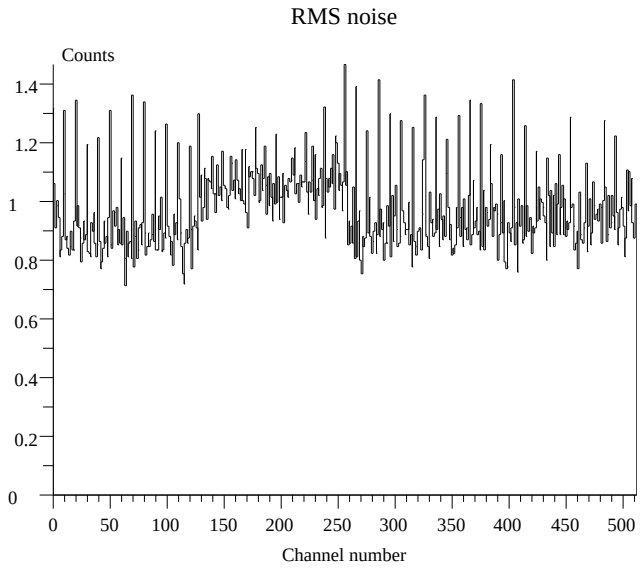
Multi-Cell Noise

The following plot show the multi-cell RMS noise:

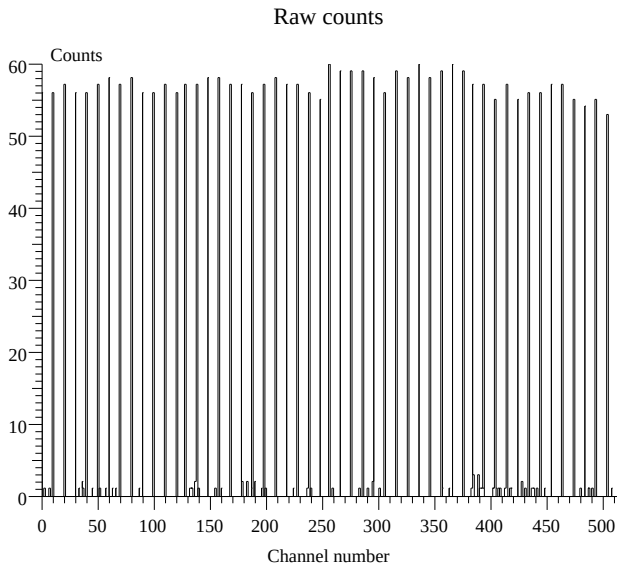
Dynamic Threshold Subtraction

The following plot shows the readout of channels with charge injection with the dynamic threshold subtraction turned on:
