Hybrid 5p0 Traveler

December 14, 1999

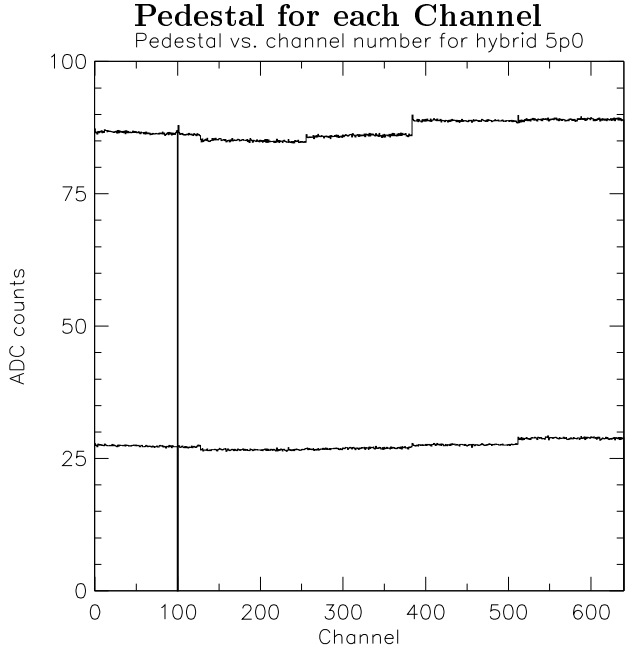
The following plot shows the pedestals vs. channel number with and without charge injection:

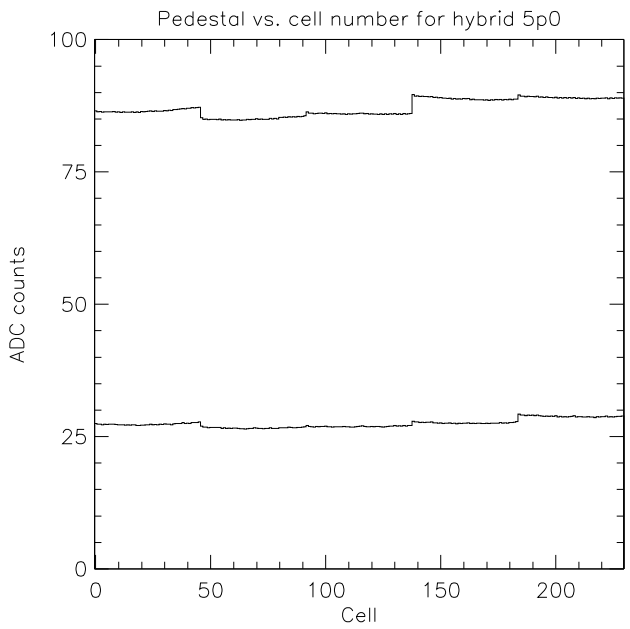
The following plot shows the average pedestal vs. pipeline cell ID with and without charge injection. The x-axis is cell ID offset by 46 for each chip. Thus cell ID 5 for chip 1 is at x=5, chip 2 at x=51, chip 3 at x=97, etc.

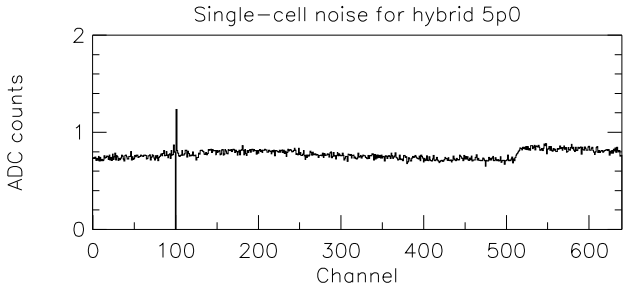
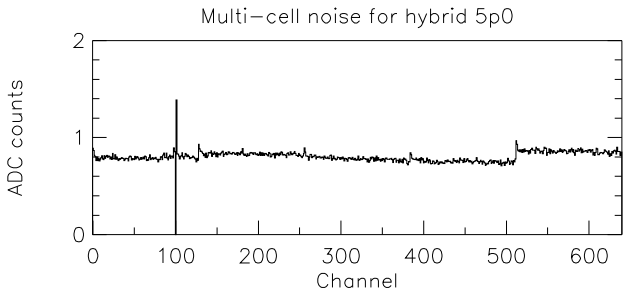
RMS Noise

The following plots show the single-cell and multi-cell RMS noise:

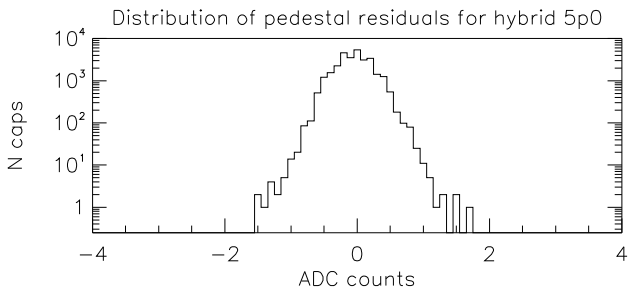
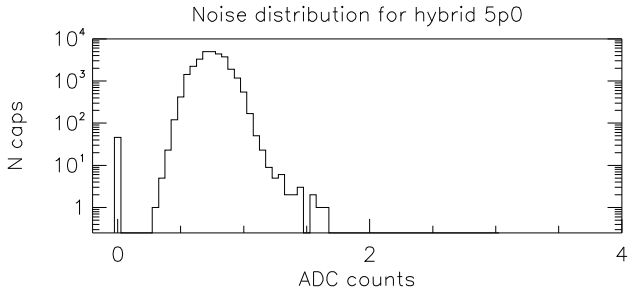
Distribution of Pedestals and Noise

The following are histograms of the pedestal of each pipeline capacitor relative to the chip average (top); and the RMS noise of each capacitor (bottom):

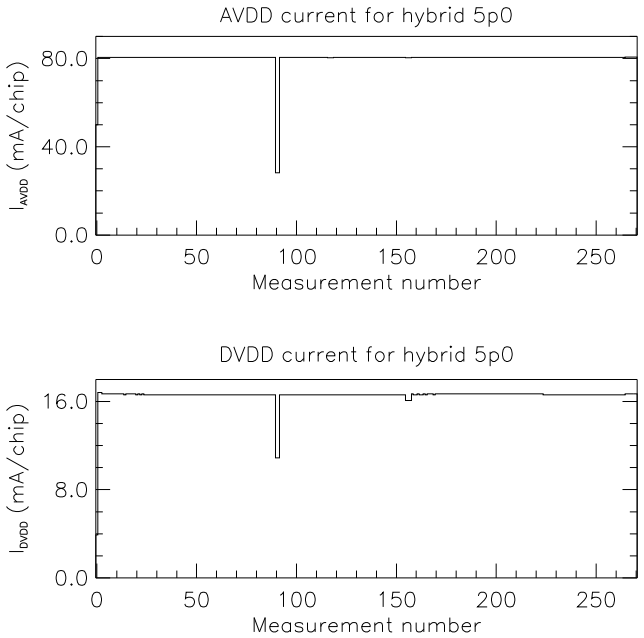
Supply Currents During Burn-in

The following plots show the supply currents per chip as a function of measurment number. Currents are measured approximately every 10 minutes:
