Hybrid 5z106 Traveler

January 19, 2000

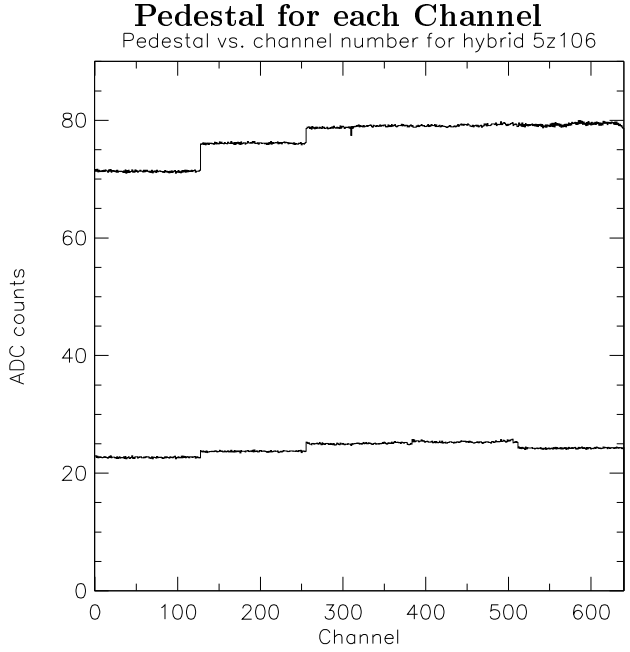
Pedestal for each Channel

The following plot shows the pedestals vs. channel number with and without charge injection:

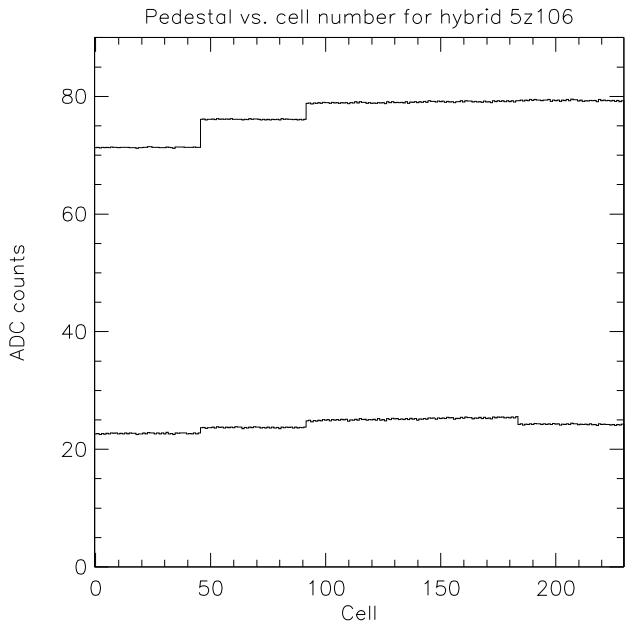
Pedestal vs. Pipeline Cell ID

The following plot shows the average pedestal vs. pipeline cell ID with and without charge injection. The x-axis is cell ID offset by 46 for each chip. Thus cell ID 5 for chip 1 is at x=5, chip 2 at x=51, chip 3 at x=97, etc.

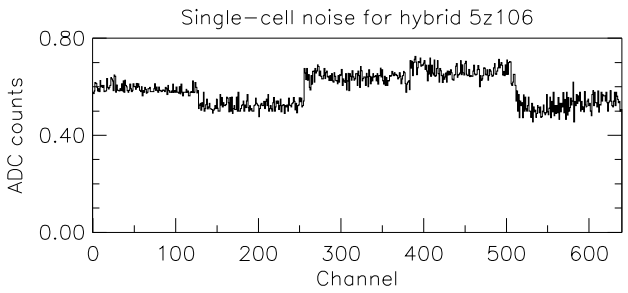
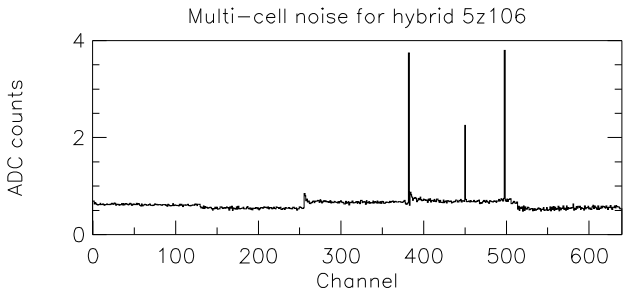
RMS Noise

The following plots show the single-cell and multi-cell RMS noise:

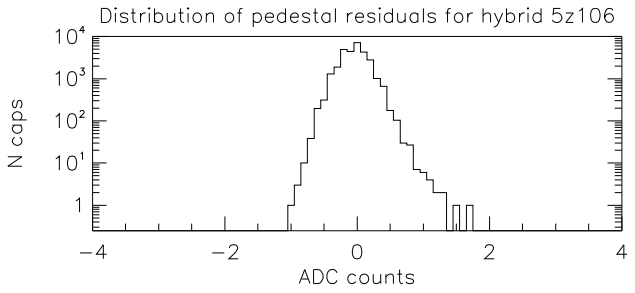
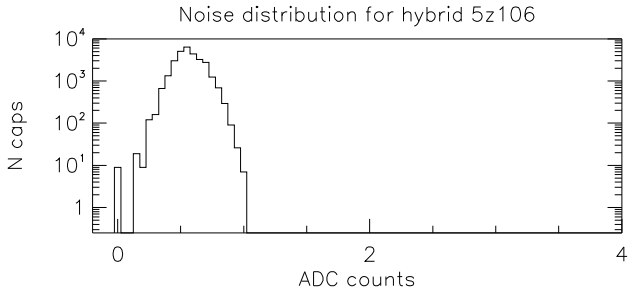
Distribution of Pedestals and Noise

The following are histograms of the pedestal of each pipeline capacitor relative to the chip average (top); and the RMS noise of each capacitor (bottom):

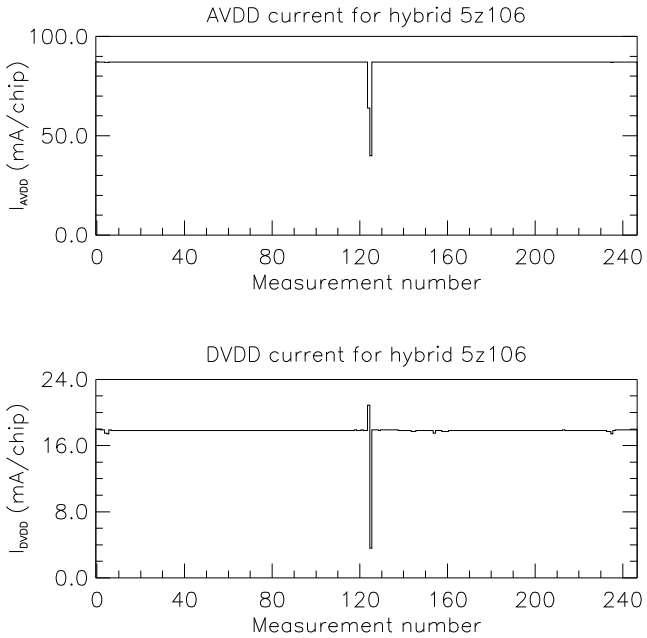
Supply Currents During Burn-in

The following plots show the supply currents per chip as a function of measurment number. Currents are measured approximately every 10 minutes:
