Hybrid 5z108 Traveler

May 1, 2000

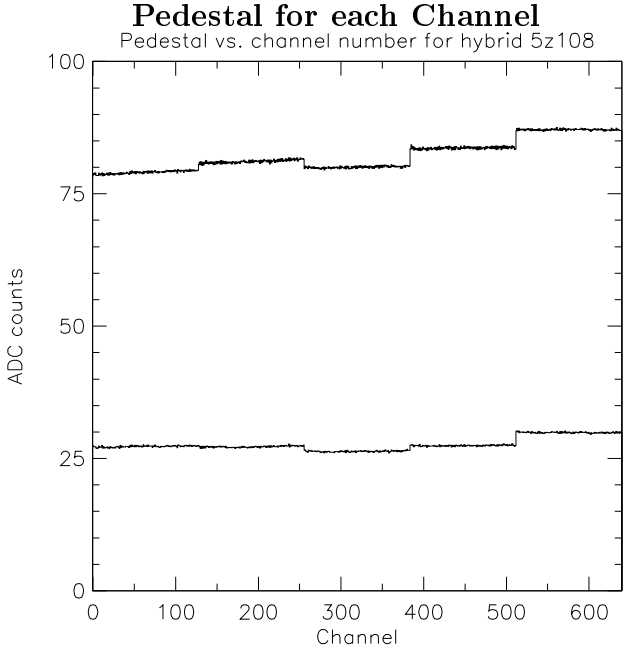
Pedestal for each Channel

The following plot shows the pedestals vs. channel number with and without charge injection:

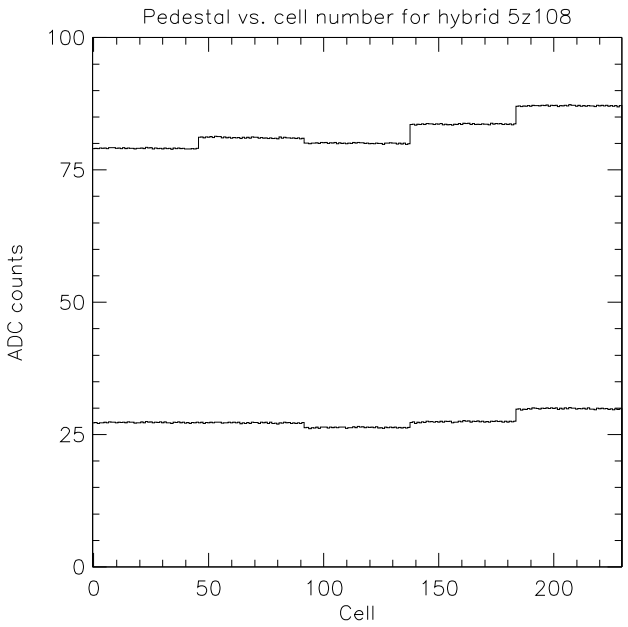
Pedestal vs. Pipeline Cell ID

The following plot shows the average pedestal vs. pipeline cell ID with and without charge injection. The x-axis is cell ID offset by 46 for each chip. Thus cell ID 5 for chip 1 is at x=5, chip 2 at x=51, chip 3 at x=97, etc.

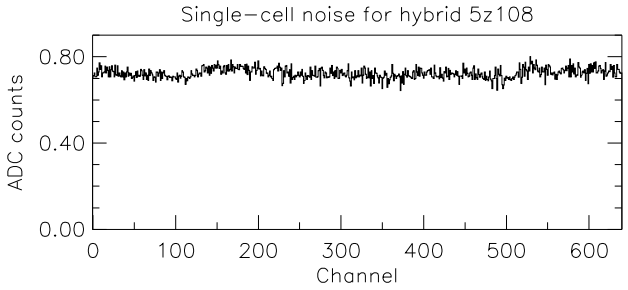
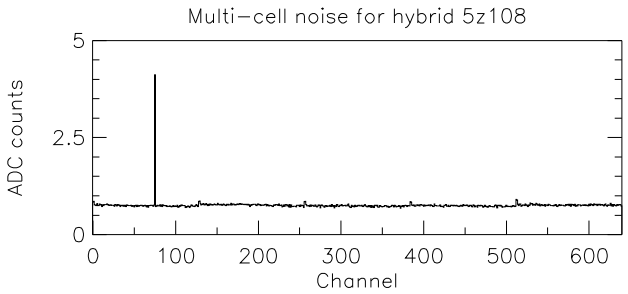
RMS Noise

The following plots show the single-cell and multi-cell RMS noise:

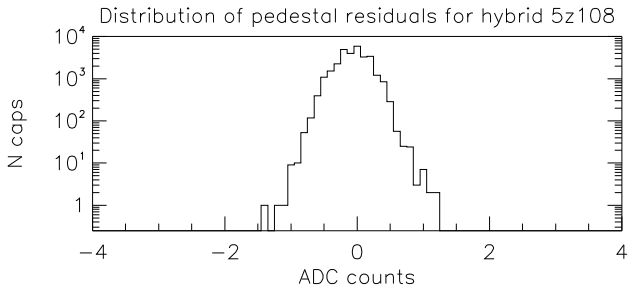
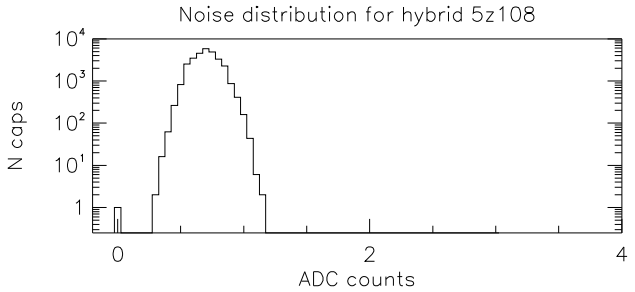
Distribution of Pedestals and Noise

The following are histograms of the pedestal of each pipeline capacitor relative to the chip average (top); and the RMS noise of each capacitor (bottom):

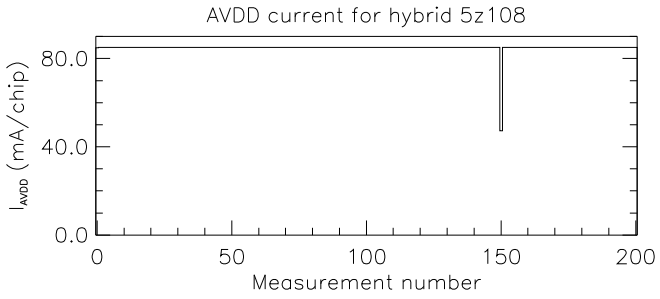
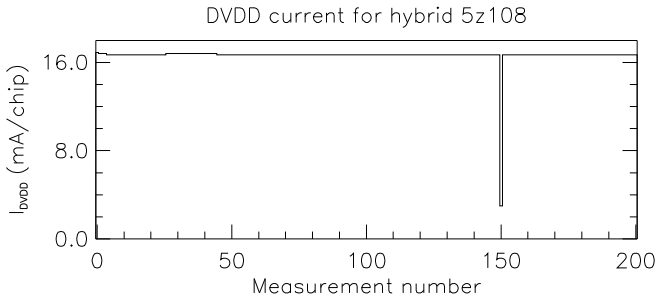
Supply Currents During Burn-in

The following plots show the supply currents per chip as a function of measurment number. Currents are measured approximately every 10 minutes:
