Hybrid 5z109 Traveler

December 13, 1999

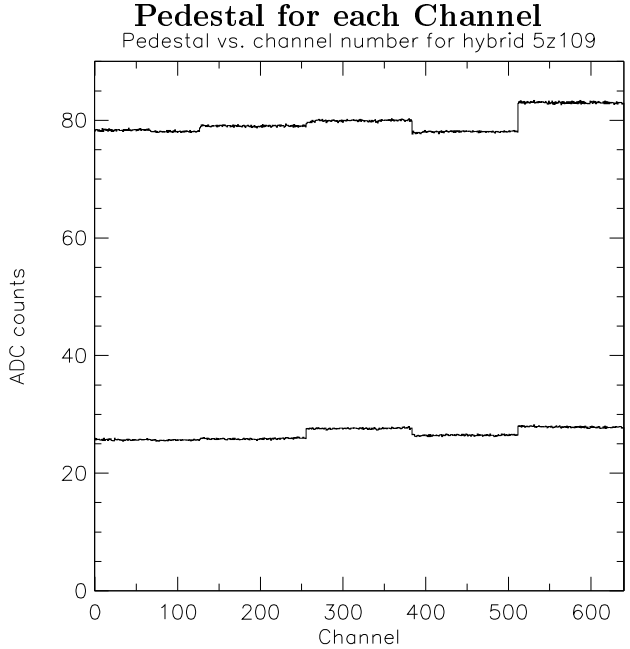
Pedestal for each Channel

The following plot shows the pedestals vs. channel number with and without charge injection:

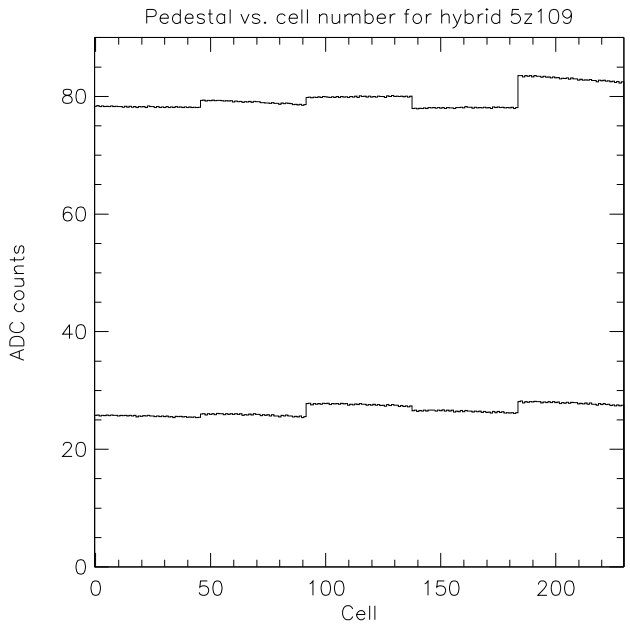
Pedestal vs. Pipeline Cell ID

The following plot shows the average pedestal vs. pipeline cell ID with and without charge injection. The x-axis is cell ID offset by 46 for each chip. Thus cell ID 5 for chip 1 is at x=5, chip 2 at x=51, chip 3 at x=97, etc.

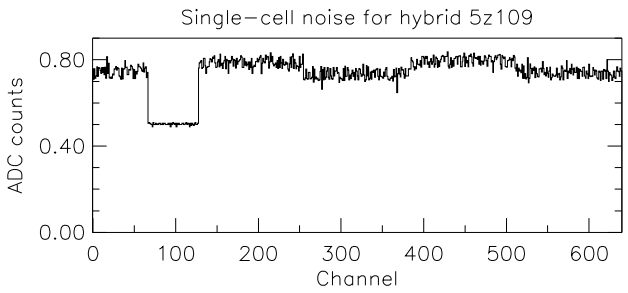
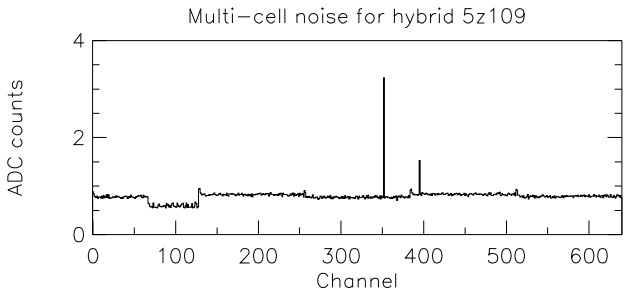
RMS Noise

The following plots show the single-cell and multi-cell RMS noise:

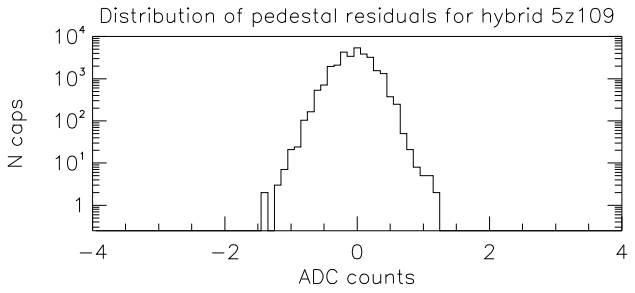
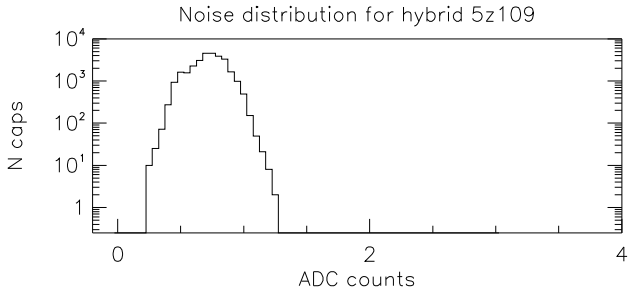
Distribution of Pedestals and Noise

The following are histograms of the pedestal of each pipeline capacitor relative to the chip average (top); and the RMS noise of each capacitor (bottom):

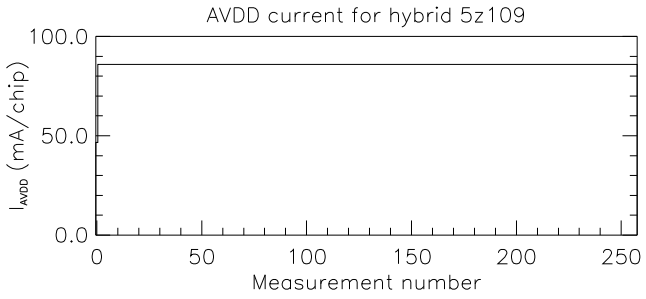
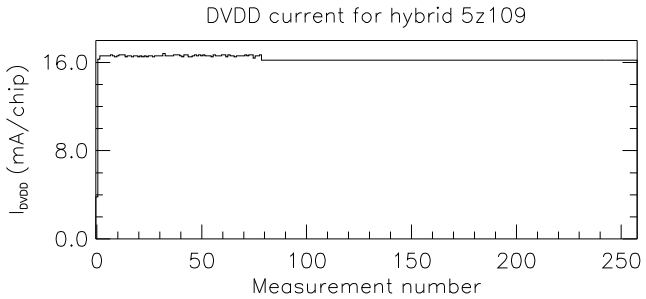
Supply Currents During Burn-in

The following plots show the supply currents per chip as a function of measurment number. Currents are measured approximately every 10 minutes:
