Hybrid 5z110 Traveler

April 17, 2000

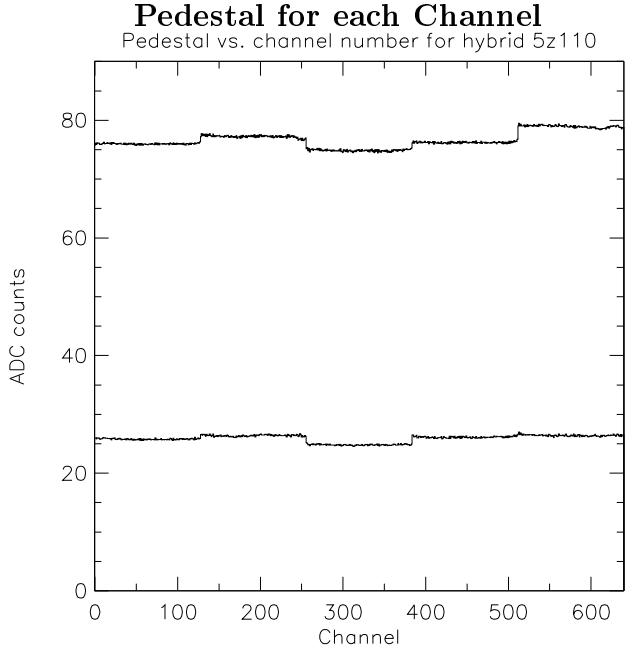
Pedestal for each Channel

The following plot shows the pedestals vs. channel number with and without charge injection:

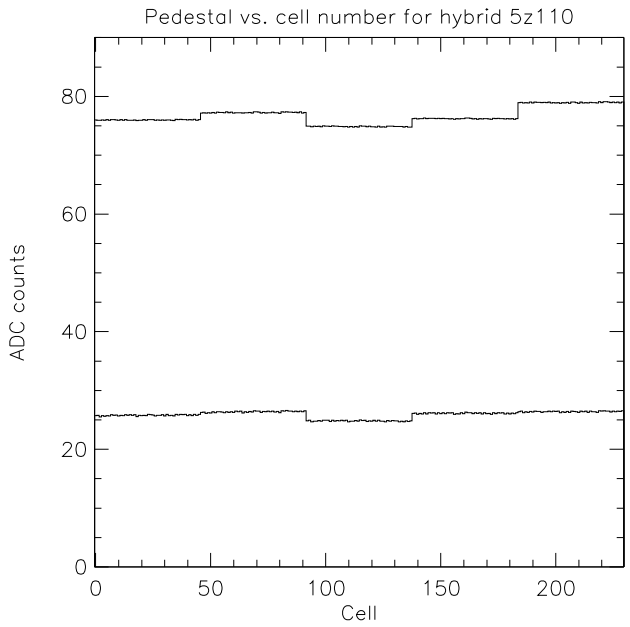
Pedestal vs. Pipeline Cell ID

The following plot shows the average pedestal vs. pipeline cell ID with and without charge injection. The x-axis is cell ID offset by 46 for each chip. Thus cell ID 5 for chip 1 is at x=5, chip 2 at x=51, chip 3 at x=97, etc.

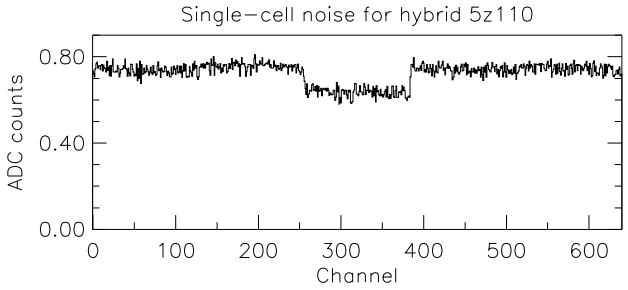
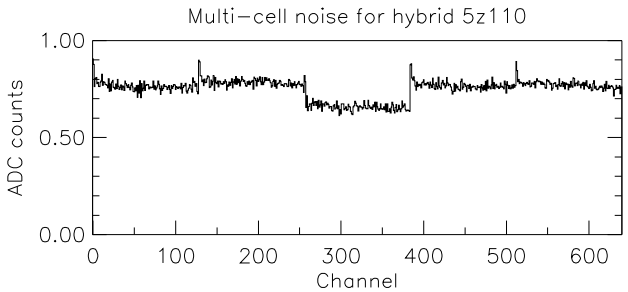
RMS Noise

The following plots show the single-cell and multi-cell RMS noise:

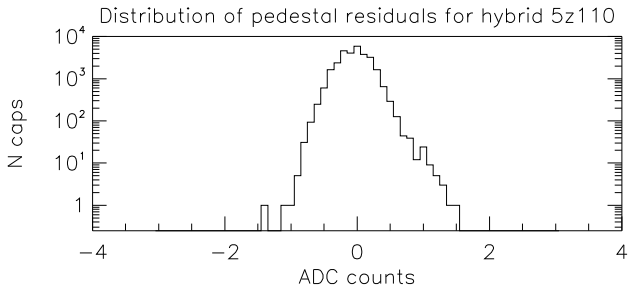
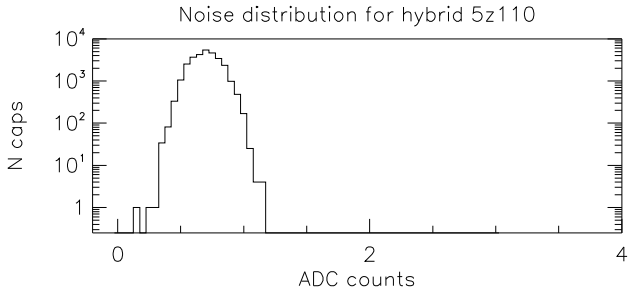
Distribution of Pedestals and Noise

The following are histograms of the pedestal of each pipeline capacitor relative to the chip average (top); and the RMS noise of each capacitor (bottom):

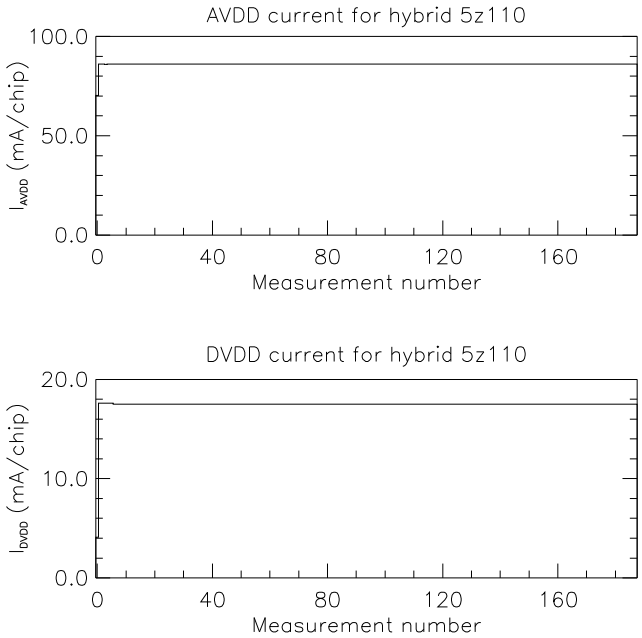
Supply Currents During Burn-in

The following plots show the supply currents per chip as a function of measurment number. Currents are measured approximately every 10 minutes:
