Hybrid 5z123 Traveler

December 8, 1999

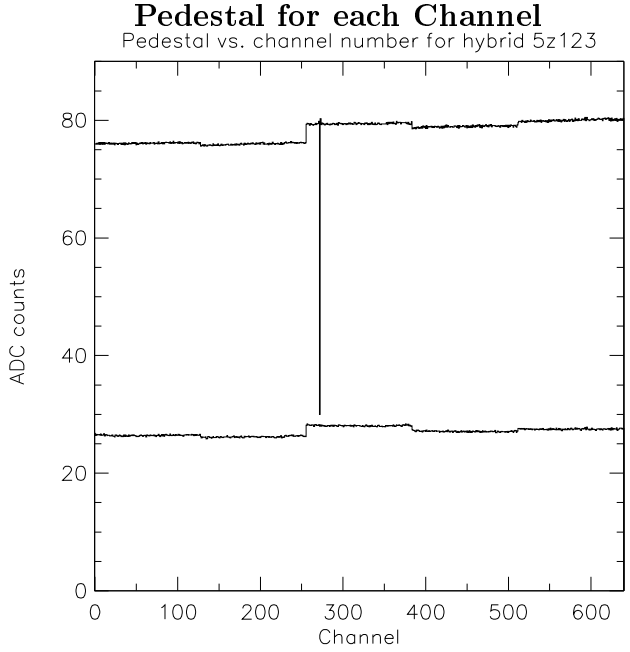
Pedestal for each Channel

The following plot shows the pedestals vs. channel number with and without charge injection:

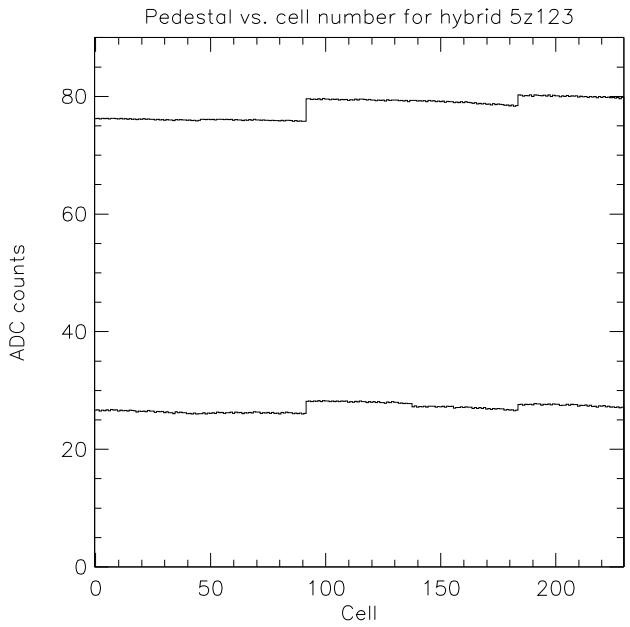
Pedestal vs. Pipeline Cell ID

The following plot shows the average pedestal vs. pipeline cell ID with and without charge injection. The x-axis is cell ID offset by 46 for each chip. Thus cell ID 5 for chip 1 is at x=5, chip 2 at x=51, chip 3 at x=97, etc.

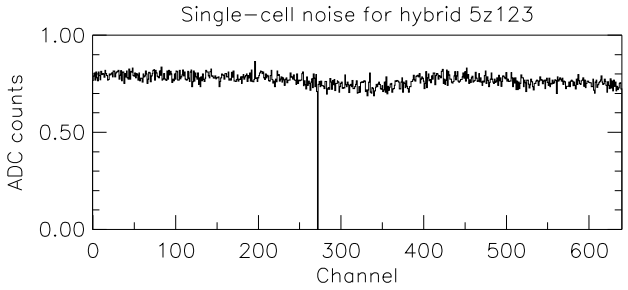
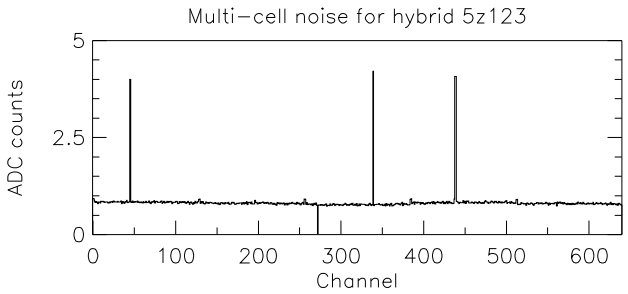
RMS Noise

The following plots show the single-cell and multi-cell RMS noise:

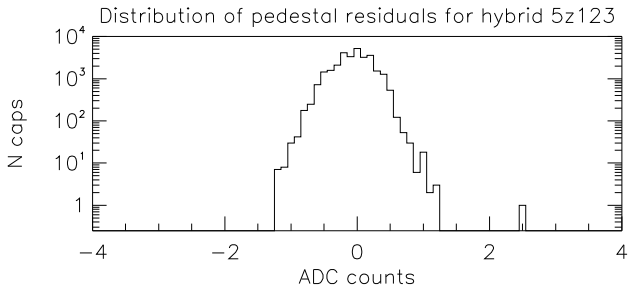
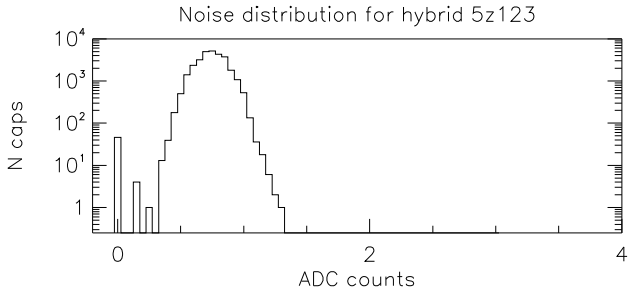
Distribution of Pedestals and Noise

The following are histograms of the pedestal of each pipeline capacitor relative to the chip average (top); and the RMS noise of each capacitor (bottom):

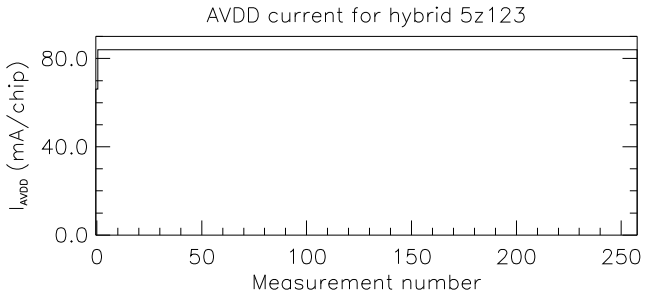
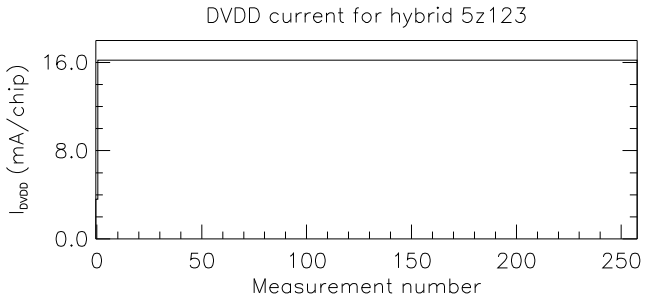
Supply Currents During Burn-in

The following plots show the supply currents per chip as a function of measurment number. Currents are measured approximately every 10 minutes:
