Hybrid 5z13 Traveler

November 22, 1999

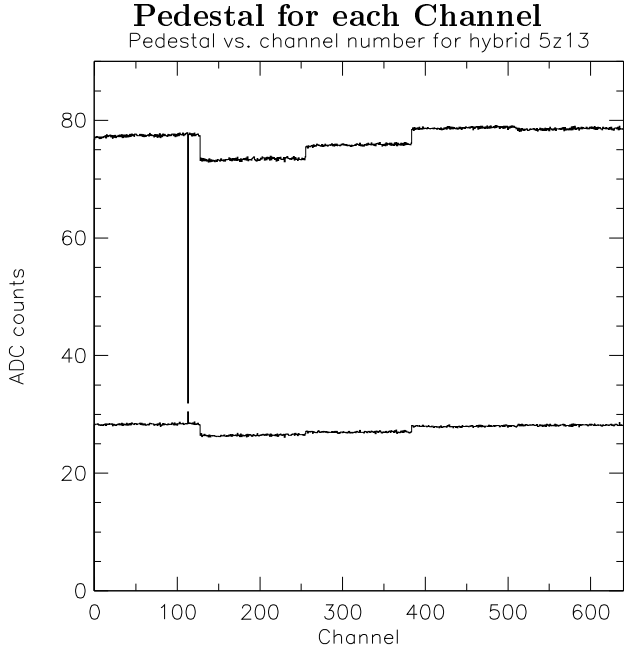
Pedestal for each Channel

Hybrid 5z13 quality: fair
Chip classification: fair good good good good
Bad channels (chip-channel): 0-113
Bad cells: none
Random bad capacitors: none
Channels at pedestal needed for DCMS: 34.7 35.7 35.7 36.7 35.6
```

The following plot shows the pedestals vs. channel number with and without charge injection:

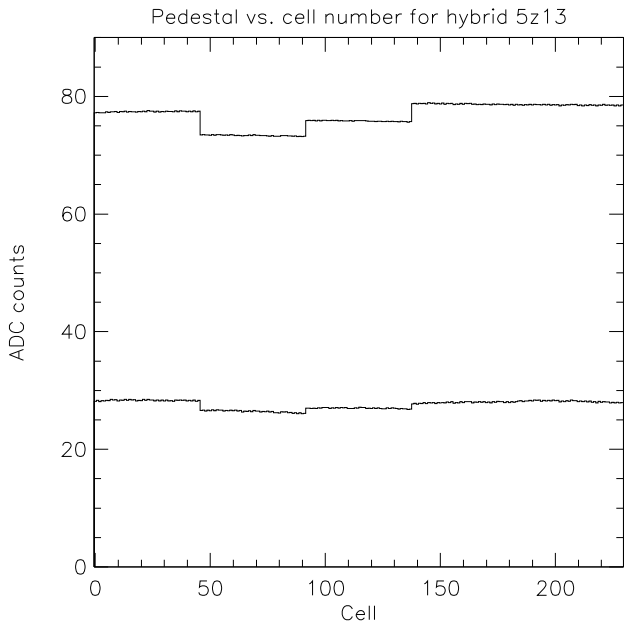
Pedestal vs. Pipeline Cell ID

The following plot shows the average pedestal vs. pipeline cell ID with and without charge injection. The x-axis is cell ID offset by 46 for each chip. Thus cell ID 5 for chip 1 is at x=5, chip 2 at x=51, chip 3 at x=97, etc.

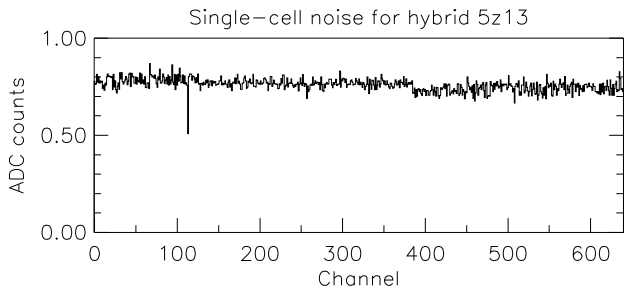
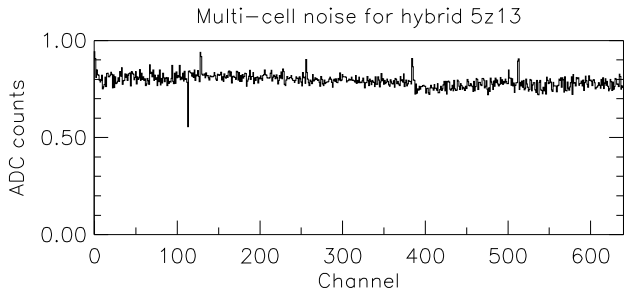
RMS Noise

The following plots show the single-cell and multi-cell RMS noise:

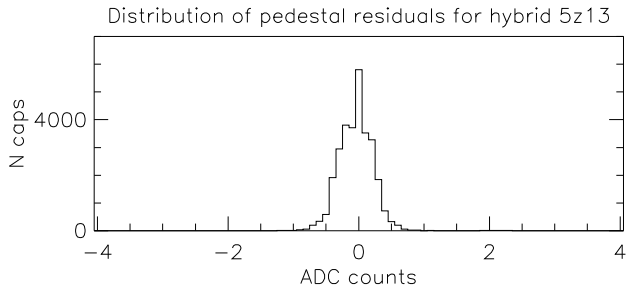
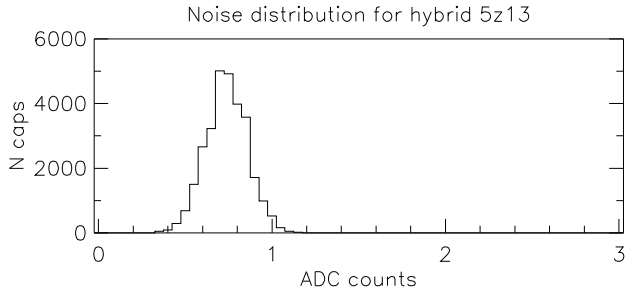
Distribution of Pedestals and Noise

The following are histograms of the pedestal of each pipeline capacitor relative to the chip average (top); and the RMS noise of each capacitor (bottom):

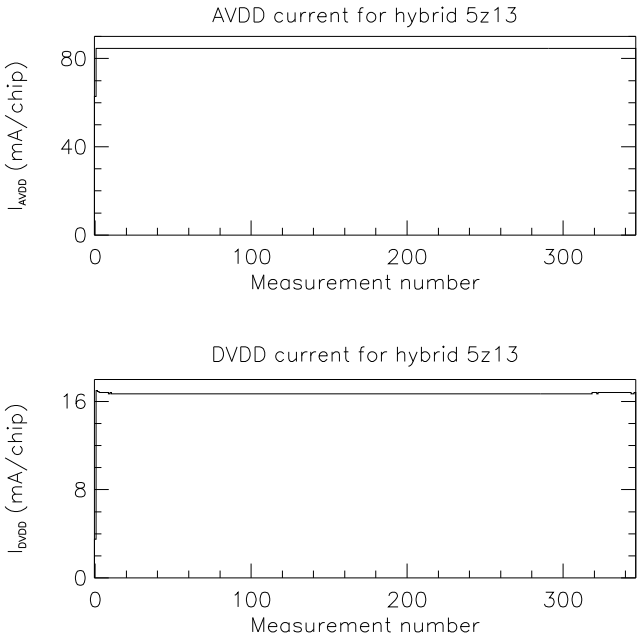
Supply Currents During Burn-in

The following plots show the supply currents per chip as a function of measurment number. Currents are measured approximately every 10 minutes:
