Hybrid 5z23 Traveler

May 11, 2000

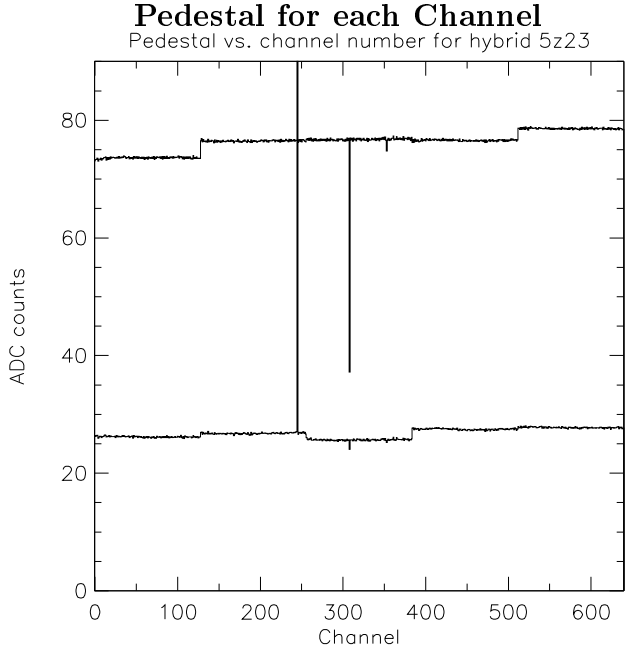
Hybrid 5z23 quality: fair
Chip classification: good fair fair good good
Bad channels (chip-channel): 1-117 2-52
Bad cells: none
Random bad capacitors: none
Channels at pedestal needed for DCMS: 36.2 32.7 34.4 35.6 37.7
```

The following plot shows the pedestals vs. channel number with and without charge injection:

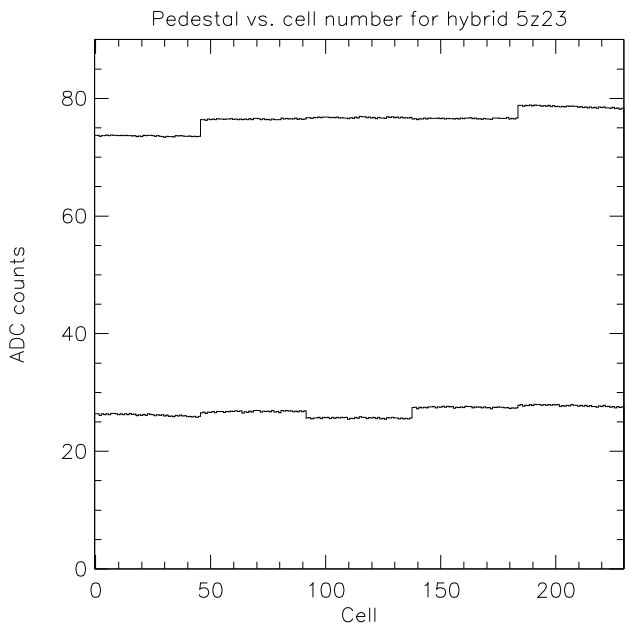
The following plot shows the average pedestal vs. pipeline cell ID with and without charge injection. The x-axis is cell ID offset by 46 for each chip. Thus cell ID 5 for chip 1 is at x=5, chip 2 at x=51, chip 3 at x=97, etc.

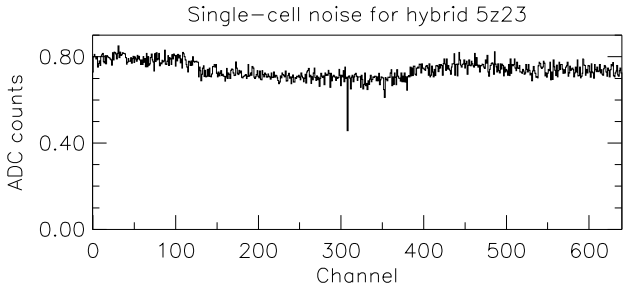
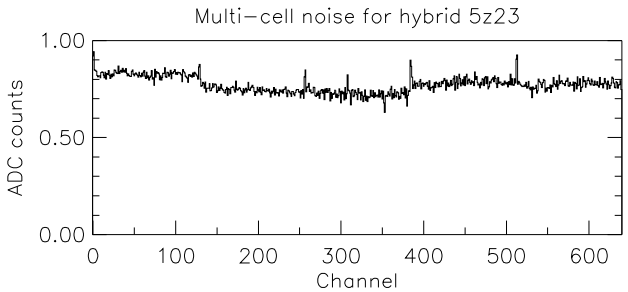
RMS Noise

The following plots show the single-cell and multi-cell RMS noise:

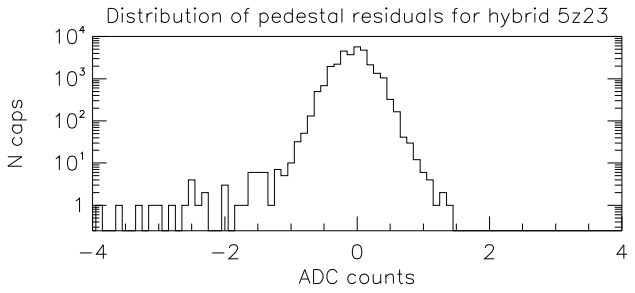
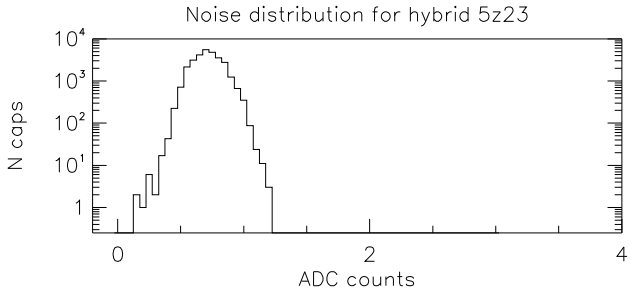
Distribution of Pedestals and Noise

The following are histograms of the pedestal of each pipeline capacitor relative to the chip average (top); and the RMS noise of each capacitor (bottom):

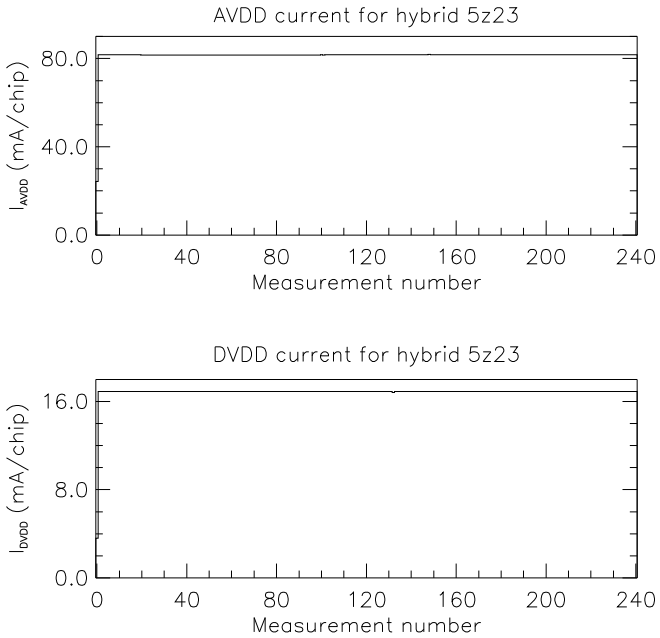
Supply Currents During Burn-in

The following plots show the supply currents per chip as a function of measurment number. Currents are measured approximately every 10 minutes:
