Hybrid 5z37 Traveler

December 8, 1999

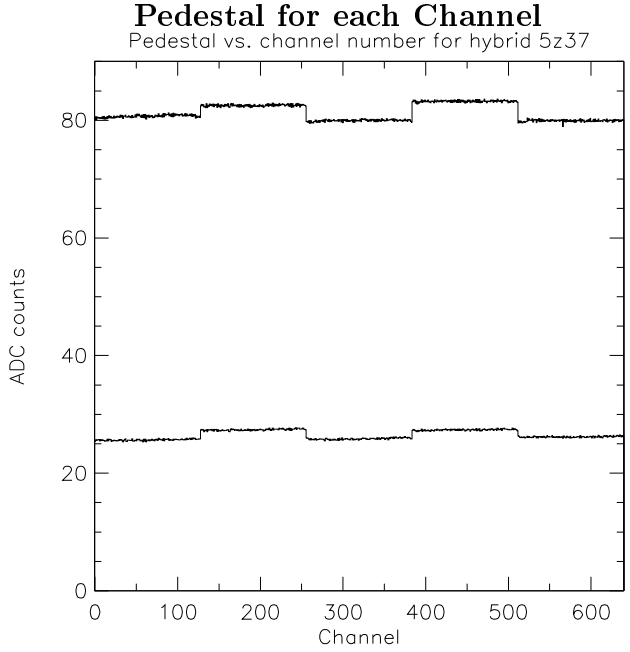
Pedestal for each Channel

The following plot shows the pedestals vs. channel number with and without charge injection:

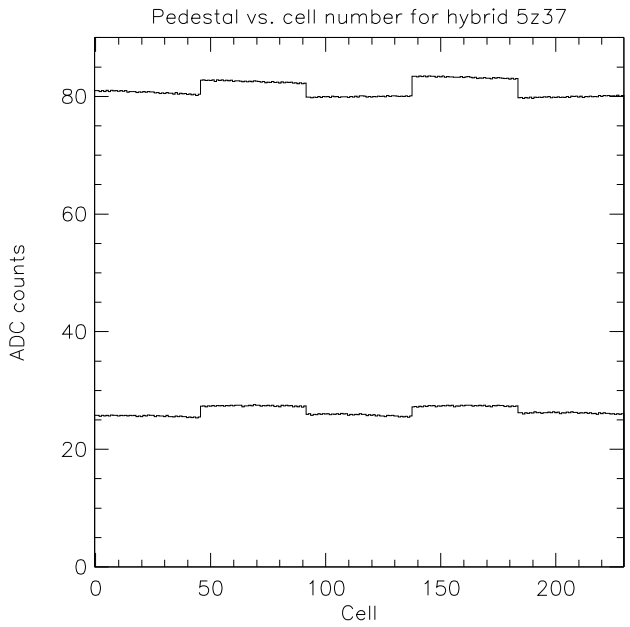
Pedestal vs. Pipeline Cell ID

The following plot shows the average pedestal vs. pipeline cell ID with and without charge injection. The x-axis is cell ID offset by 46 for each chip. Thus cell ID 5 for chip 1 is at x=5, chip 2 at x=51, chip 3 at x=97, etc.

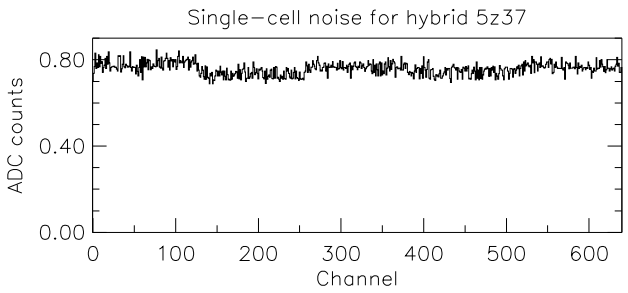
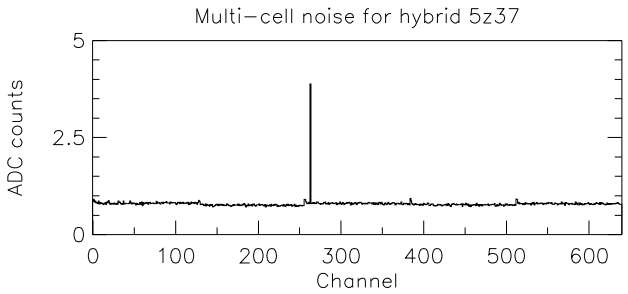
RMS Noise

The following plots show the single-cell and multi-cell RMS noise:

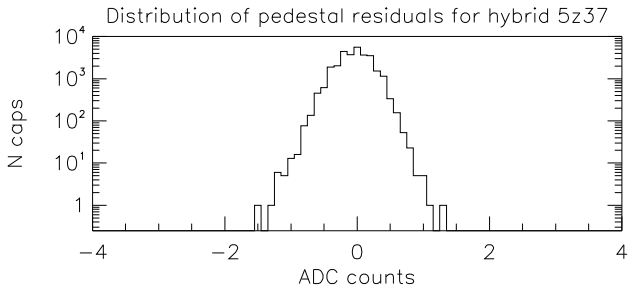
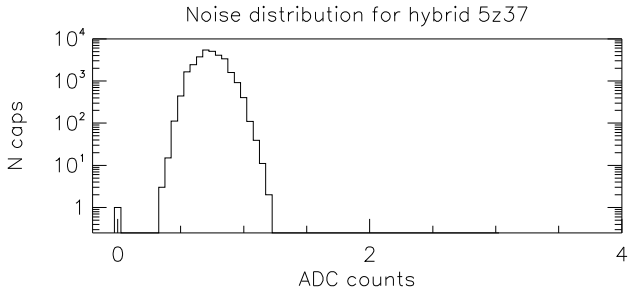
Distribution of Pedestals and Noise

The following are histograms of the pedestal of each pipeline capacitor relative to the chip average (top); and the RMS noise of each capacitor (bottom):

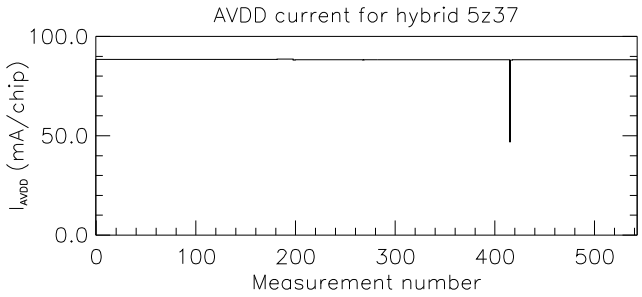
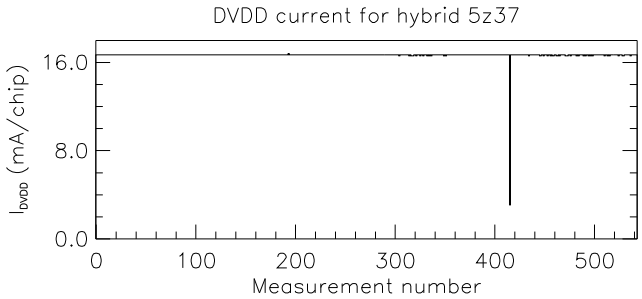
Supply Currents During Burn-in

The following plots show the supply currents per chip as a function of measurment number. Currents are measured approximately every 10 minutes:
