Hybrid 5z69 Traveler

March 7, 2000

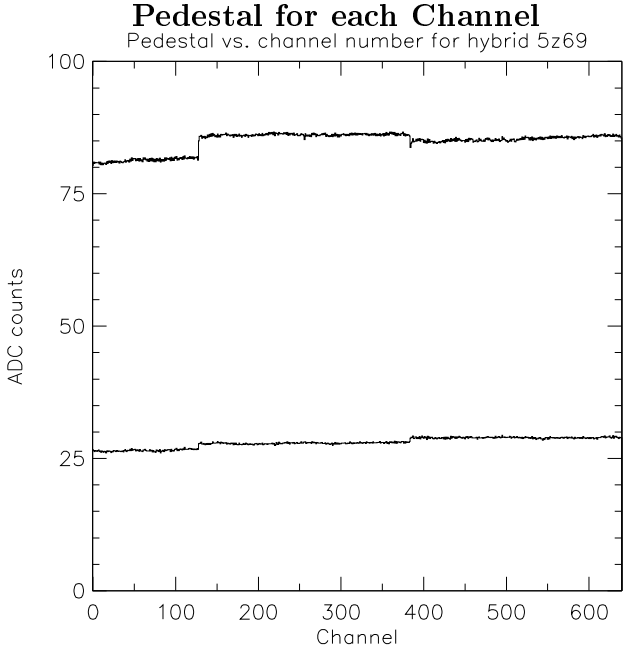
Pedestal for each Channel

The following plot shows the pedestals vs. channel number with and without charge injection:

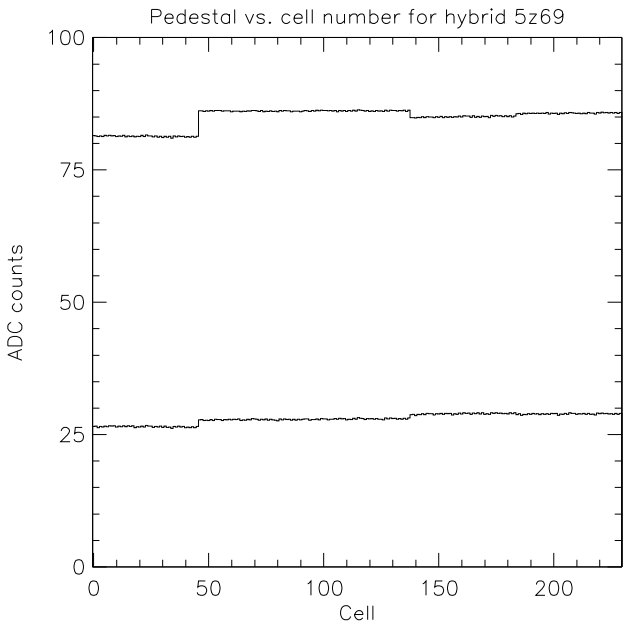
Pedestal vs. Pipeline Cell ID

The following plot shows the average pedestal vs. pipeline cell ID with and without charge injection. The x-axis is cell ID offset by 46 for each chip. Thus cell ID 5 for chip 1 is at x=5, chip 2 at x=51, chip 3 at x=97, etc.

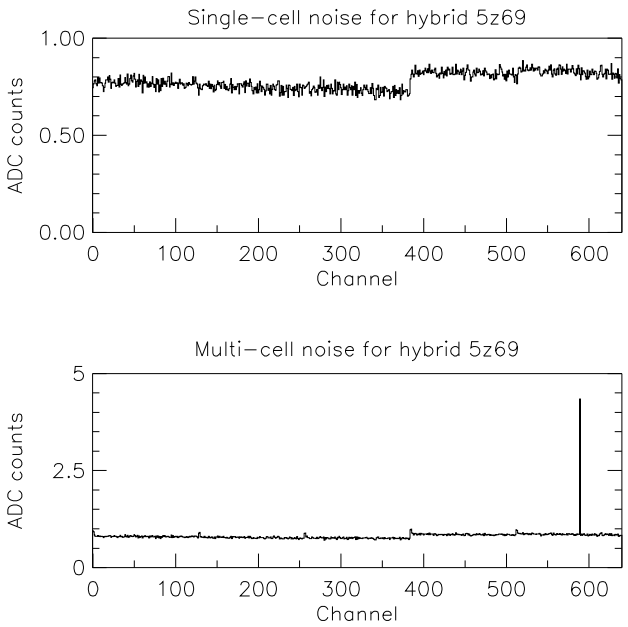
RMS Noise

The following plots show the single-cell and multi-cell RMS noise:

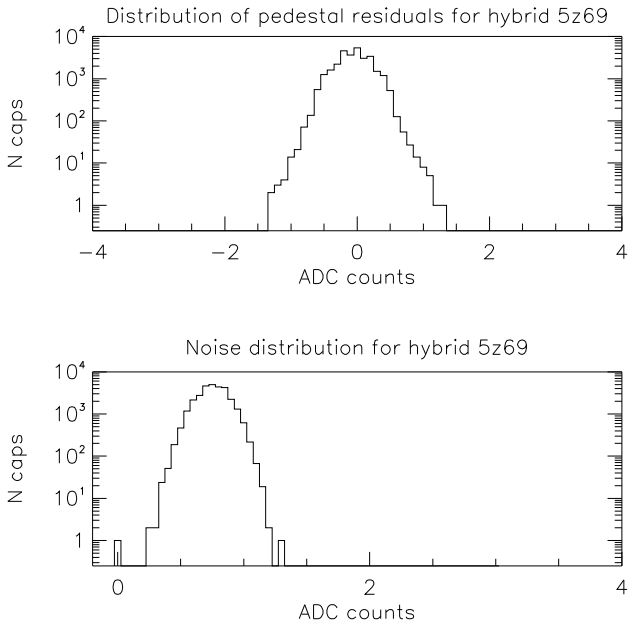
Distribution of Pedestals and Noise

The following are histograms of the pedestal of each pipeline capacitor relative to the chip average (top); and the RMS noise of each capacitor (bottom):

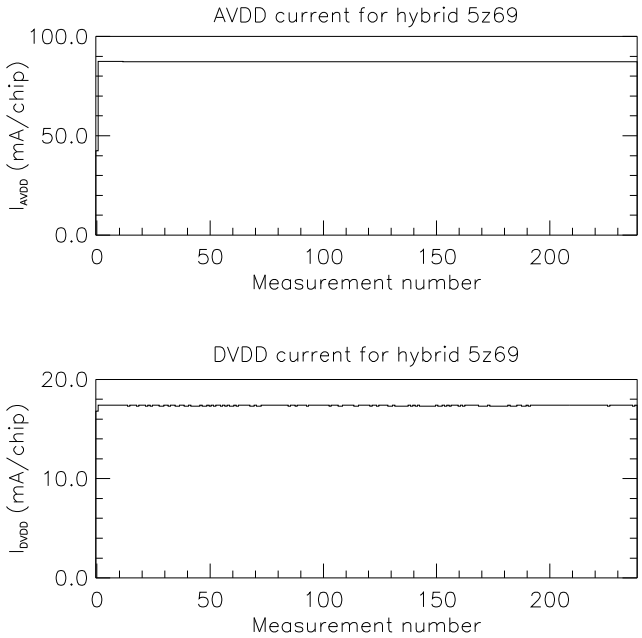
Supply Currents During Burn-in

The following plots show the supply currents per chip as a function of measurment number. Currents are measured approximately every 10 minutes:
