Hybrid 5z89 Traveler

December 8, 1999

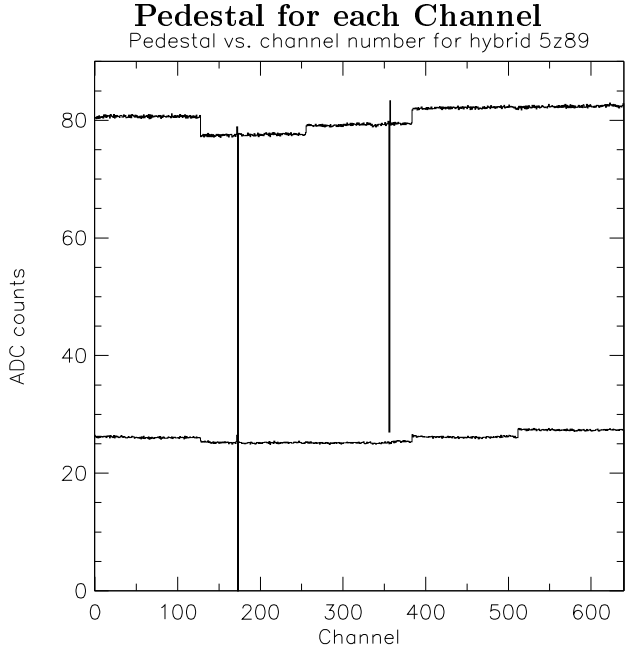
Pedestal for each Channel

Hybrid 5z89 quality: fair
Chip classification: good fair fair good good
Bad channels (chip-channel): 1-45 2-100
Bad cells: none
Random bad capacitors: none
Channels at pedestal needed for DCMS: 39.7 34.7 37.7 34.6 35.7
```
