Hybrid 5z98 Traveler

April 21, 2000

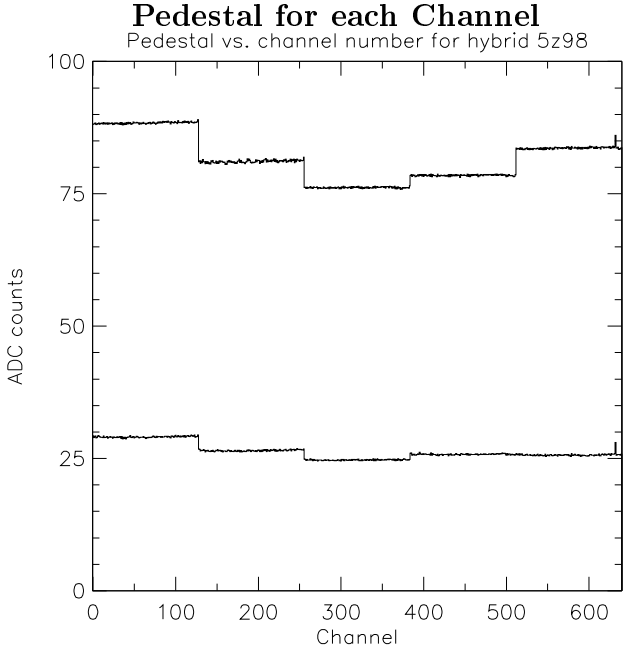
Pedestal for each Channel

The following plot shows the pedestals vs. channel number with and without charge injection:

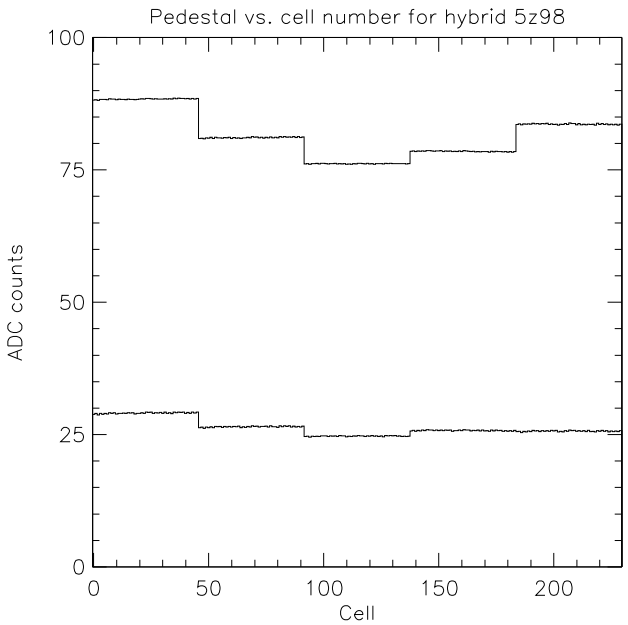
Pedestal vs. Pipeline Cell ID

The following plot shows the average pedestal vs. pipeline cell ID with and without charge injection. The x-axis is cell ID offset by 46 for each chip. Thus cell ID 5 for chip 1 is at x=5, chip 2 at x=51, chip 3 at x=97, etc.

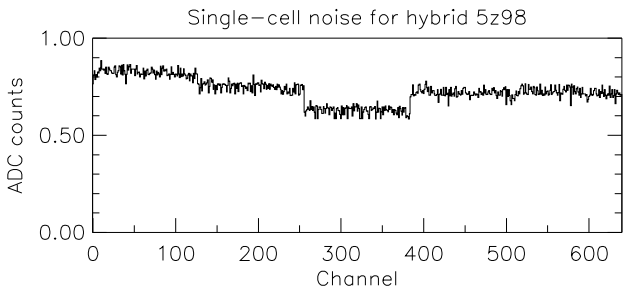
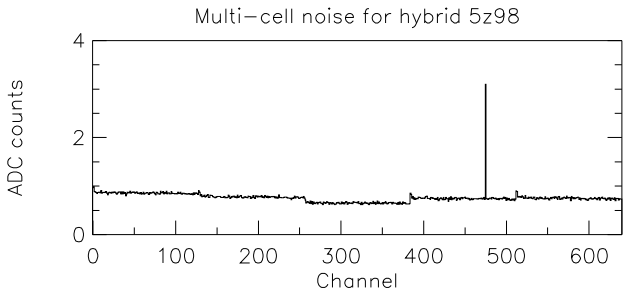
RMS Noise

The following plots show the single-cell and multi-cell RMS noise:

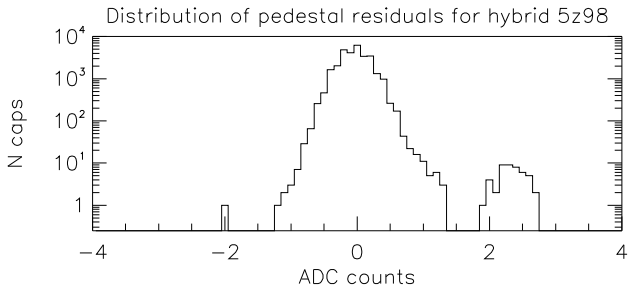
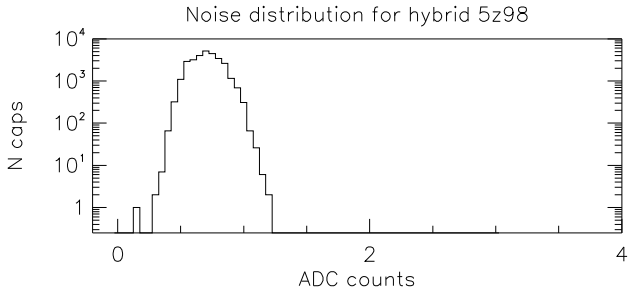
Distribution of Pedestals and Noise

The following are histograms of the pedestal of each pipeline capacitor relative to the chip average (top); and the RMS noise of each capacitor (bottom):

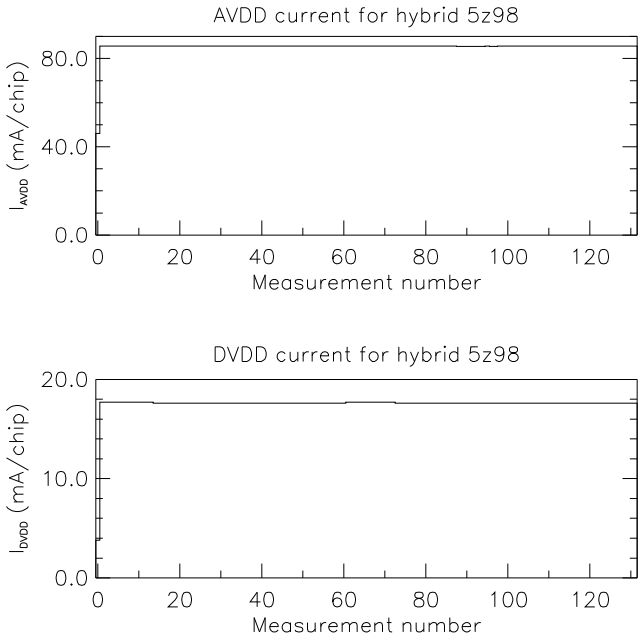
Supply Currents During Burn-in

The following plots show the supply currents per chip as a function of measurment number. Currents are measured approximately every 10 minutes:
