Hybrid 5z99 Traveler

December 14, 1999

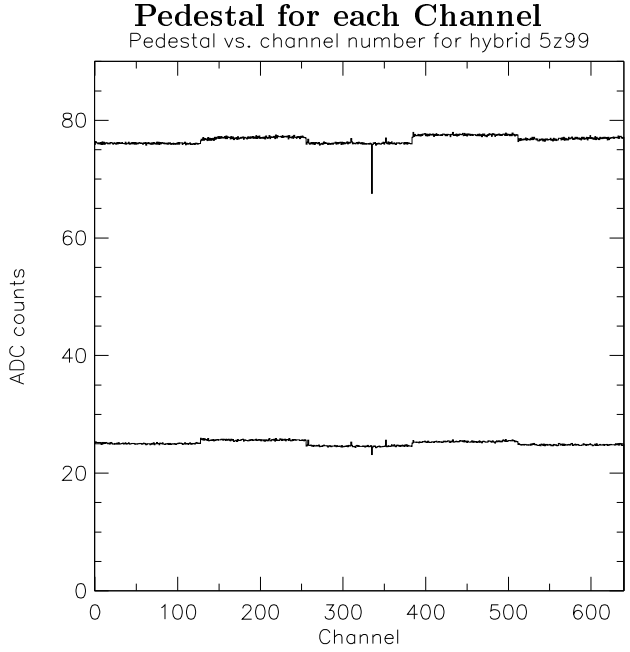
Pedestal for each Channel

The following plot shows the pedestals vs. channel number with and without charge injection:

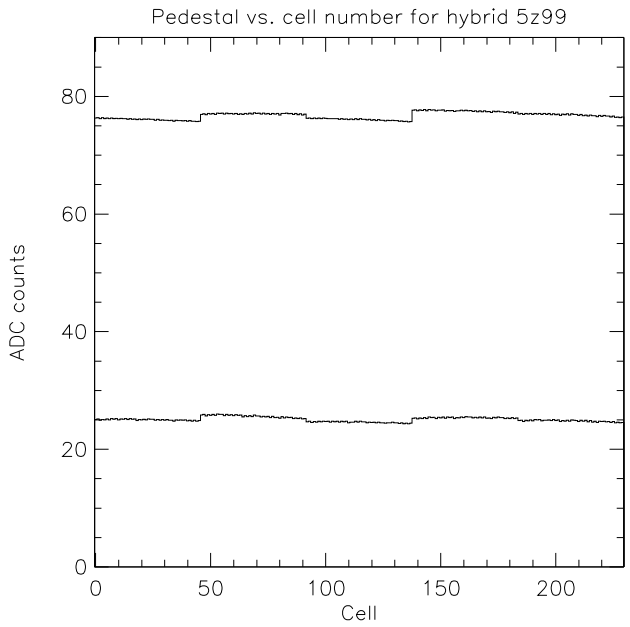
Pedestal vs. Pipeline Cell ID

The following plot shows the average pedestal vs. pipeline cell ID with and without charge injection. The x-axis is cell ID offset by 46 for each chip. Thus cell ID 5 for chip 1 is at x=5, chip 2 at x=51, chip 3 at x=97, etc.

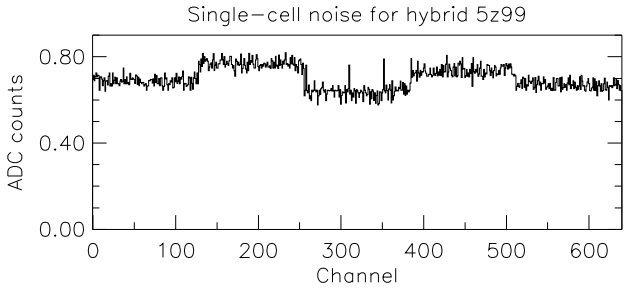
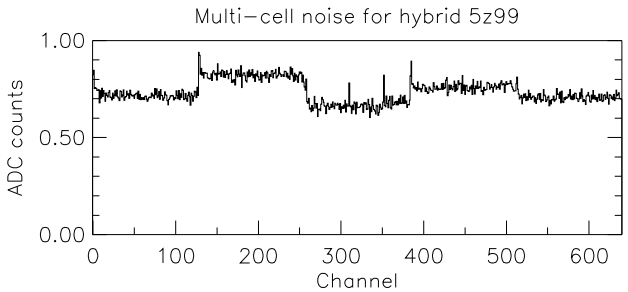
RMS Noise

The following plots show the single-cell and multi-cell RMS noise:

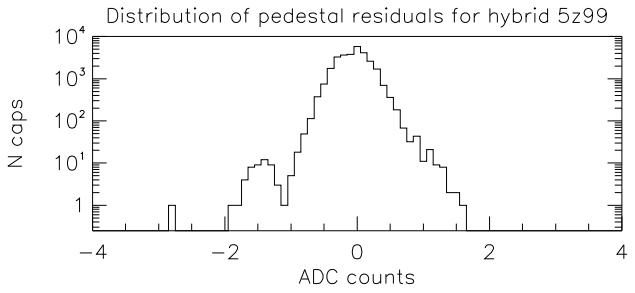
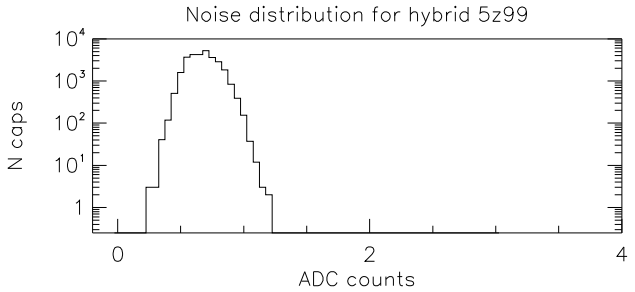
Distribution of Pedestals and Noise

The following are histograms of the pedestal of each pipeline capacitor relative to the chip average (top); and the RMS noise of each capacitor (bottom):

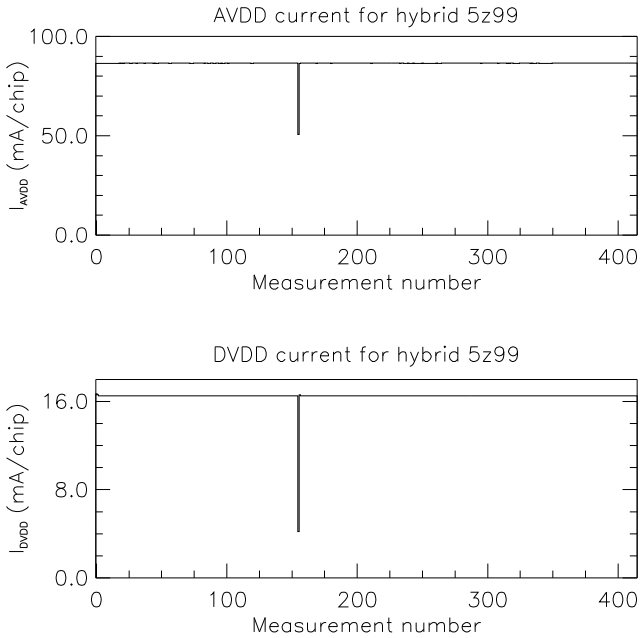
Supply Currents During Burn-in

The following plots show the supply currents per chip as a function of measurment number. Currents are measured approximately every 10 minutes:
