Hybrid 6p127 Traveler

January 13, 2000

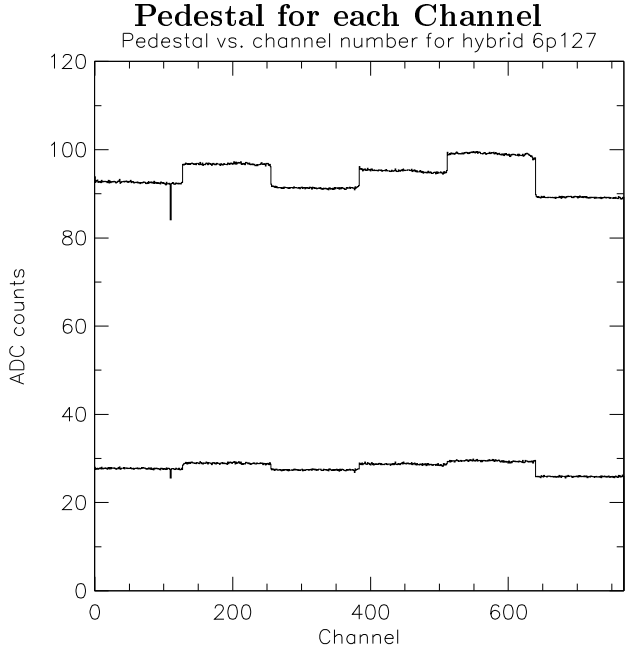
Pedestal for each Channel

Hybrid 6p127 quality: fair
Chip classification: fair good good good good good
Bad channels (chip-channel): 0-110
Bad cells: none
Random bad capacitors: none
Channels at pedestal needed for DCMS: 35.5 35.7 34.6 32.6 32.7 36.7
```

The following plot shows the pedestals vs. channel number with and without charge injection:

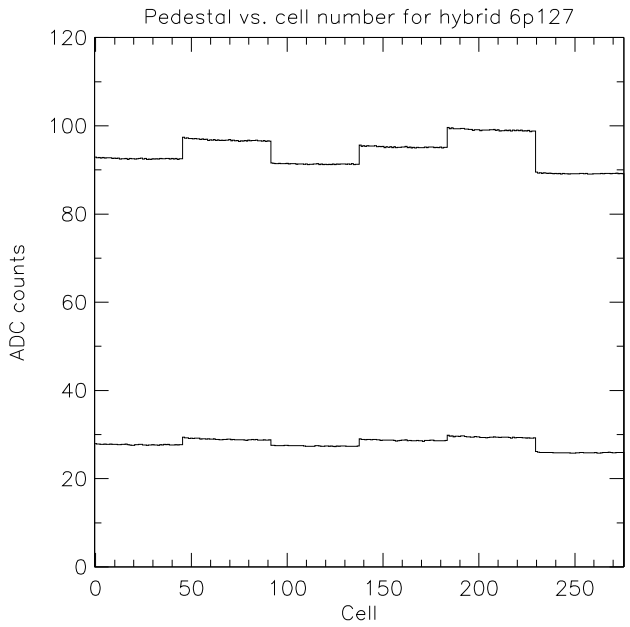
Pedestal vs. Pipeline Cell ID

The following plot shows the average pedestal vs. pipeline cell ID with and without charge injection. The x-axis is cell ID offset by 46 for each chip. Thus cell ID 5 for chip 1 is at x=5, chip 2 at x=51, chip 3 at x=97, etc.

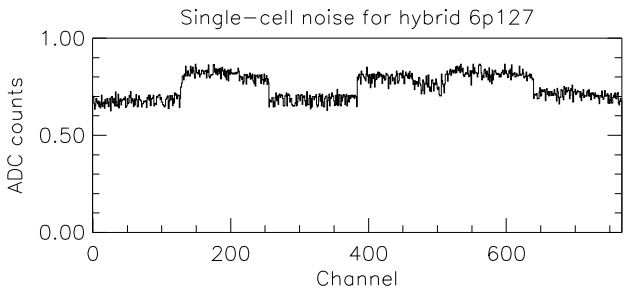
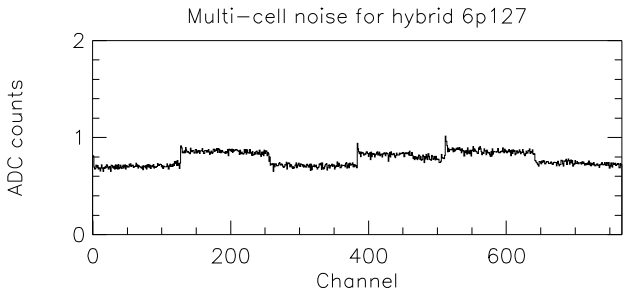
RMS Noise

The following plots show the single-cell and multi-cell RMS noise:

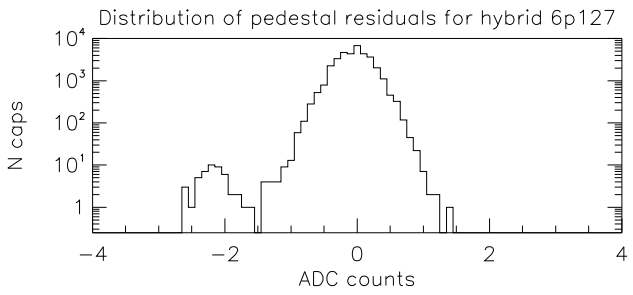
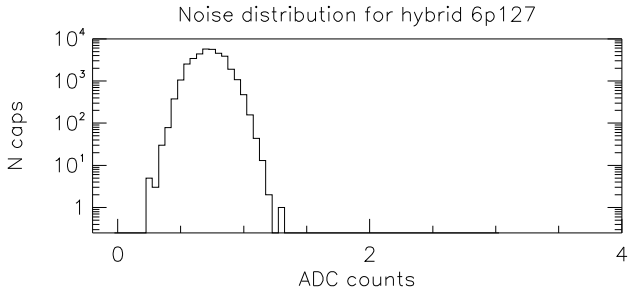
Distribution of Pedestals and Noise

The following are histograms of the pedestal of each pipeline capacitor relative to the chip average (top); and the RMS noise of each capacitor (bottom):

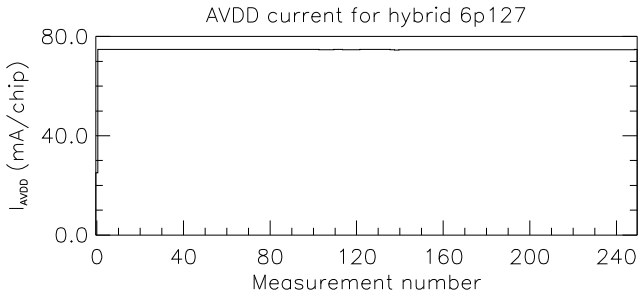
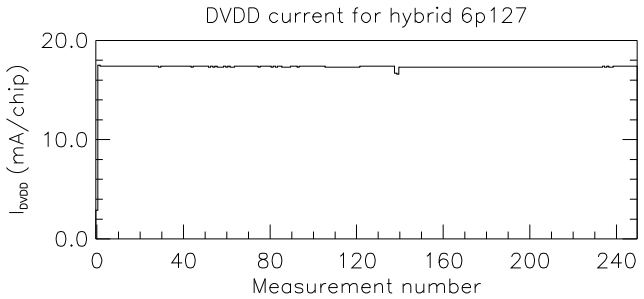
Supply Currents During Burn-in

The following plots show the supply currents per chip as a function of measurment number. Currents are measured approximately every 10 minutes:
