Hybrid 6p27 Traveler

October 4, 1999

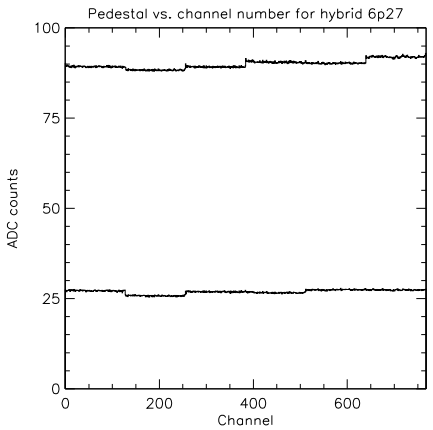
Pedestal for each Channel

The following plot shows the pedestals vs. channel number with and without charge injection:

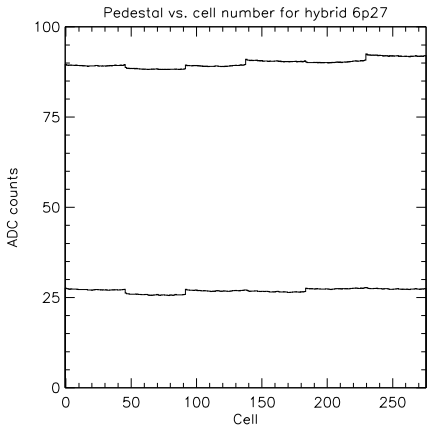
Pedestal vs. Pipeline Cell ID

The following plot shows the average pedestal vs. pipeline cell ID with and without charge injection. The x-axis is cell ID offset by 46 for each chip. Thus cell ID 5 on chip 1 is at x=5, chip 2 at x=49, chip 3 at x=97, etc.

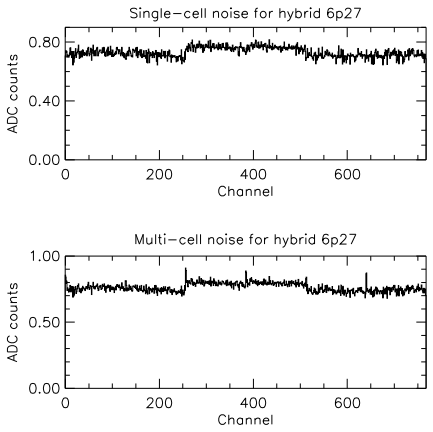
RMS Noise

The following plots show the single-cell and multi-cell RMS noise:

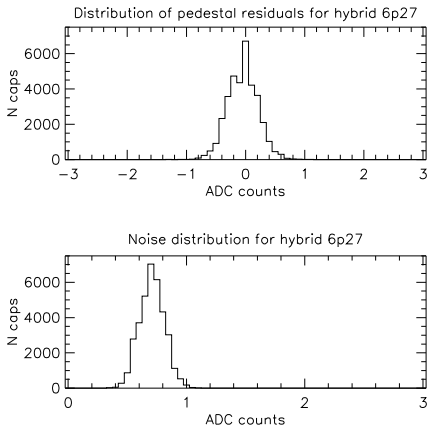
Distribution of pedestals and noise

The upper plot shows the difference between the pedestal of each channel and the average pedestal and the lower plots shows the RMS noise of all the channels:

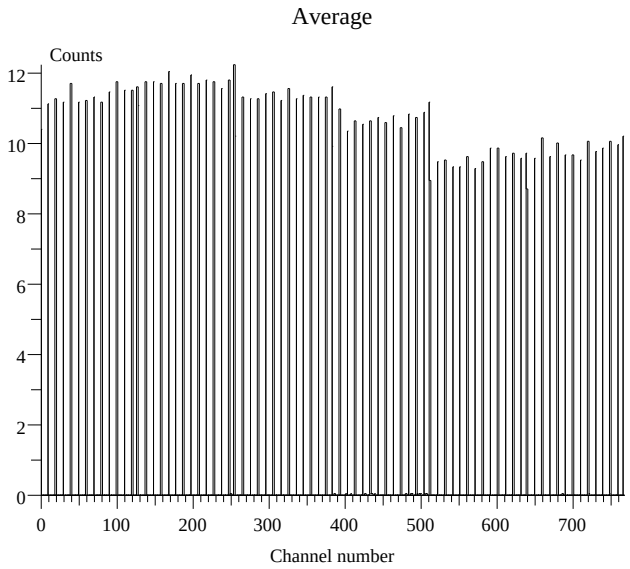
Dynamic Threshold Subtraction

The following plot shows the readout of channels with charge injection with the dynamic threshold subtraction turned on:
