Hybrid 6p58 Traveler

January 7, 2000

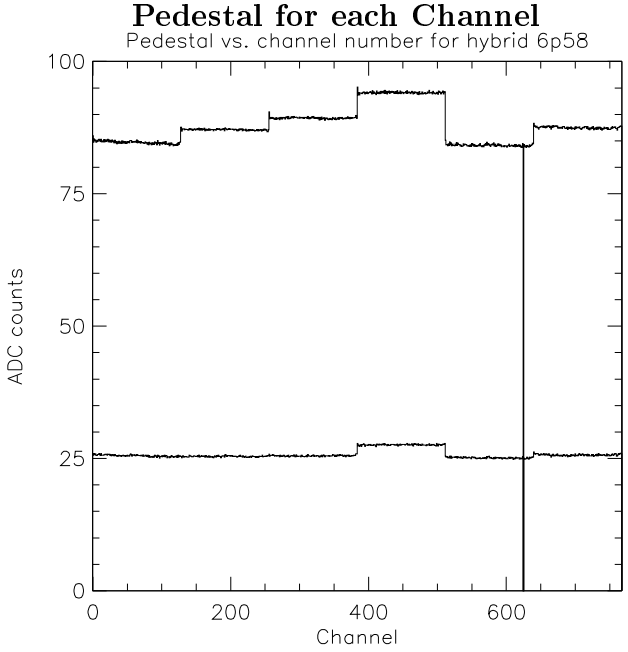
Pedestal for each Channel

Hybrid 6p58 quality: fair
Chip classification: fair good good good fair good
Bad channels (chip-channel): 0-15 4-113
Bad cells: none
Random bad capacitors (chip-cell-channel): 4-7-112
Channels at pedestal needed for DCMS: 34.7 32.6 31.6 33.7 34.5 34.6
```

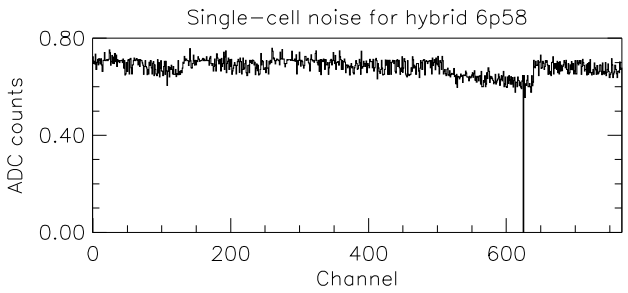
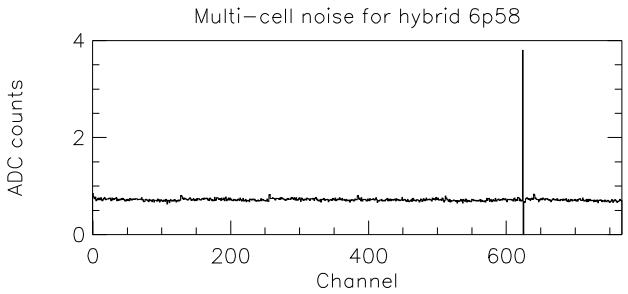
RMS Noise

Noisy channel #625.
Has Au FE DVDD and DGND bonds.
HV test.
