Hybrid 6p72 Traveler

January 13, 2000

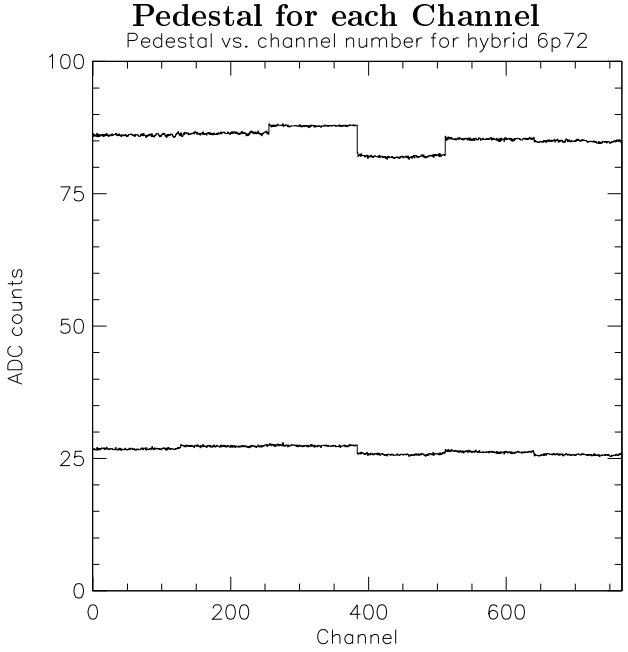
Pedestal for each Channel

Hybrid 6p72 quality: fair
Chip classification: good good good good good fair
Bad channels (chip-channel): 5-6
Bad cells: none
Random bad capacitors (chip-cell-channel): 5-0-6
Channels at pedestal needed for DCMS: 33.6 29.7 34.6 31.5 33.6 32.6
```
