Hybrid 7z114 Traveler

May 26, 2000

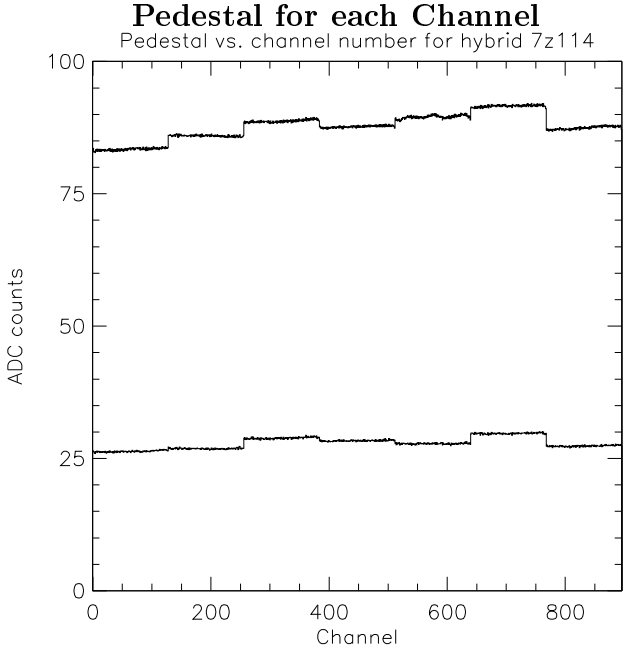
Pedestal for each Channel

The following plot shows the pedestals vs. channel number with and without charge injection:

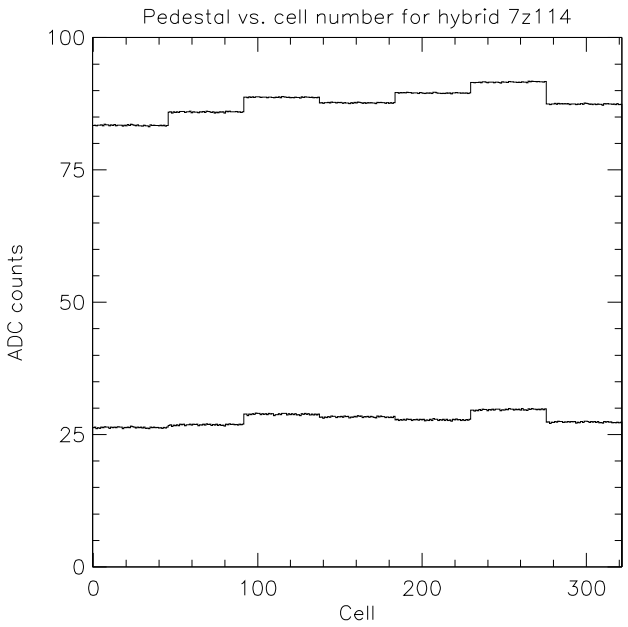
Pedestal vs. Pipeline Cell ID

The following plot shows the average pedestal vs. pipeline cell ID with and without charge injection. The x-axis is cell ID offset by 46 for each chip. Thus cell ID 5 for chip 1 is at x=5, chip 2 at x=51, chip 3 at x=97, etc.

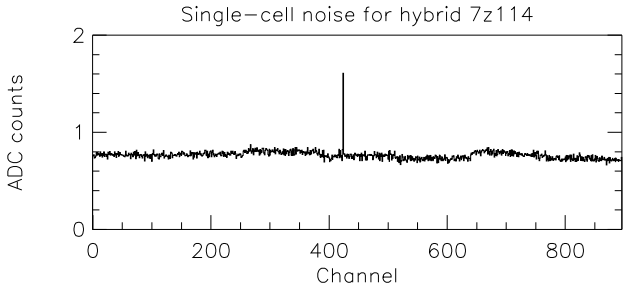
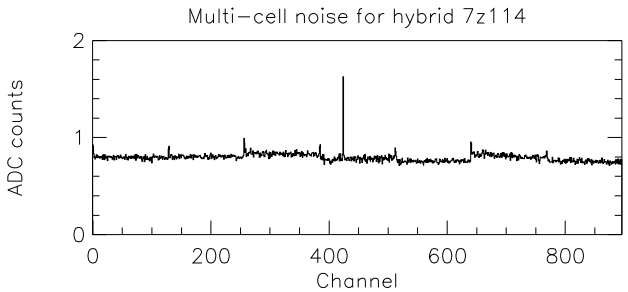
RMS Noise

The following plots show the single-cell and multi-cell RMS noise:

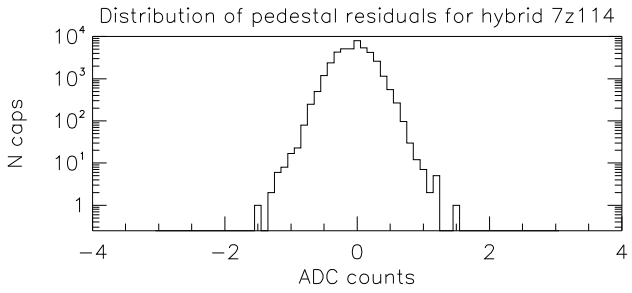
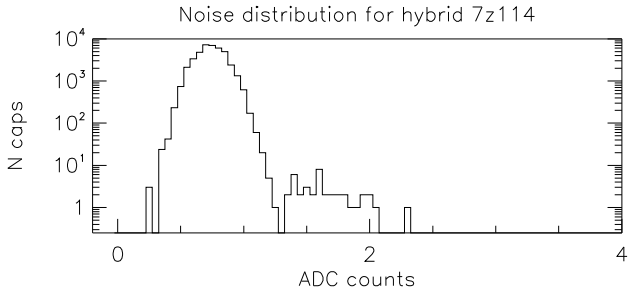
Distribution of Pedestals and Noise

The following are histograms of the pedestal of each pipeline capacitor relative to the chip average (top); and the RMS noise of each capacitor (bottom):

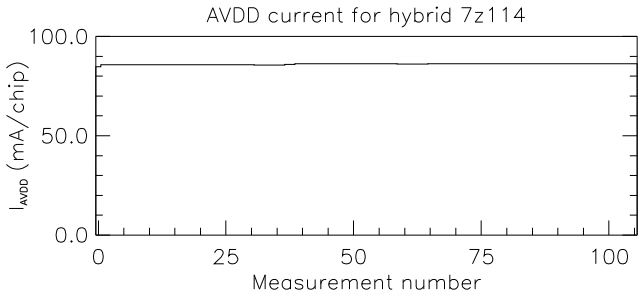
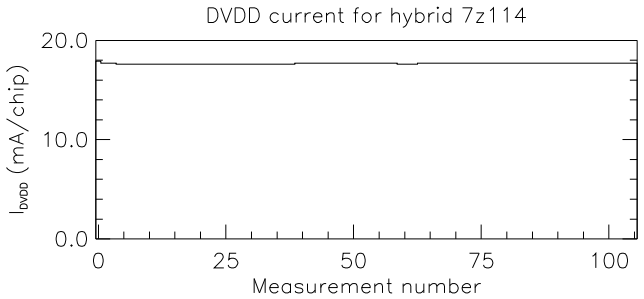
Supply Currents During Burn-in

The following plots show the supply currents per chip as a function of measurment number. Currents are measured approximately every 10 minutes:
