# Hybrid 7z149 Traveler

April 13, 2000

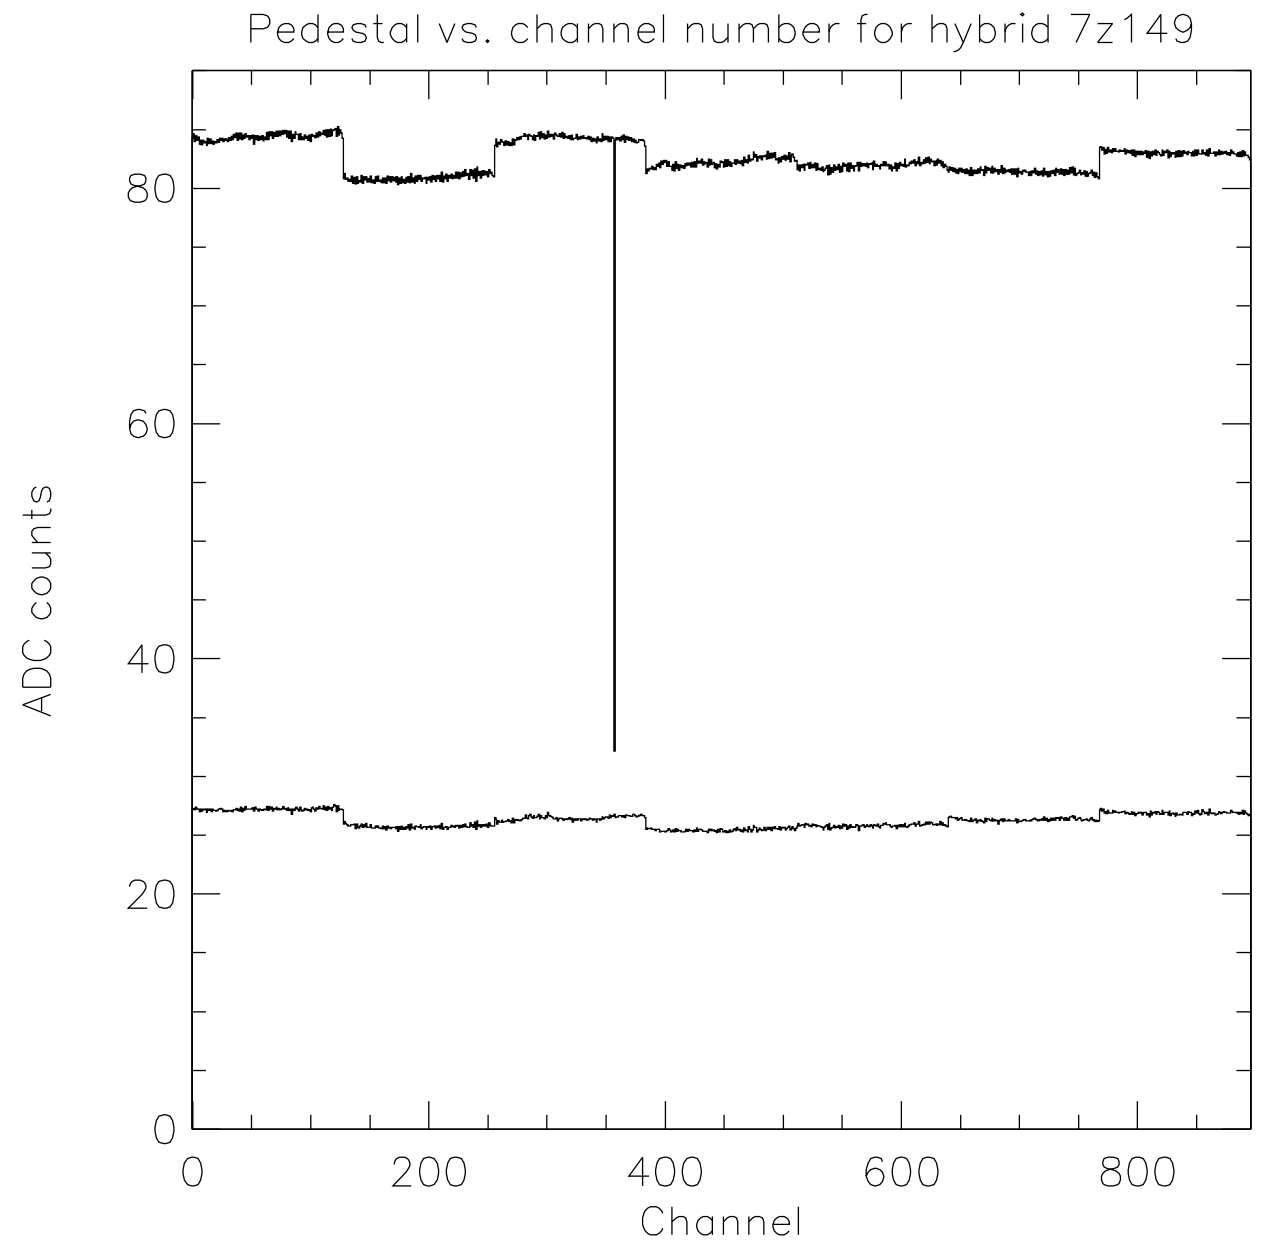
**Pedestal for each Channel**

The following plot shows the pedestals vs. channel number with and without charge injection:

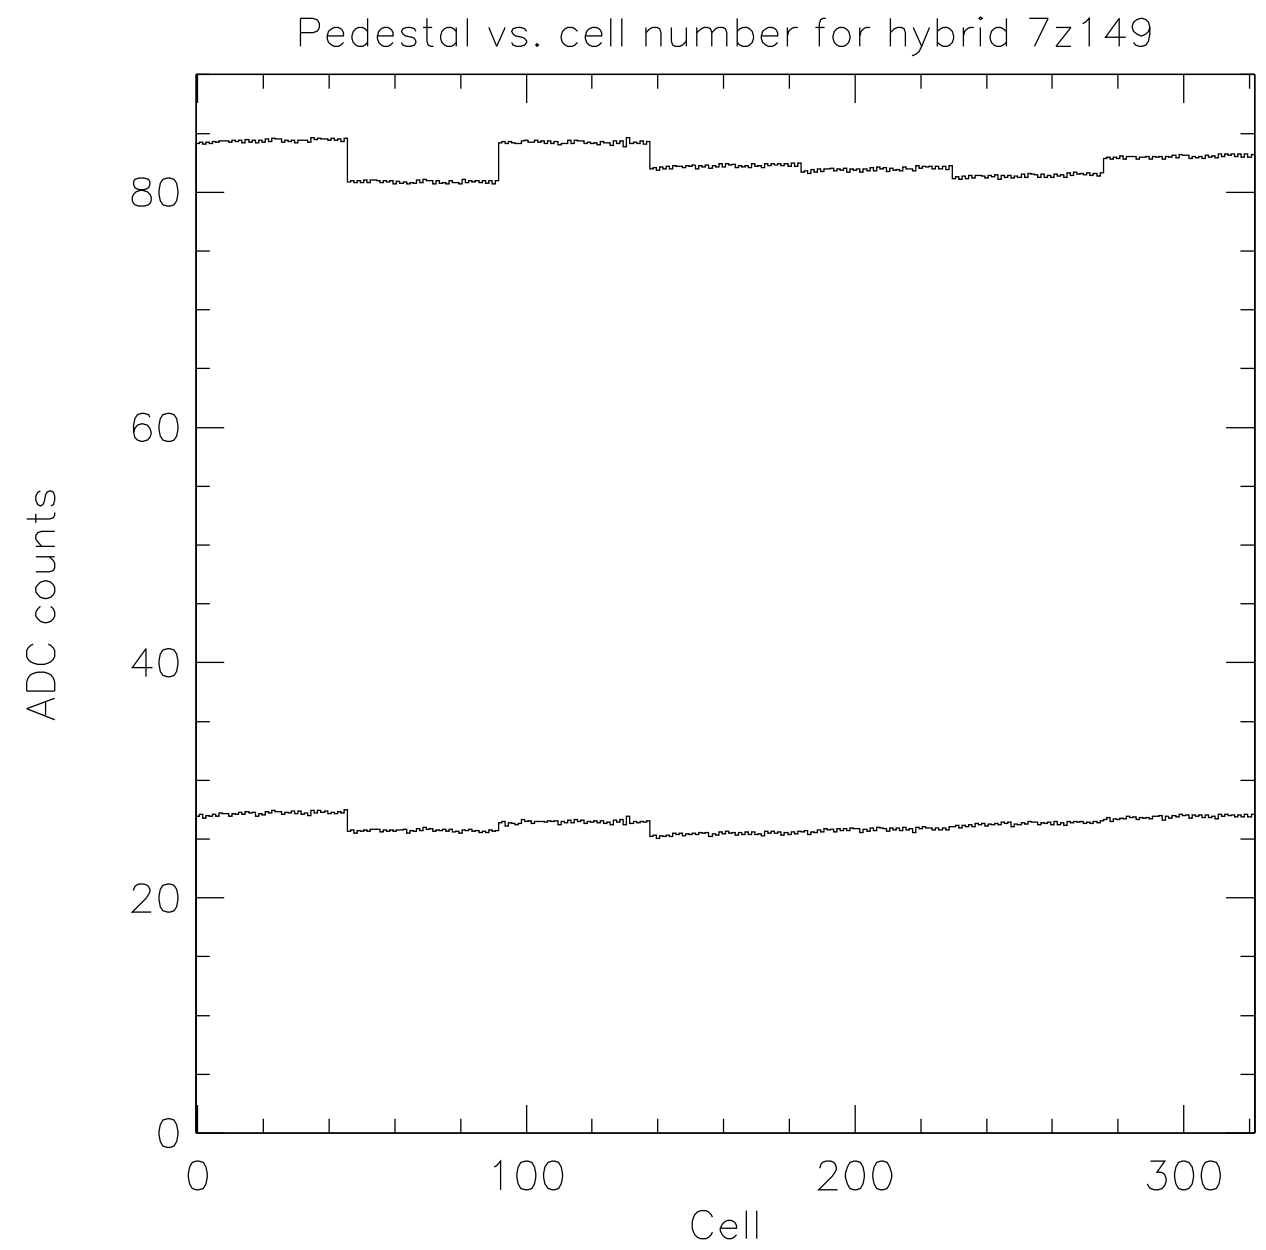
**Pedestal vs. Pipeline Cell ID**

The following plot shows the average pedestal vs. pipeline cell ID with and without charge injection. The x-axis is cell ID offset by 46 for each chip. Thus cell ID 5 for chip 1 is at x=5, chip 2 at x=51, chip 3 at x=97, etc.

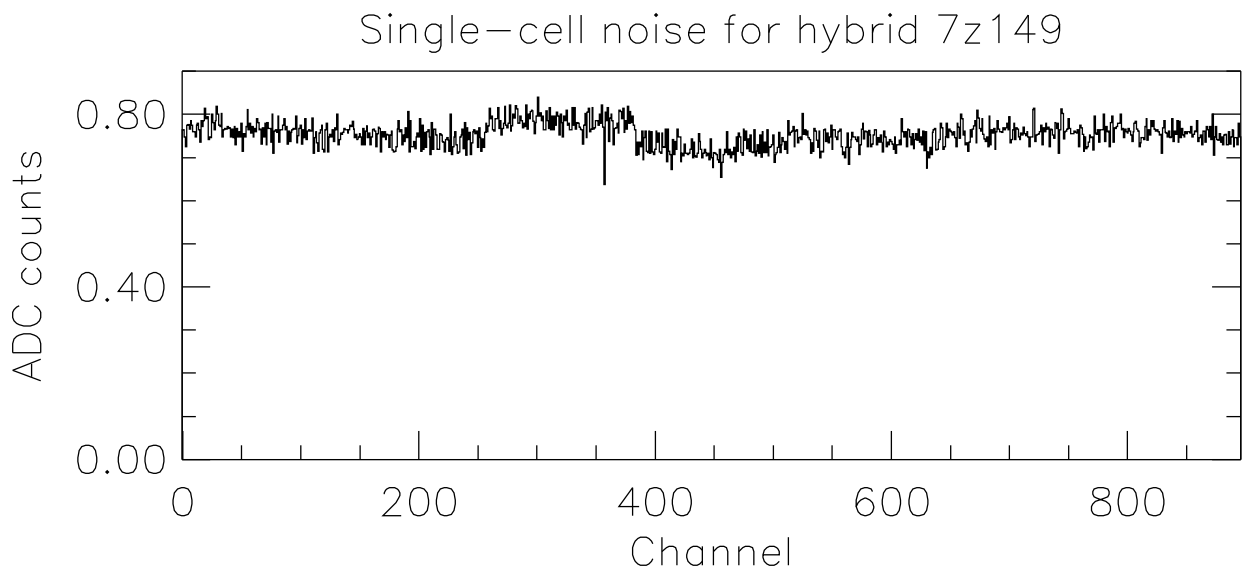
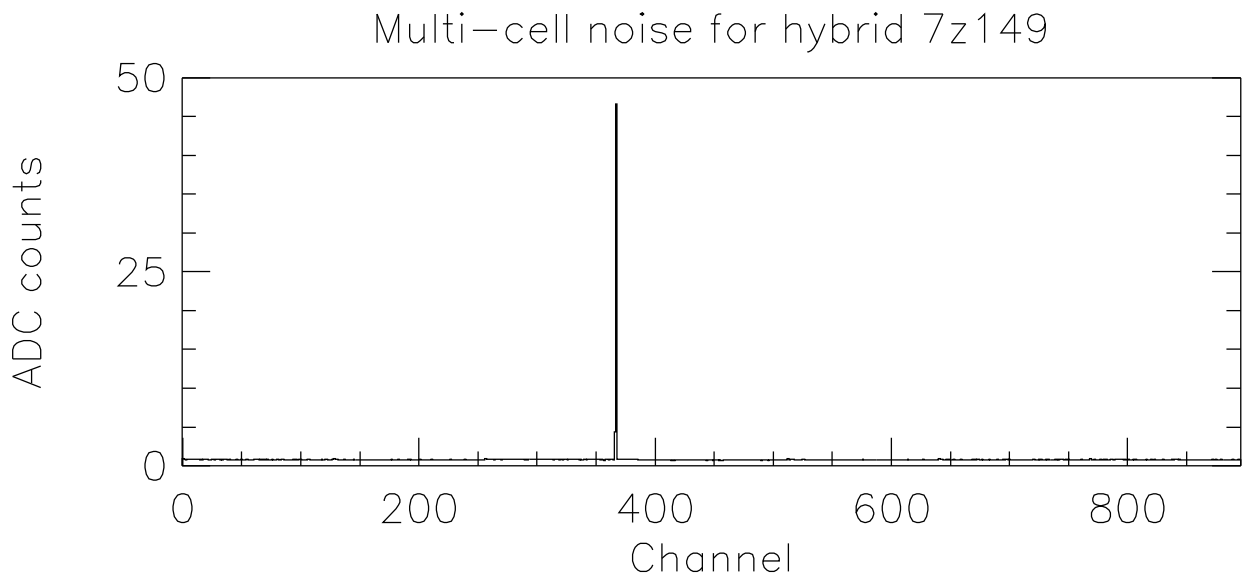
**RMS Noise**

The following plots show the single-cell and multi-cell RMS noise:

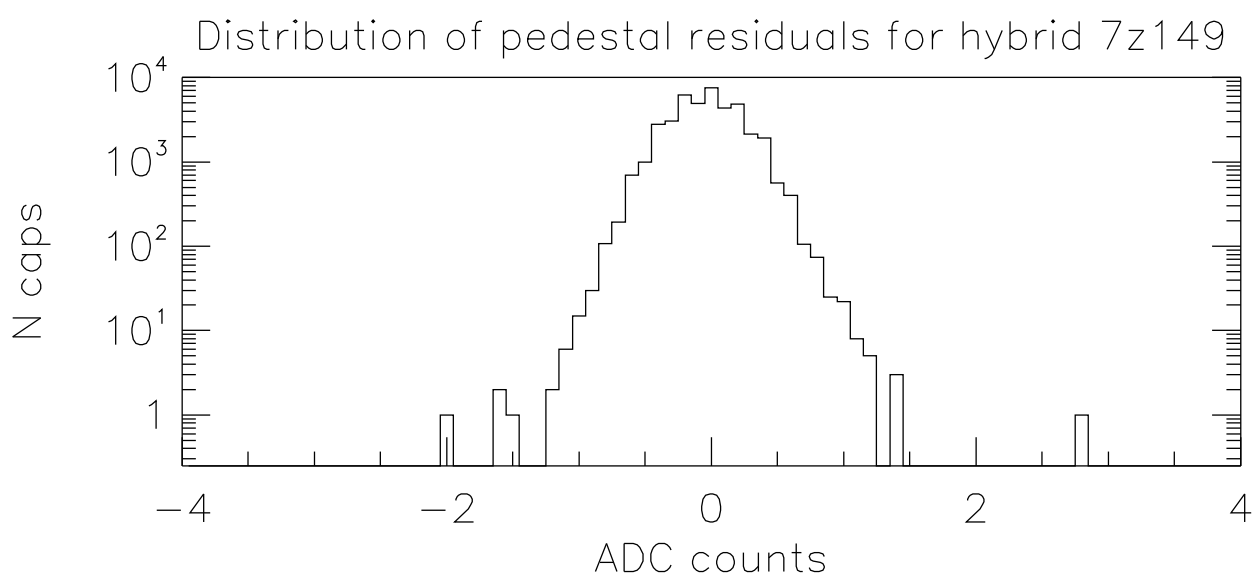
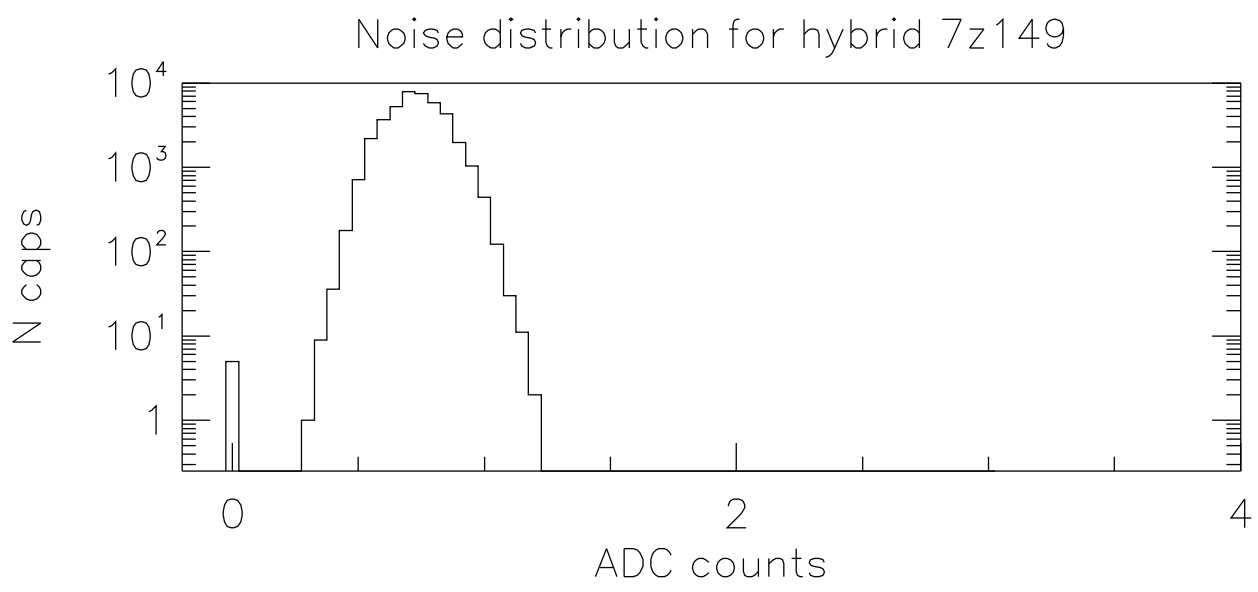
**Distribution of Pedestals and Noise**

The following are histograms of the pedestal of each pipeline capacitor relative to the chip average (top); and the RMS noise of each capacitor (bottom):
