Hybrid 7z62 Traveler

May 30, 2000

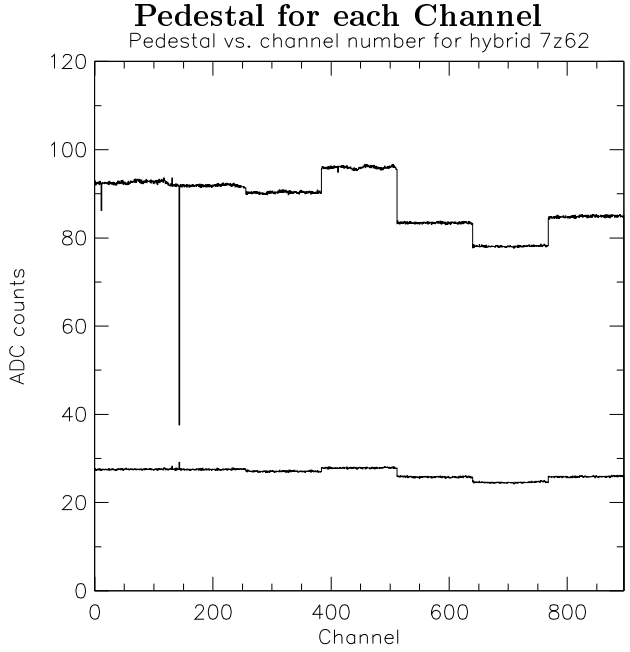
Pedestal for each Channel

The following plot shows the pedestals vs. channel number with and without charge injection:

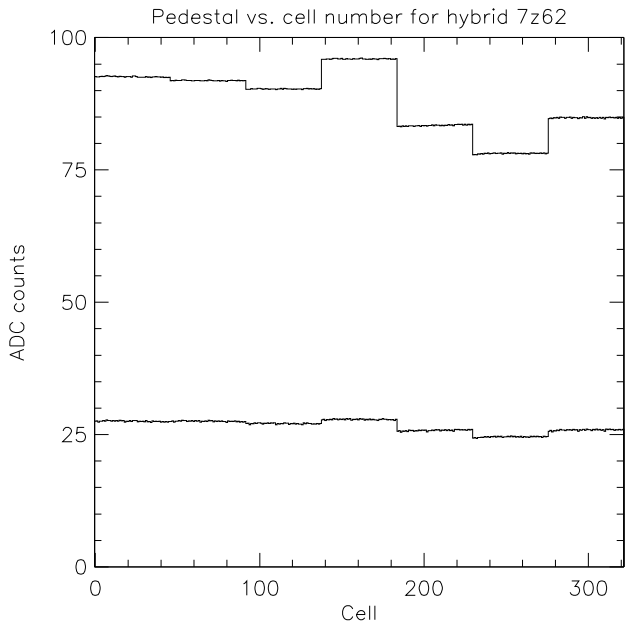
Pedestal vs. Pipeline Cell ID

The following plot shows the average pedestal vs. pipeline cell ID with and without charge injection. The x-axis is cell ID offset by 46 for each chip. Thus cell ID 5 for chip 1 is at x=5, chip 2 at x=51, chip 3 at x=97, etc.

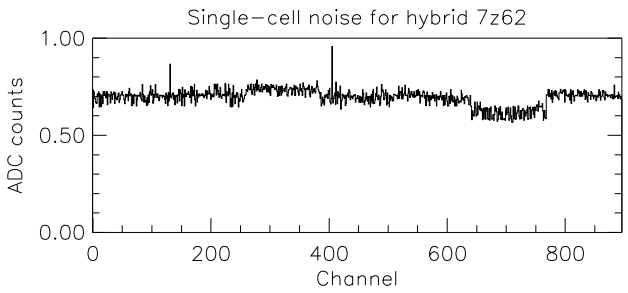
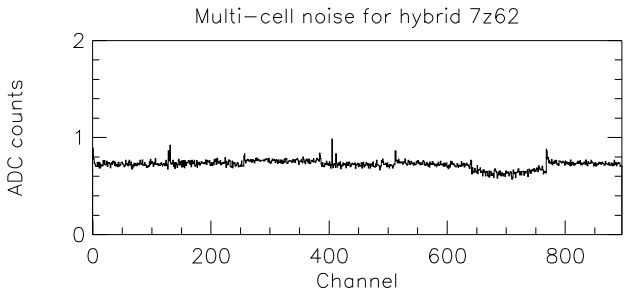
RMS Noise

The following plots show the single-cell and multi-cell RMS noise:

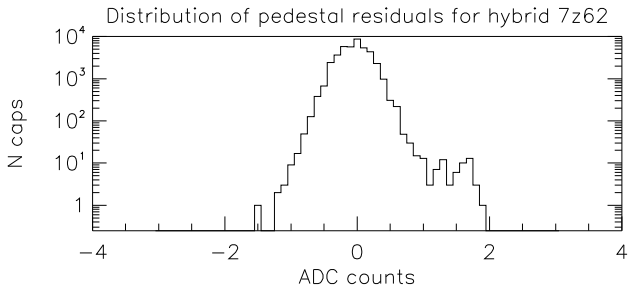
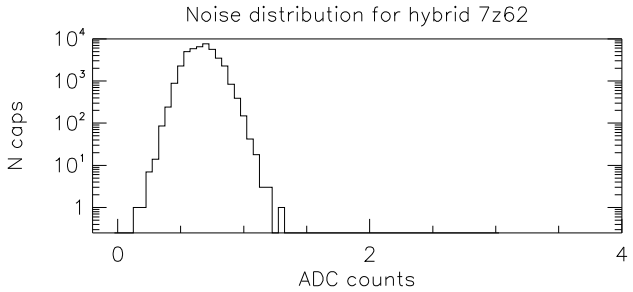
Distribution of Pedestals and Noise

The following are histograms of the pedestal of each pipeline capacitor relative to the chip average (top); and the RMS noise of each capacitor (bottom):

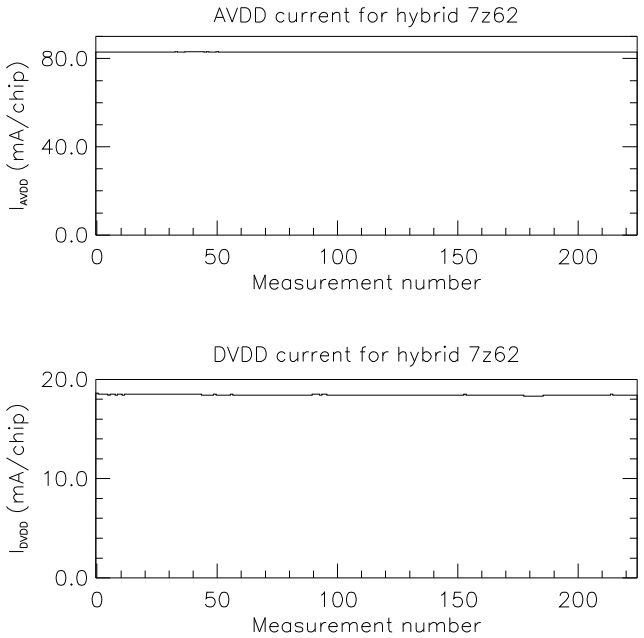
Supply Currents During Burn-in

The following plots show the supply currents per chip as a function of measurment number. Currents are measured approximately every 10 minutes:
