# Hybrid 7z87 Traveler

April 10, 2000

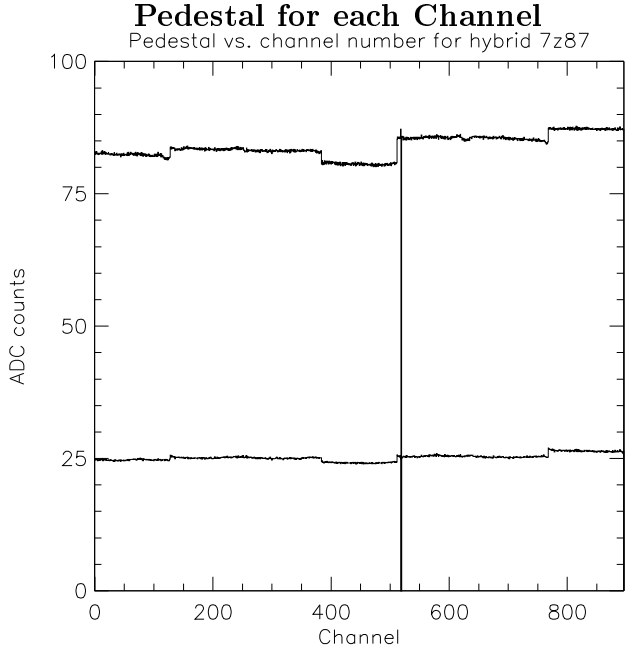
**Pedestal for each Channel**

The following plot shows the pedestals vs. channel number with and without charge injection:

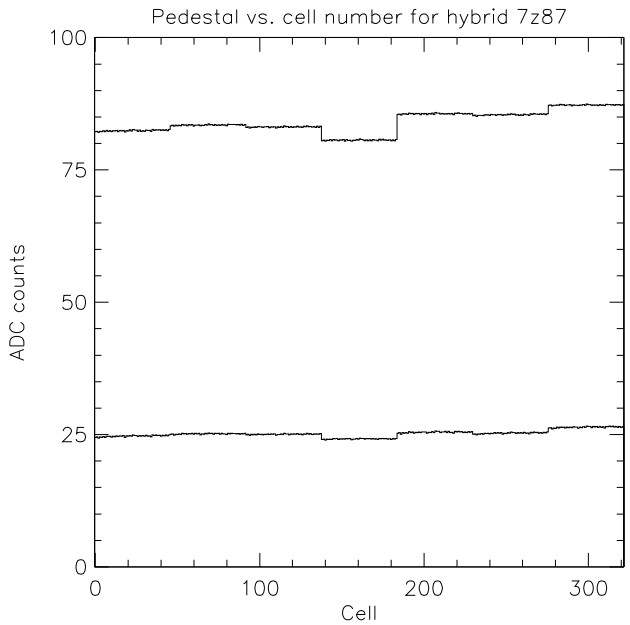
**Pedestal vs. Pipeline Cell ID**

The following plot shows the average pedestal vs. pipeline cell ID with and without charge injection. The x-axis is cell ID offset by 46 for each chip. Thus cell ID 5 for chip 1 is at x=5, chip 2 at x=51, chip 3 at x=97, etc.

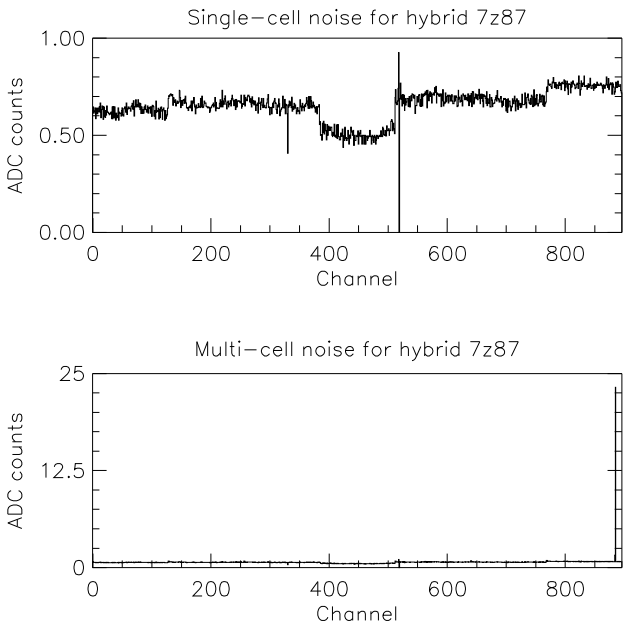
**RMS Noise**

The following plots show the single-cell and multi-cell RMS noise:

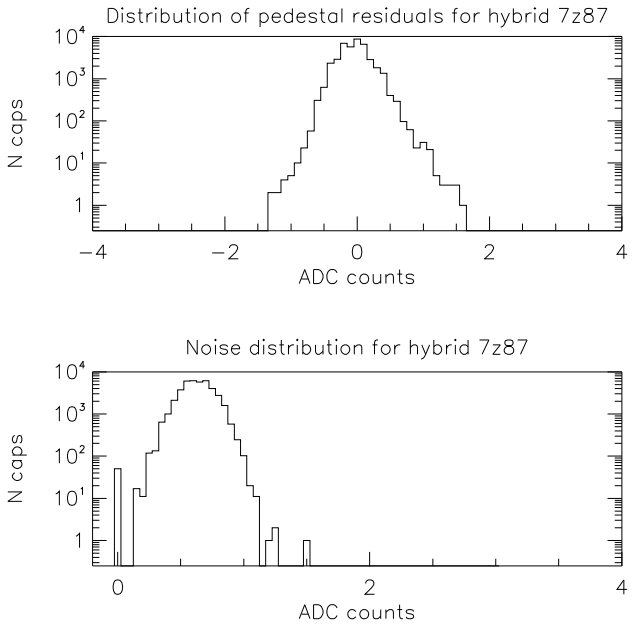
**Distribution of Pedestals and Noise**

The following are histograms of the pedestal of each pipeline capacitor relative to the chip average (top); and the RMS noise of each capacitor (bottom):

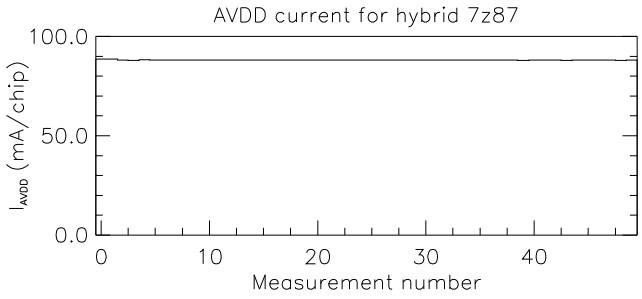
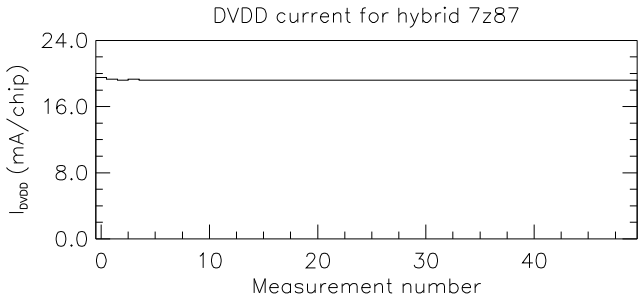
**Supply Currents During Burn-in**

The following plots show the supply currents per chip as a function of measurment number. Currents are measured approximately every 10 minutes:
