Hybrid 7z88 Traveler

March 27, 2000

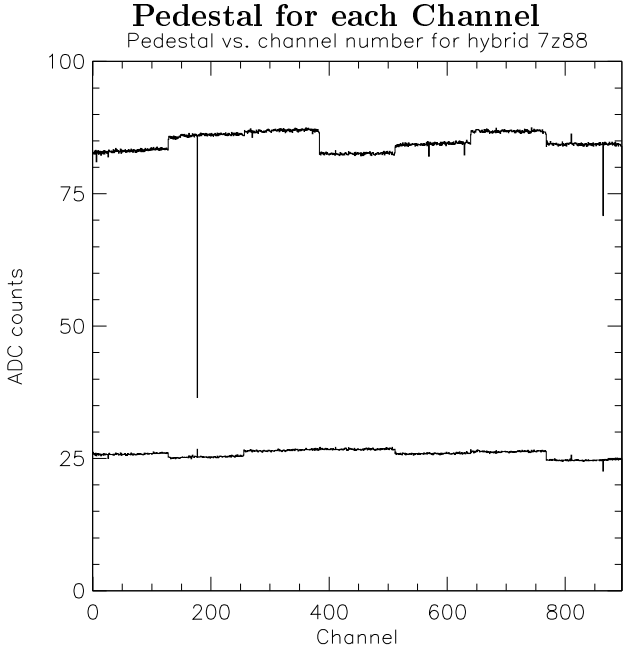
Pedestal for each Channel

The following plot shows the pedestals vs. channel number with and without charge injection:

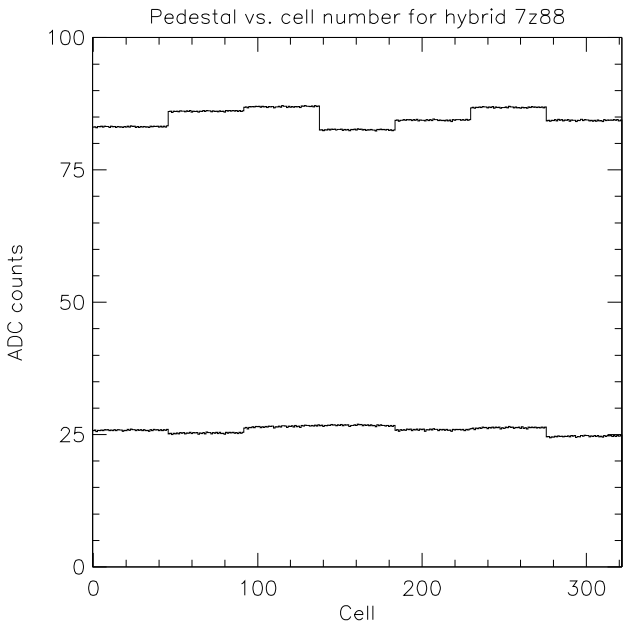
Pedestal vs. Pipeline Cell ID

The following plot shows the average pedestal vs. pipeline cell ID with and without charge injection. The x-axis is cell ID offset by 46 for each chip. Thus cell ID 5 for chip 1 is at x=5, chip 2 at x=51, chip 3 at x=97, etc.

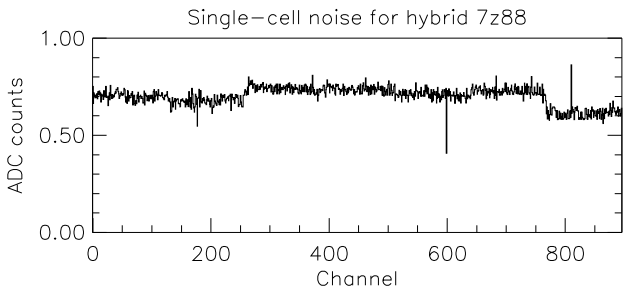
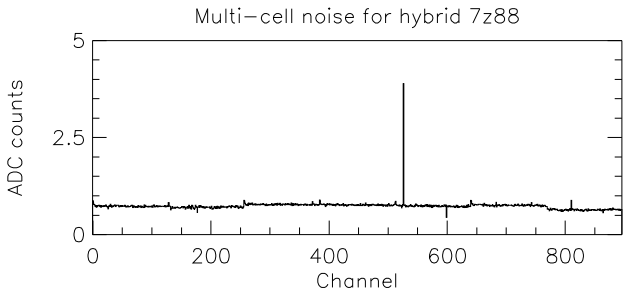
RMS Noise

The following plots show the single-cell and multi-cell RMS noise:

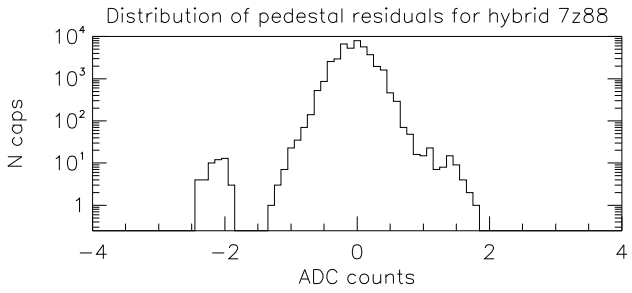
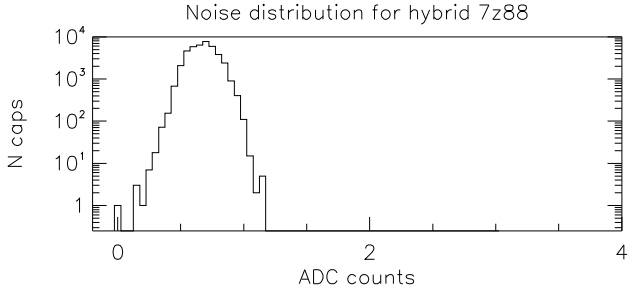
Distribution of Pedestals and Noise

The following are histograms of the pedestal of each pipeline capacitor relative to the chip average (top); and the RMS noise of each capacitor (bottom):

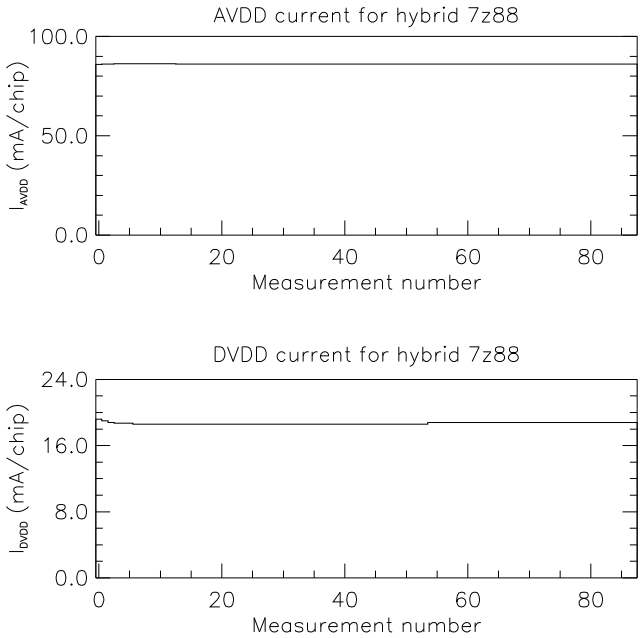
Supply Currents During Burn-in

The following plots show the supply currents per chip as a function of measurment number. Currents are measured approximately every 10 minutes:
