Hybrid 8j108 Traveler

June 2, 2000

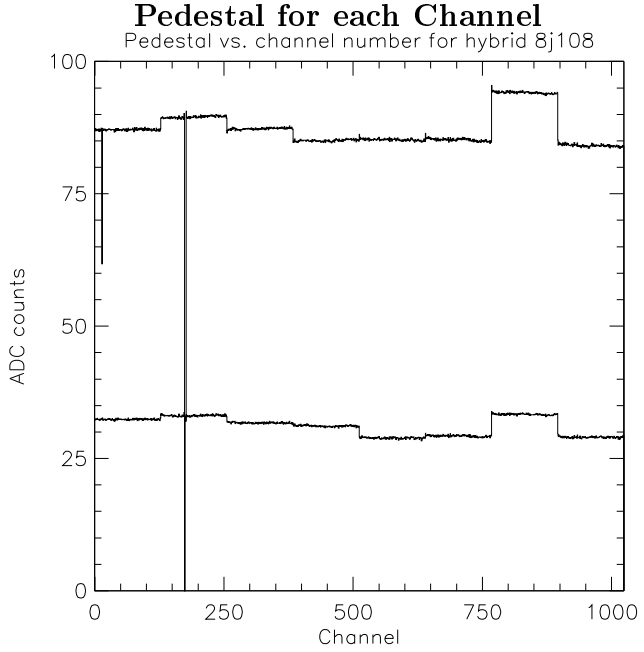
Pedestal for each Channel

The following plot shows the pedestals vs. channel number with and without charge injection:

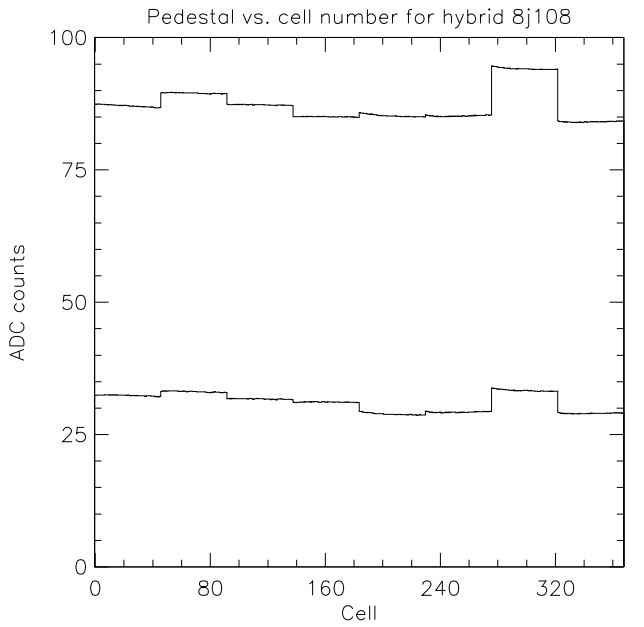
Pedestal vs. Pipeline Cell ID

The following plot shows the average pedestal vs. pipeline cell ID with and without charge injection. The x-axis is cell ID offset by 46 for each chip. Thus cell ID 5 for chip 1 is at x=5, chip 2 at x=51, chip 3 at x=97, etc.

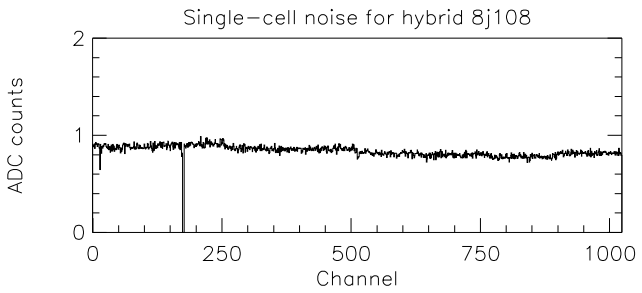
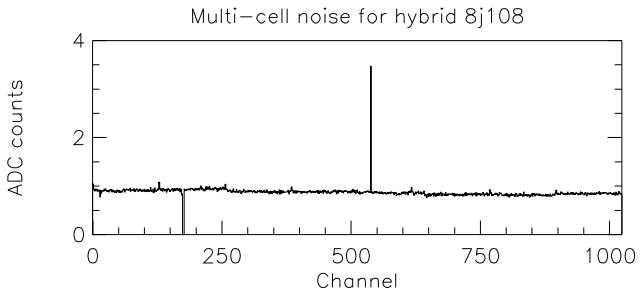
RMS Noise

The following plots show the single-cell and multi-cell RMS noise:

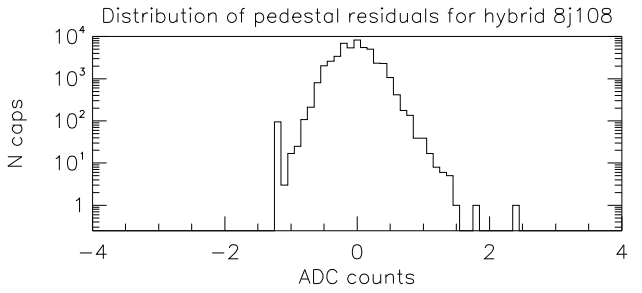
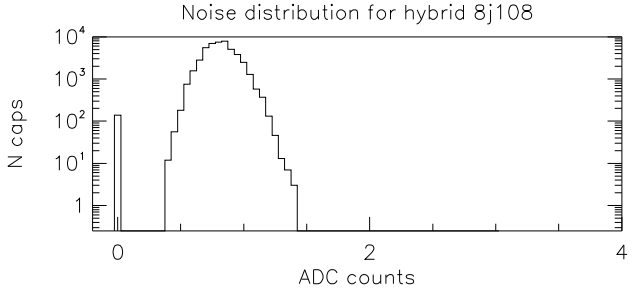
Distribution of Pedestals and Noise

The following are histograms of the pedestal of each pipeline capacitor relative to the chip average (top); and the RMS noise of each capacitor (bottom):

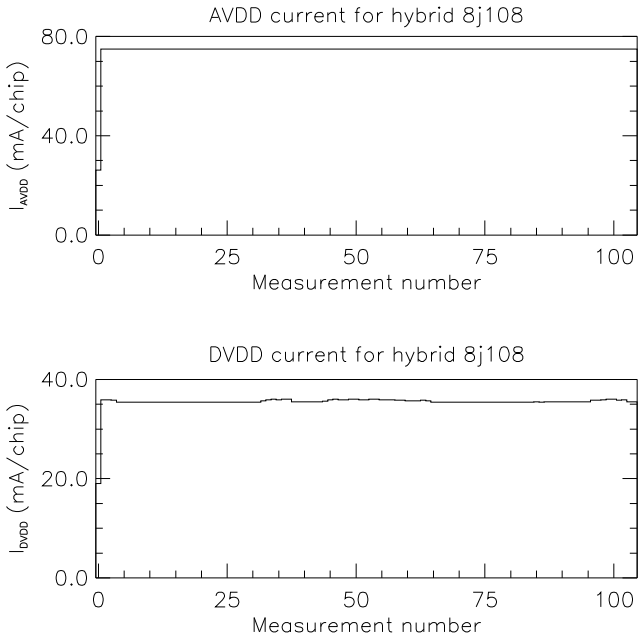
Supply Currents During Burn-in

The following plots show the supply currents per chip as a function of measurment number. Currents are measured approximately every 10 minutes:
