Hybrid 8j111 Traveler

January 4, 2000

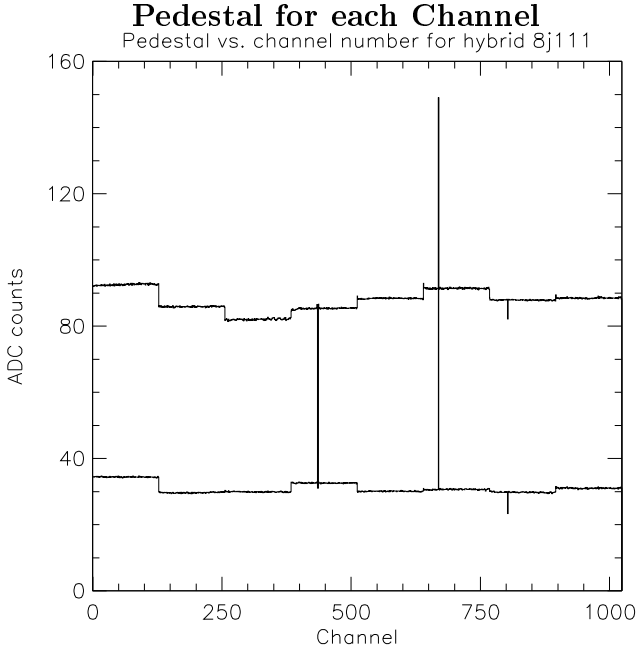
Pedestal for each Channel

The following plot shows the pedestals vs. channel number with and without charge injection:

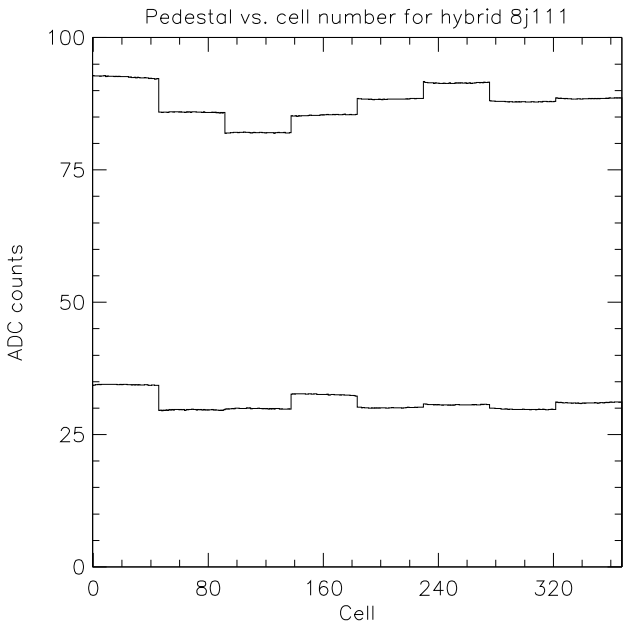
Pedestal vs. Pipeline Cell ID

The following plot shows the average pedestal vs. pipeline cell ID with and without charge injection. The x-axis is cell ID offset by 46 for each chip. Thus cell ID 5 for chip 1 is at x=5, chip 2 at x=51, chip 3 at x=97, etc.

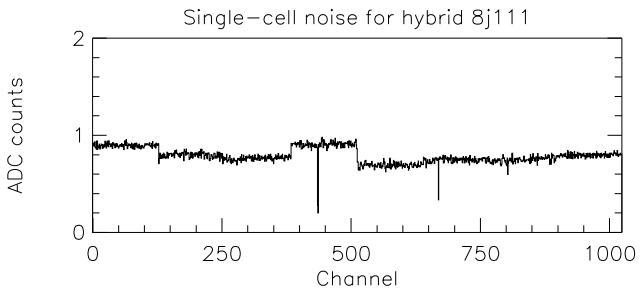
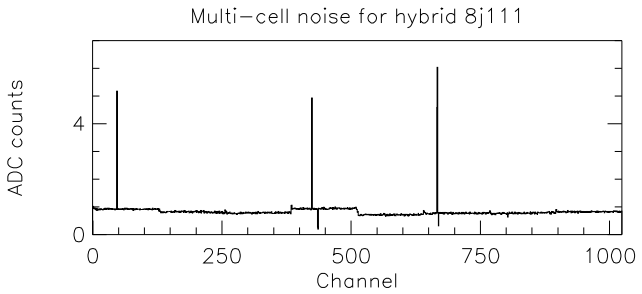
RMS Noise

The following plots show the single-cell and multi-cell RMS noise:

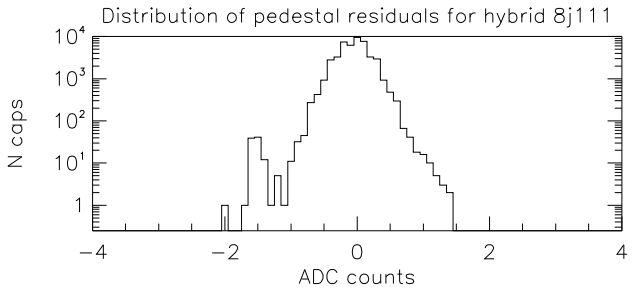
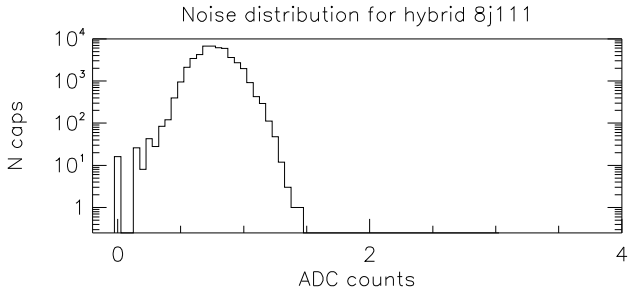
Distribution of Pedestals and Noise

The following are histograms of the pedestal of each pipeline capacitor relative to the chip average (top); and the RMS noise of each capacitor (bottom):

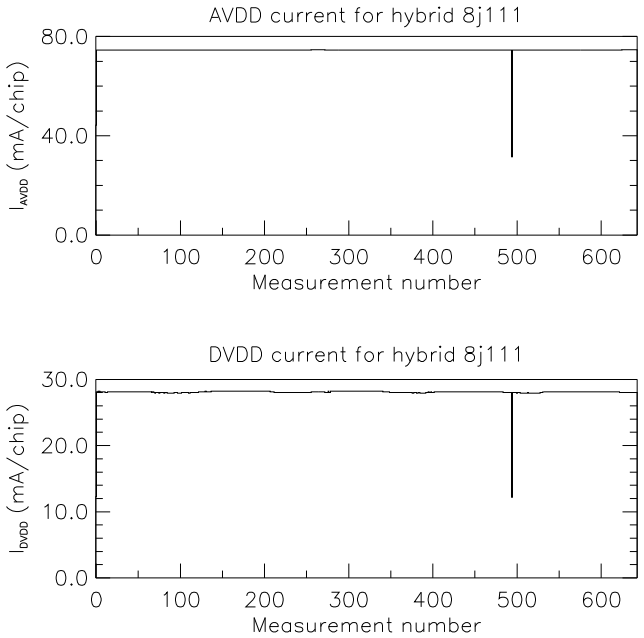
Supply Currents During Burn-in

The following plots show the supply currents per chip as a function of measurment number. Currents are measured approximately every 10 minutes:
