Hybrid 8j113 Traveler

December 9, 1999

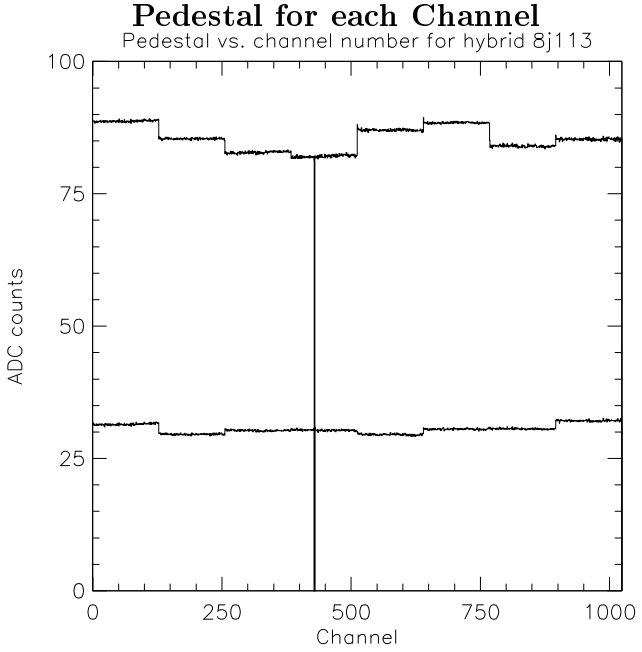
Pedestal for each Channel

The following plot shows the pedestals vs. channel number with and without charge injection:

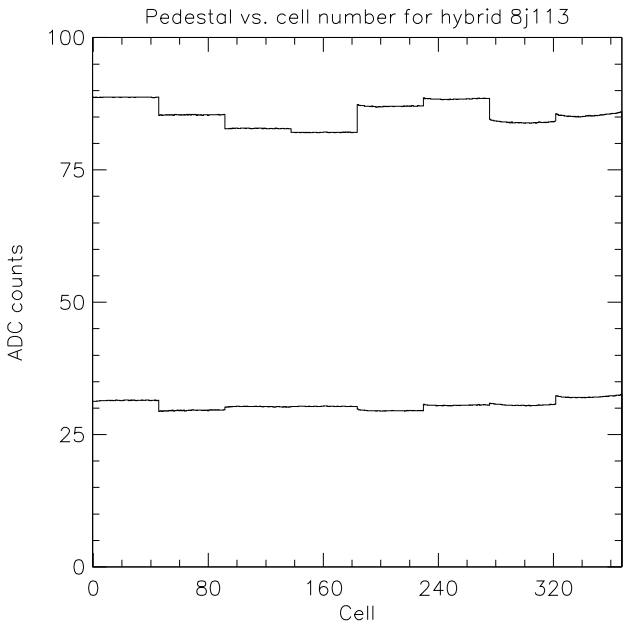
Pedestal vs. Pipeline Cell ID

The following plot shows the average pedestal vs. pipeline cell ID with and without charge injection. The x-axis is cell ID offset by 46 for each chip. Thus cell ID 5 for chip 1 is at x=5, chip 2 at x=51, chip 3 at x=97, etc.

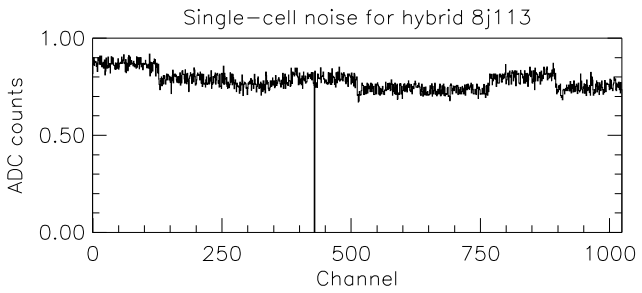
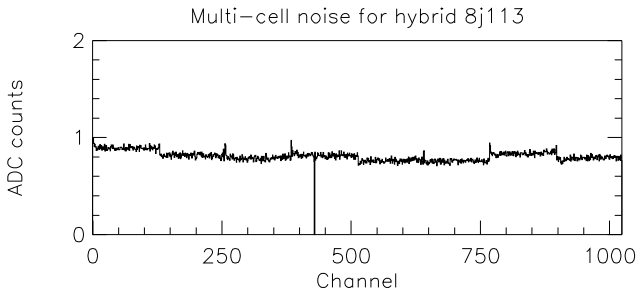
RMS Noise

The following plots show the single-cell and multi-cell RMS noise:

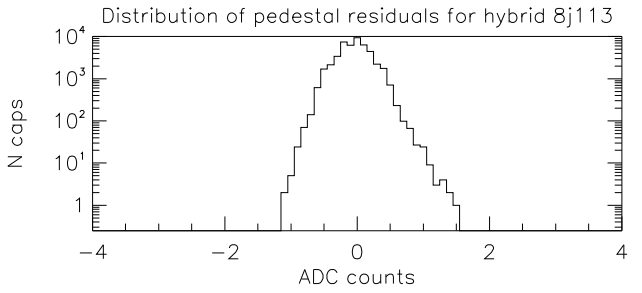
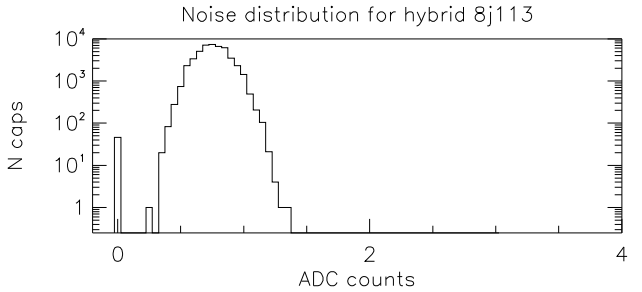
Distribution of Pedestals and Noise

The following are histograms of the pedestal of each pipeline capacitor relative to the chip average (top); and the RMS noise of each capacitor (bottom):

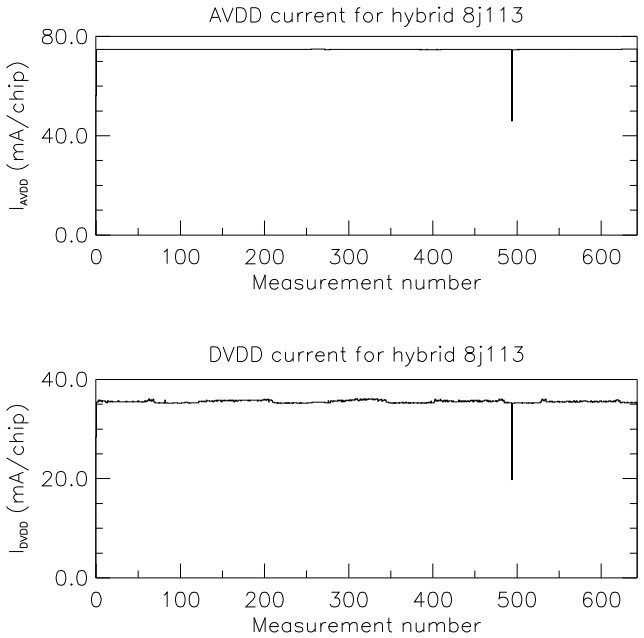
Supply Currents During Burn-in

The following plots show the supply currents per chip as a function of measurment number. Currents are measured approximately every 10 minutes:
