Hybrid 8j360 Traveler

July 27, 2000

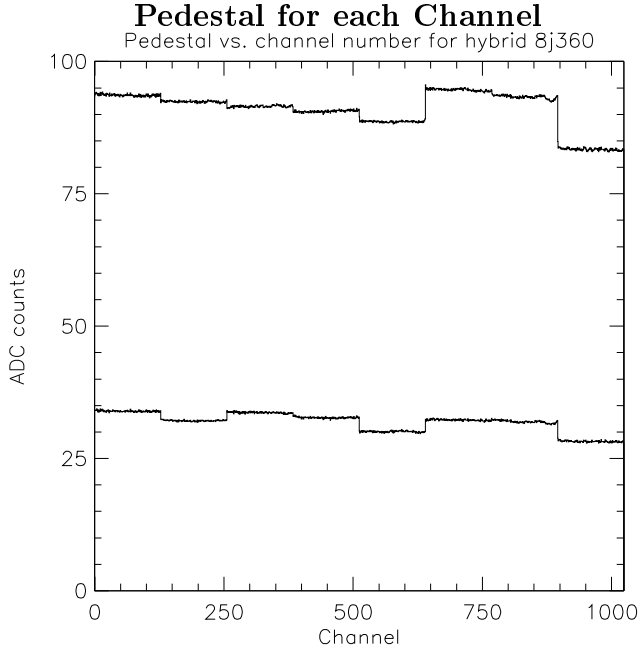
Pedestal for each Channel

The following plot shows the pedestals vs. channel number with and without charge injection:

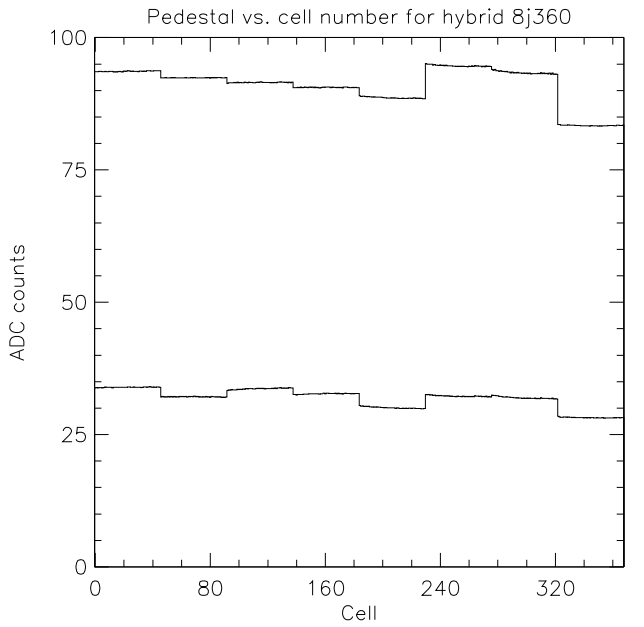
Pedestal vs. Pipeline Cell ID

The following plot shows the average pedestal vs. pipeline cell ID with and without charge injection. The x-axis is cell ID offset by 46 for each chip. Thus cell ID 5 for chip 1 is at x=5, chip 2 at x=51, chip 3 at x=97, etc.

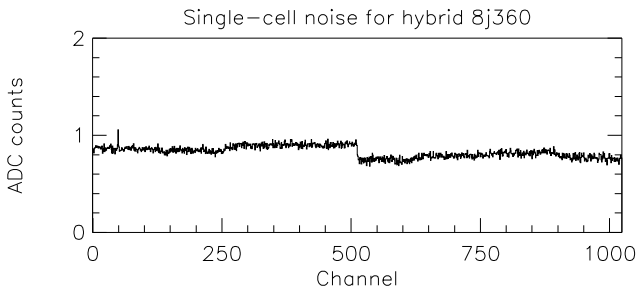
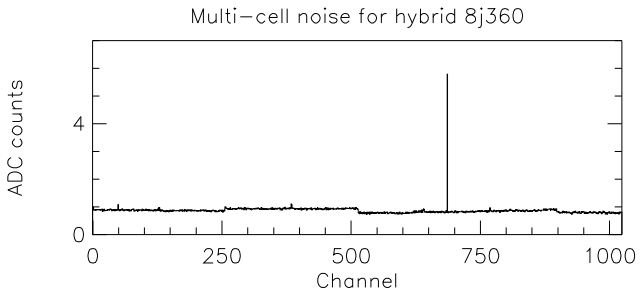
RMS Noise

The following plots show the single-cell and multi-cell RMS noise:

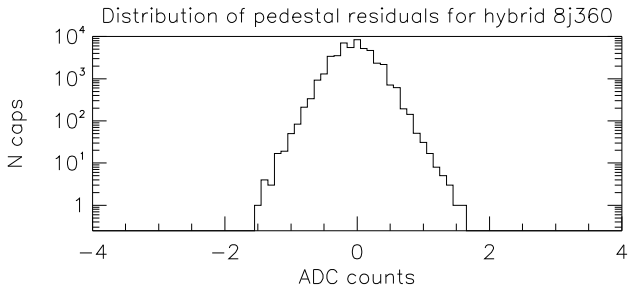
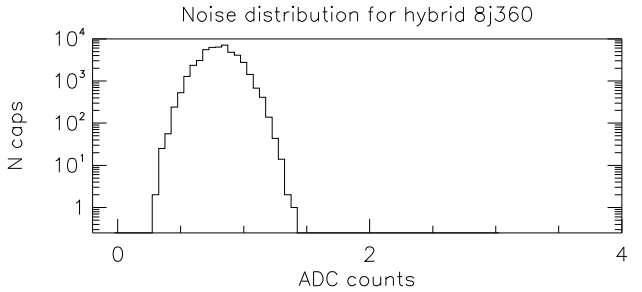
Distribution of Pedestals and Noise

The following are histograms of the pedestal of each pipeline capacitor relative to the chip average (top); and the RMS noise of each capacitor (bottom):

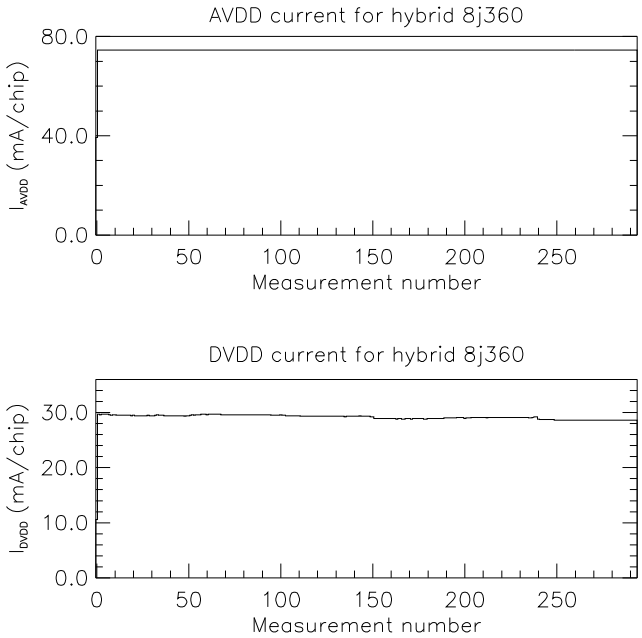
Supply Currents During Burn-in

The following plots show the supply currents per chip as a function of measurment number. Currents are measured approximately every 10 minutes:
