Hybrid 8j87 Traveler

December 7, 1999

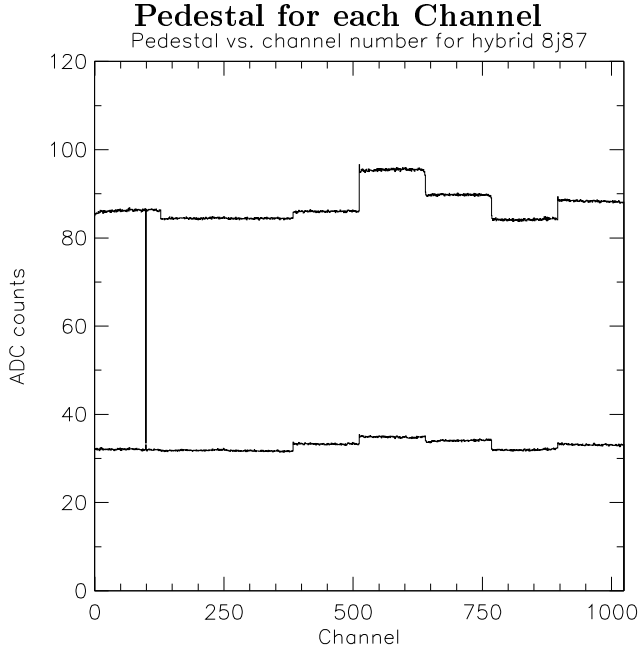
Pedestal for each Channel

The following plot shows the pedestals vs. channel number with and without charge injection:

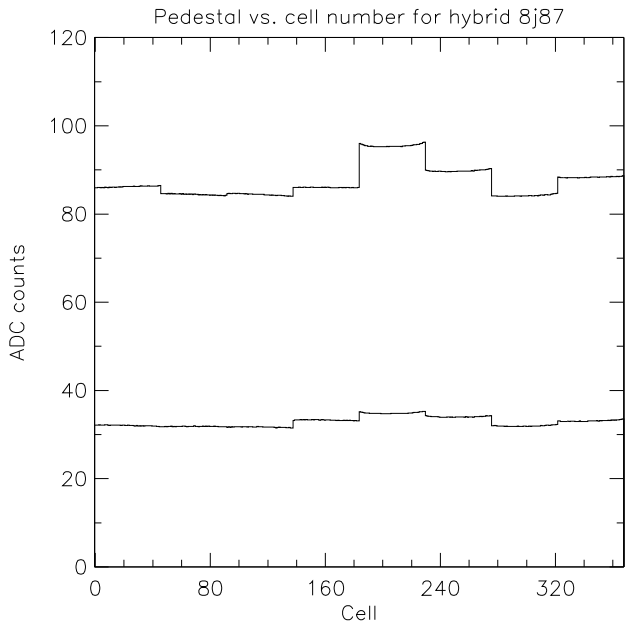
Pedestal vs. Pipeline Cell ID

The following plot shows the average pedestal vs. pipeline cell ID with and without charge injection. The x-axis is cell ID offset by 46 for each chip. Thus cell ID 5 for chip 1 is at x=5, chip 2 at x=51, chip 3 at x=97, etc.

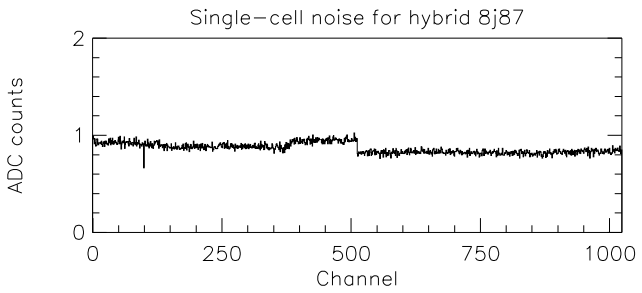
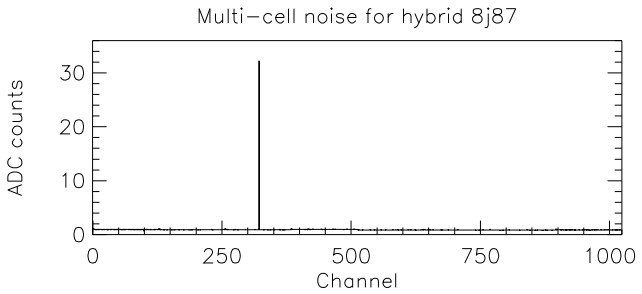
RMS Noise

The following plots show the single-cell and multi-cell RMS noise:

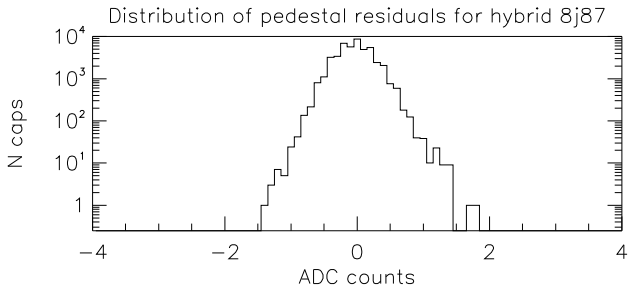
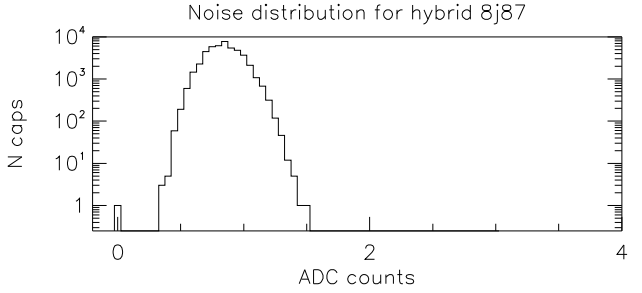
Distribution of Pedestals and Noise

The following are histograms of the pedestal of each pipeline capacitor relative to the chip average (top); and the RMS noise of each capacitor (bottom):

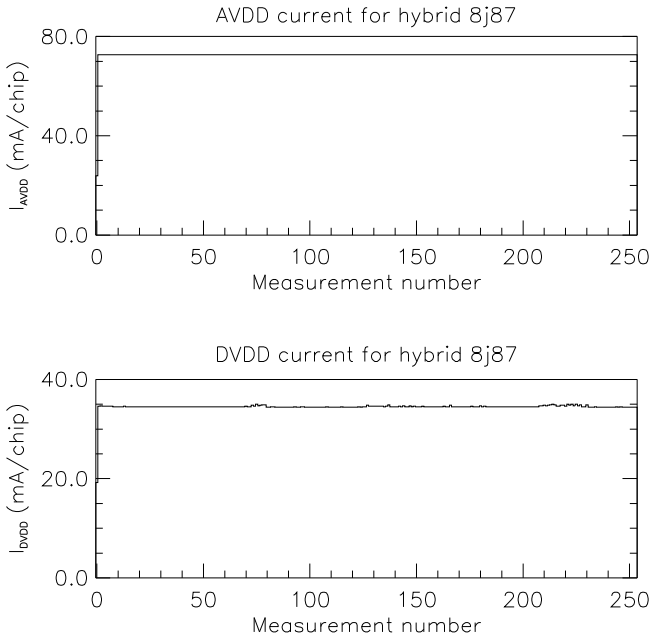
Supply Currents During Burn-in

The following plots show the supply currents per chip as a function of measurment number. Currents are measured approximately every 10 minutes:
