Hybrid 2l1 Traveler

May 8, 2000

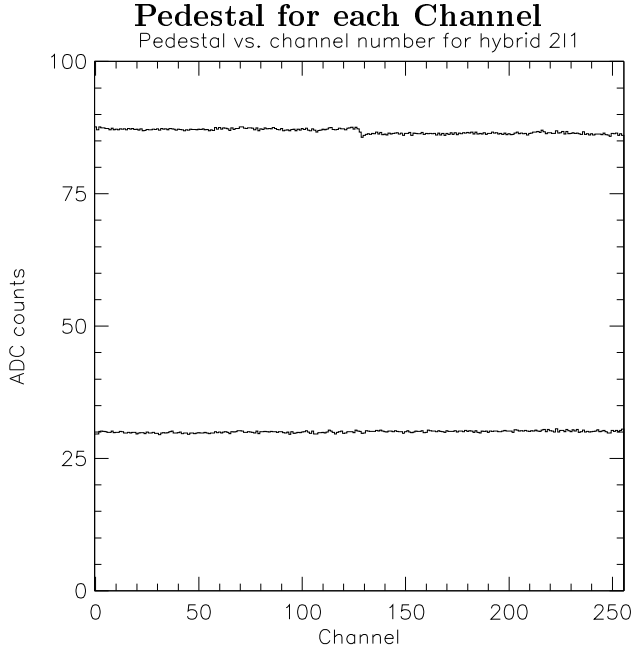
Pedestal for each Channel

The following plot shows the pedestals vs. channel number with and without charge injection:

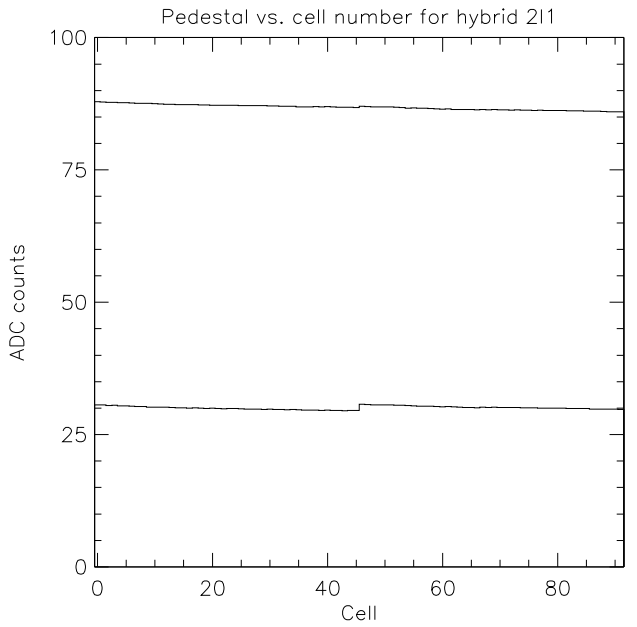
Pedestal vs. Pipeline Cell ID

The following plot shows the average pedestal vs. pipeline cell ID with and without charge injection. The x-axis is cell ID offset by 46 for each chip. Thus cell ID 5 for chip 1 is at x=5, chip 2 at x=51, chip 3 at x=97, etc.

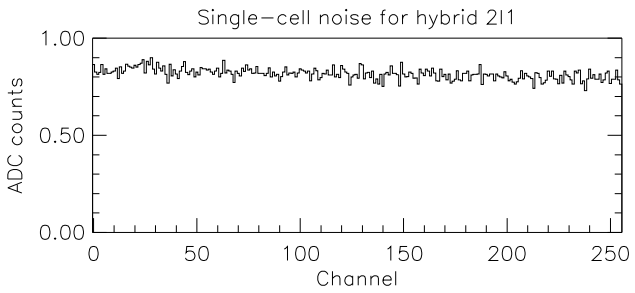
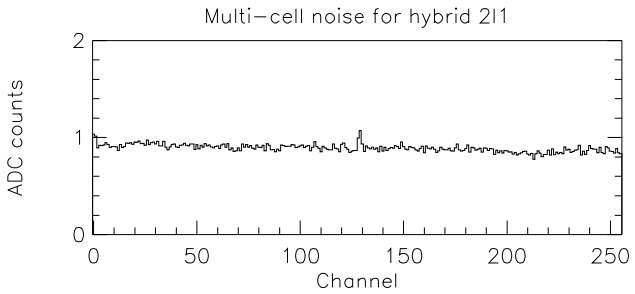
RMS Noise

The following plots show the single-cell and multi-cell RMS noise:

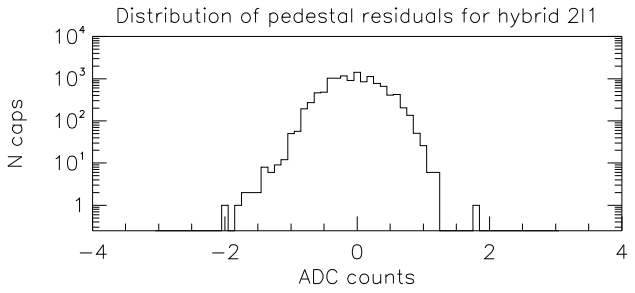
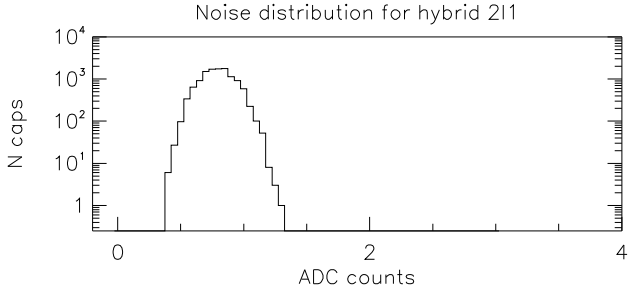
Distribution of Pedestals and Noise

The following are histograms of the pedestal of each pipeline capacitor relative to the chip average (top); and the RMS noise of each capacitor (bottom):

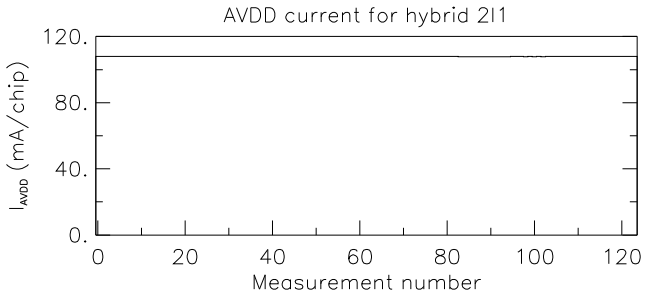
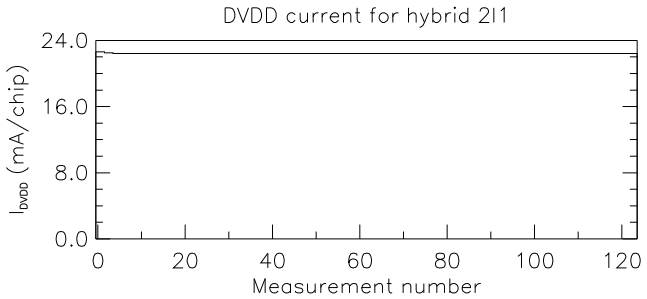
Supply Currents During Burn-in

The following plots show the supply currents per chip as a function of measurment number. Currents are measured approximately every 10 minutes:
