Hybrid 2l44 Traveler

August 3, 2000

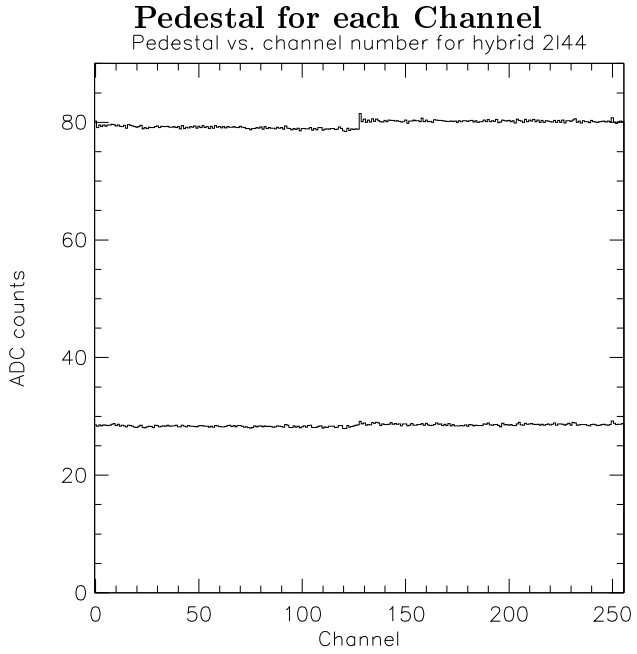
The following plot shows the pedestals vs. channel number with and without charge injection:

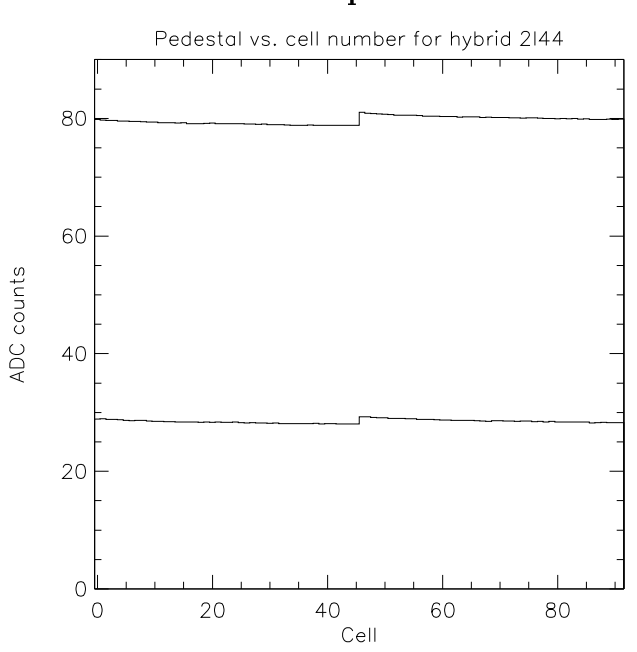
The following plot shows the average pedestal vs. pipeline cell ID with and without charge injection. The x-axis is cell ID offset by 46 for each chip. Thus cell ID 5 for chip 1 is at x=5, chip 2 at x=51, chip 3 at x=97, etc.

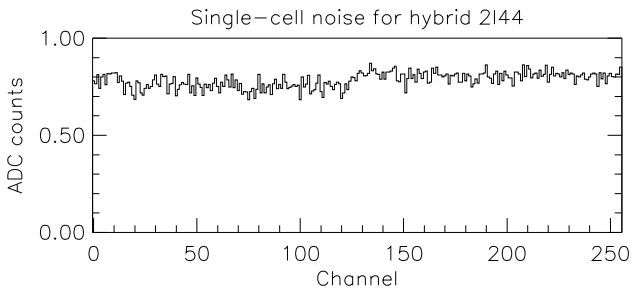
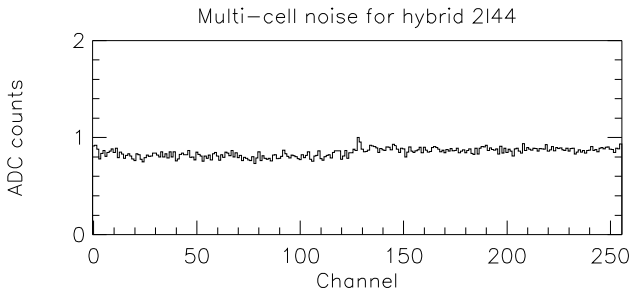
RMS Noise

The following plots show the single-cell and multi-cell RMS noise:

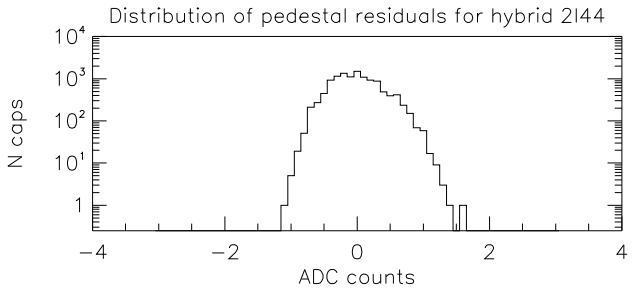
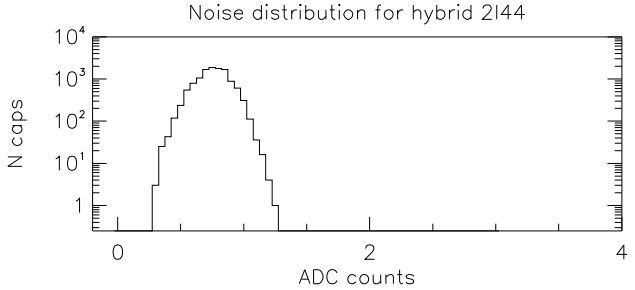
Distribution of Pedestals and Noise

The following are histograms of the pedestal of each pipeline capacitor relative to the chip average (top); and the RMS noise of each capacitor (bottom):

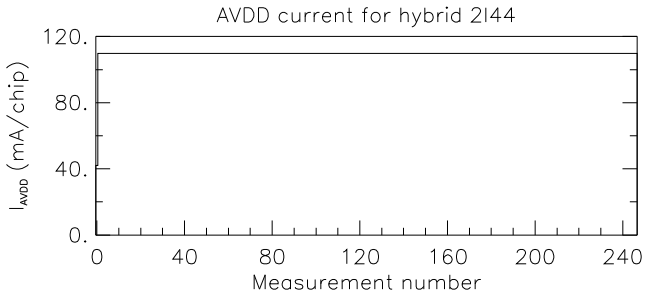
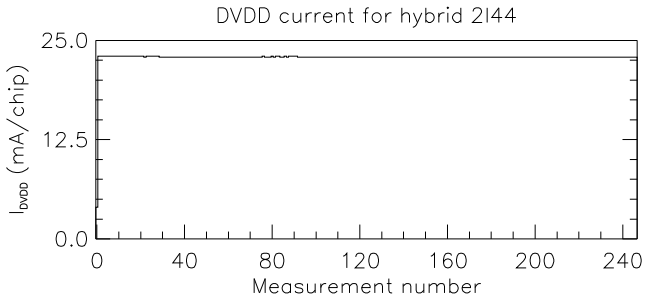
Supply Currents During Burn-in

The following plots show the supply currents per chip as a function of measurment number. Currents are measured approximately every 10 minutes:
