Hybrid 2l5 Traveler

May 8, 2000

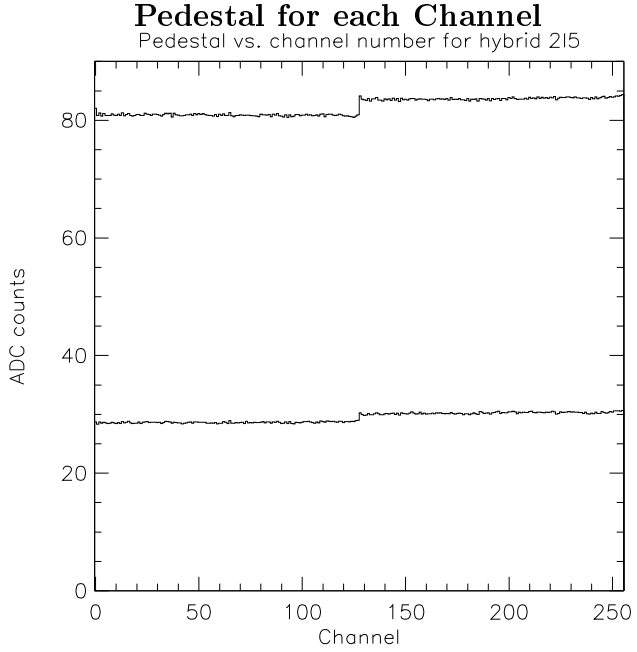
Pedestal for each Channel

The following plot shows the pedestals vs. channel number with and without charge injection:

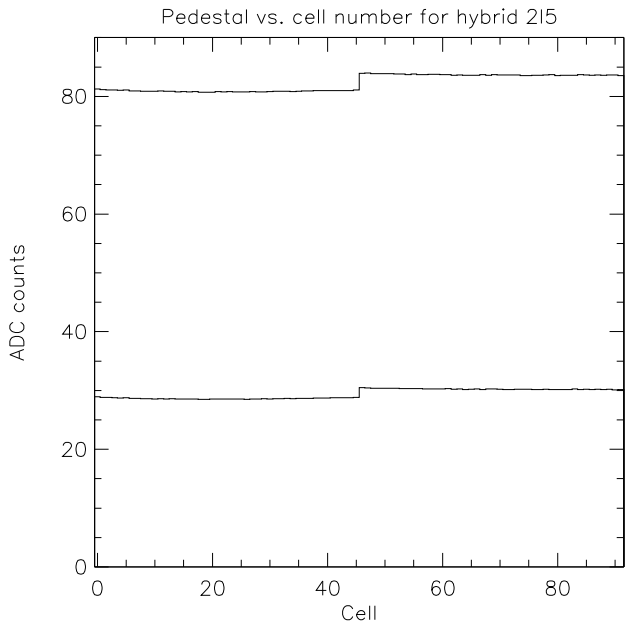
Pedestal vs. Pipeline Cell ID

The following plot shows the average pedestal vs. pipeline cell ID with and without charge injection. The x-axis is cell ID offset by 46 for each chip. Thus cell ID 5 for chip 1 is at x=5, chip 2 at x=51, chip 3 at x=97, etc.

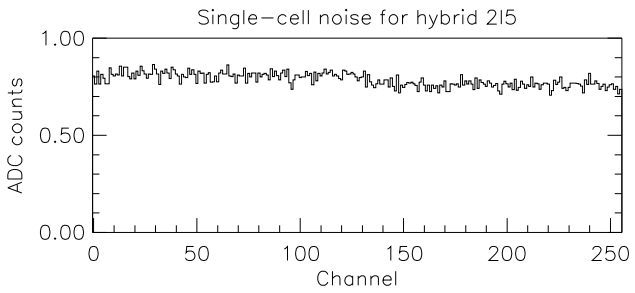
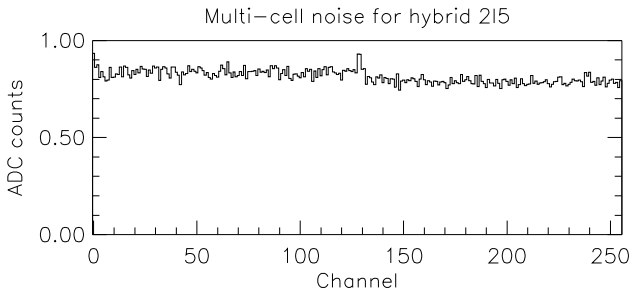
RMS Noise

The following plots show the single-cell and multi-cell RMS noise:

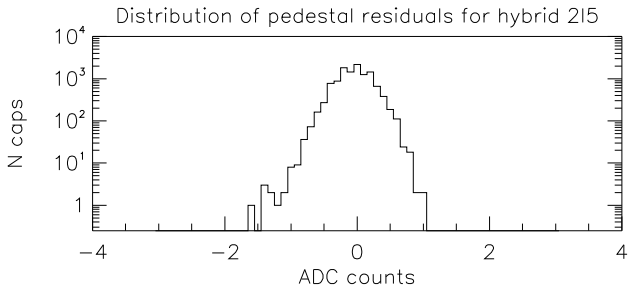
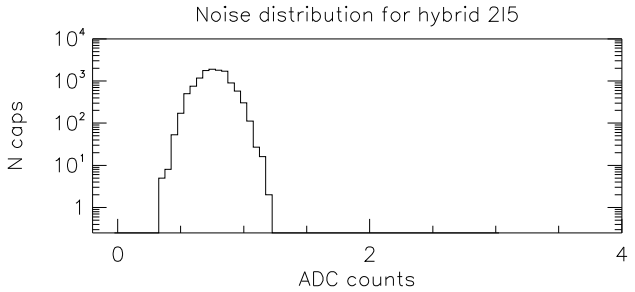
Distribution of Pedestals and Noise

The following are histograms of the pedestal of each pipeline capacitor relative to the chip average (top); and the RMS noise of each capacitor (bottom):

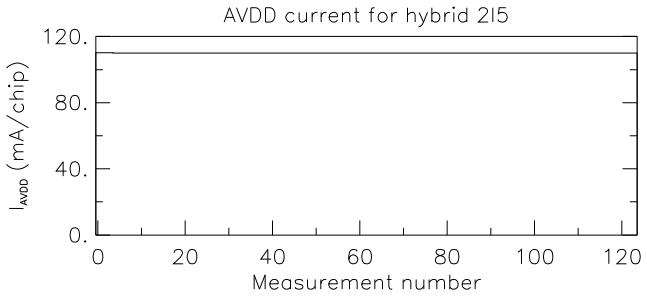
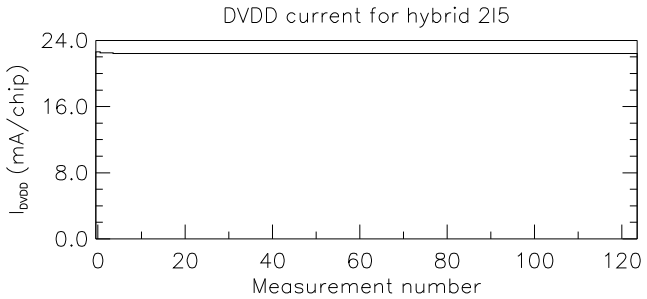
Supply Currents During Burn-in

The following plots show the supply currents per chip as a function of measurment number. Currents are measured approximately every 10 minutes:
