Hybrid 2p121 Traveler

October 29, 1999

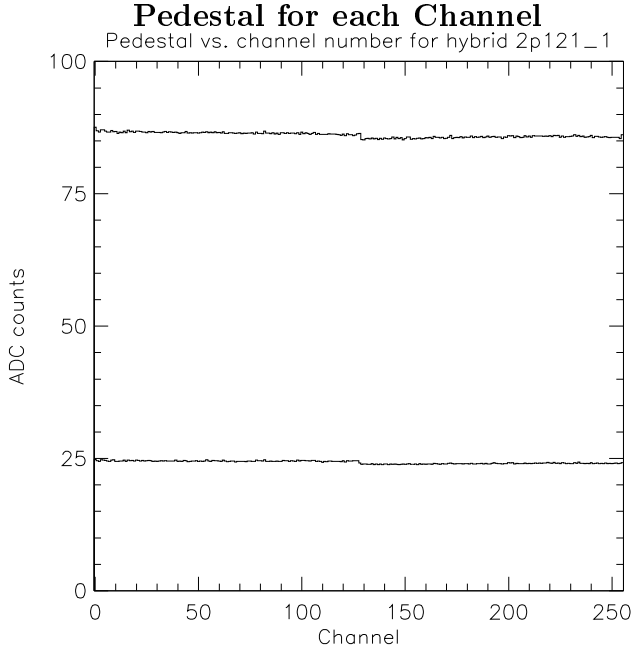
Pedestal for each Channel

The following plot shows the pedestals vs. channel number with and without charge injection:

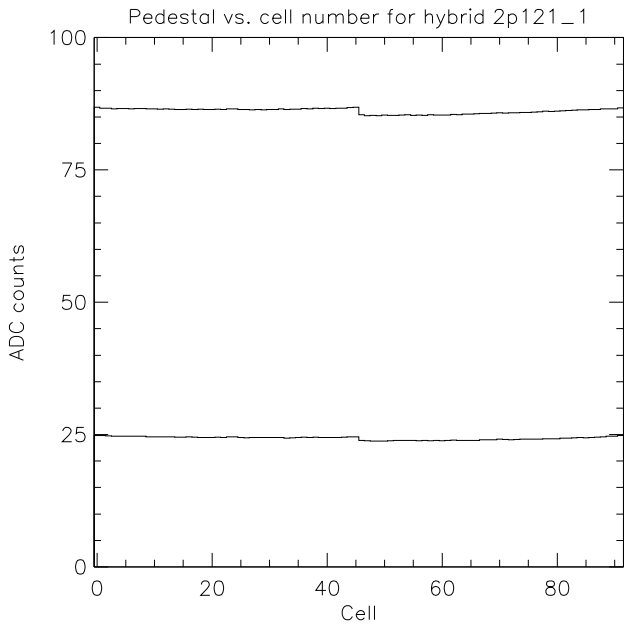
Pedestal vs. Pipeline Cell ID

The following plot shows the average pedestal vs. pipeline cell ID with and without charge injection. The x-axis is cell ID offset by 46 for each chip. Thus cell ID 5 for chip 1 is at x=5, chip 2 at x=51, chip 3 at x=97, etc.

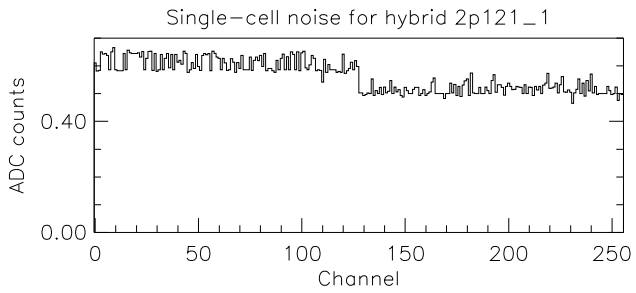
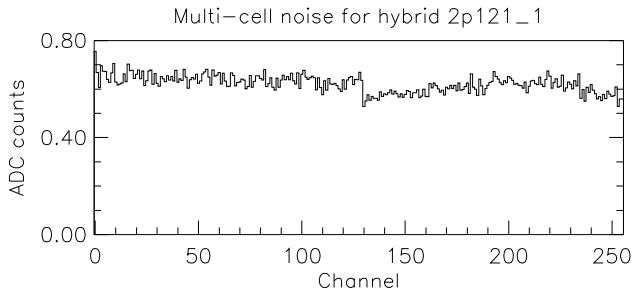
RMS Noise

The following plots show the single-cell and multi-cell RMS noise:

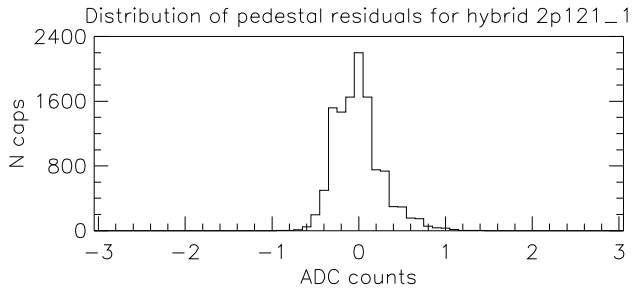
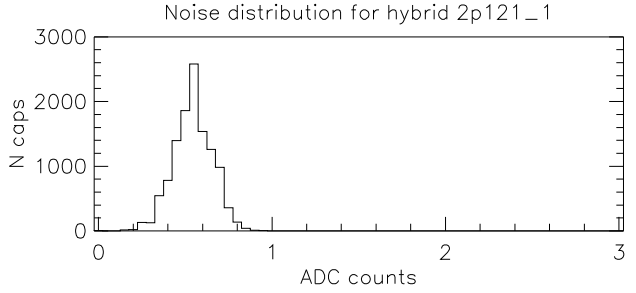
Distribution of Pedestals and Noise

The following are histograms of the pedestal of each pipeline capacitor relative to the chip average (top); and the RMS noise of each capacitor (bottom):

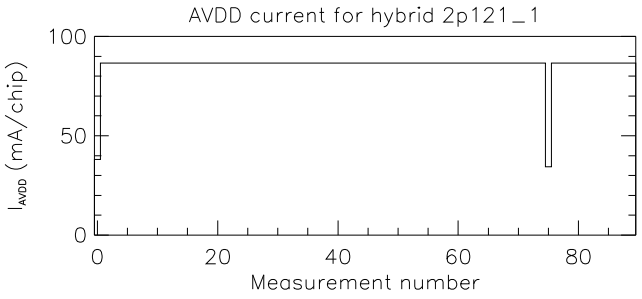
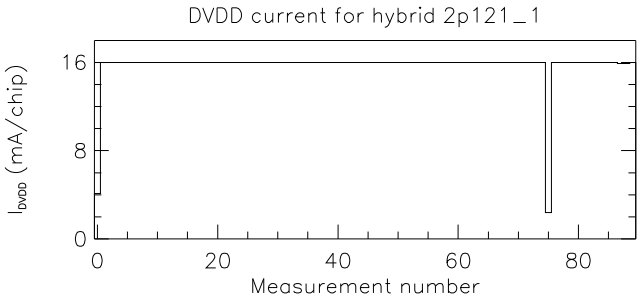
Supply Currents During Burn-in

The following plots show the supply currents per chip as a function of measurment number. Currents are measured approximately every 10 minutes:
