Hybrid 2p126 Traveler

November 3, 1999

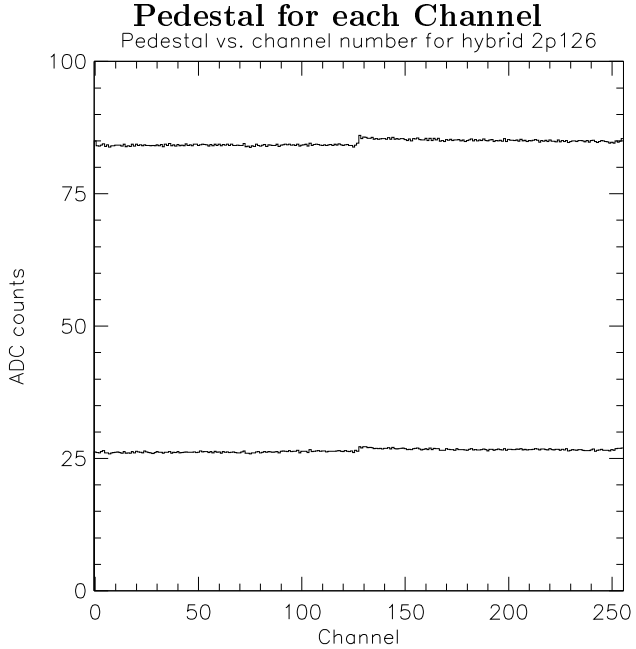
Pedestal for each Channel

The following plot shows the pedestals vs. channel number with and without charge injection:

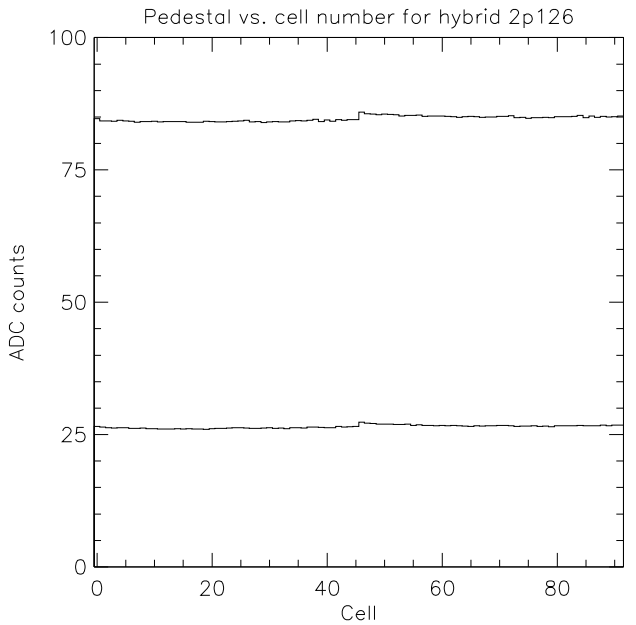
Pedestal vs. Pipeline Cell ID

The following plot shows the average pedestal vs. pipeline cell ID with and without charge injection. The x-axis is cell ID offset by 46 for each chip. Thus cell ID 5 for chip 1 is at x=5, chip 2 at x=51, chip 3 at x=97, etc.

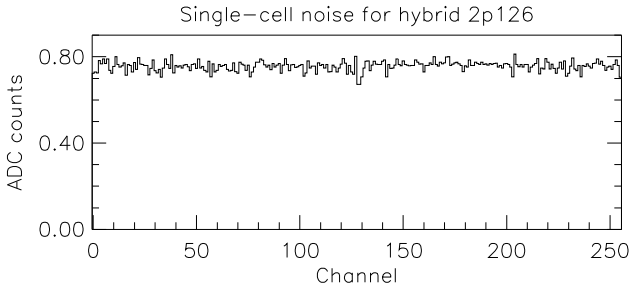
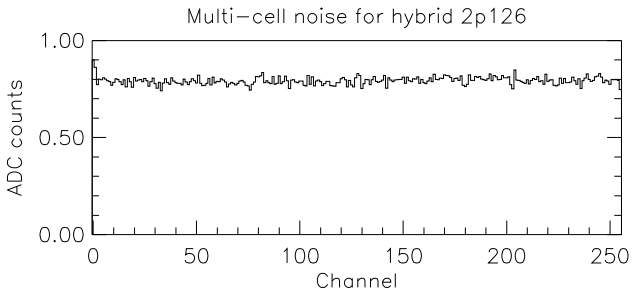
RMS Noise

The following plots show the single-cell and multi-cell RMS noise:

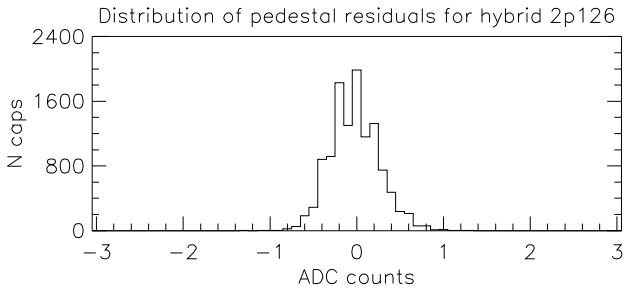
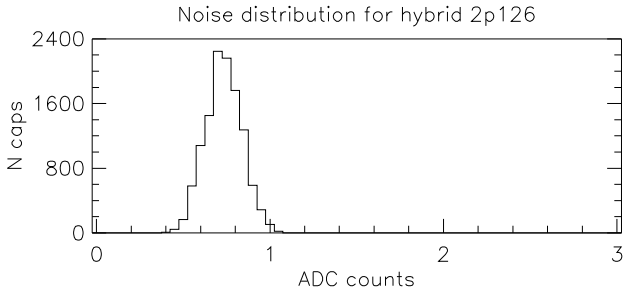
Distribution of Pedestals and Noise

The following are histograms of the pedestal of each pipeline capacitor relative to the chip average (top); and the RMS noise of each capacitor (bottom):

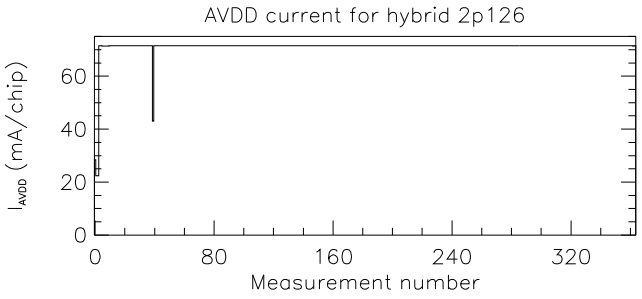
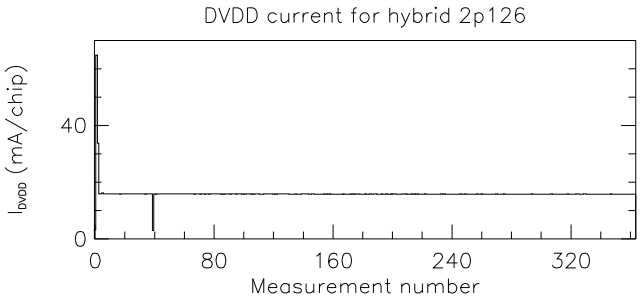
Supply Currents During Burn-in

The following plots show the supply currents per chip as a function of measurment number. Currents are measured approximately every 10 minutes:
