Hybrid 2p215 Traveler

April 4, 2000

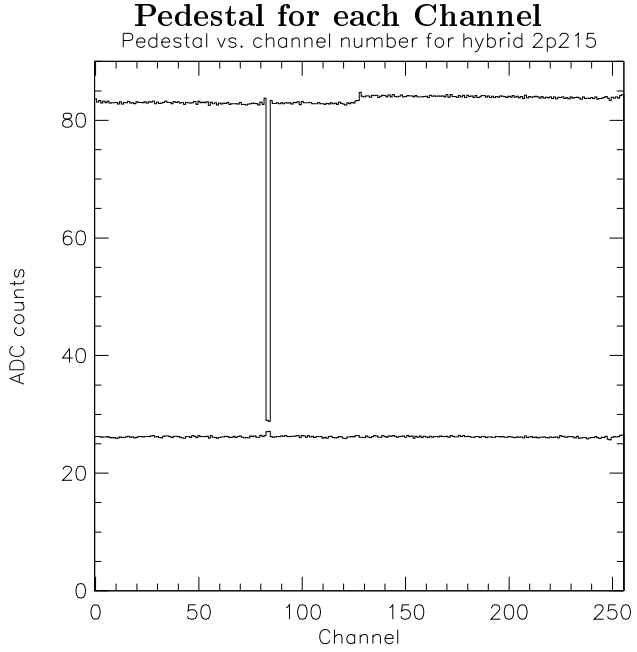
Pedestal for each Channel

The following plot shows the pedestals vs. channel number with and without charge injection:

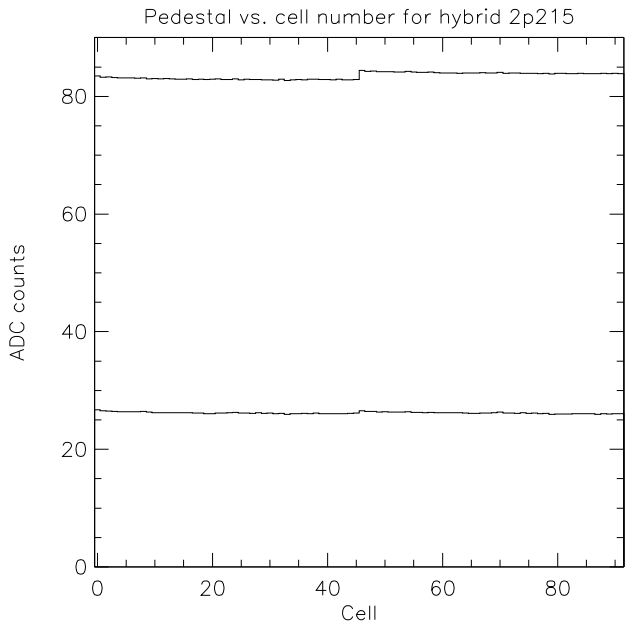
Pedestal vs. Pipeline Cell ID

The following plot shows the average pedestal vs. pipeline cell ID with and without charge injection. The x-axis is cell ID offset by 46 for each chip. Thus cell ID 5 for chip 1 is at x=5, chip 2 at x=51, chip 3 at x=97, etc.

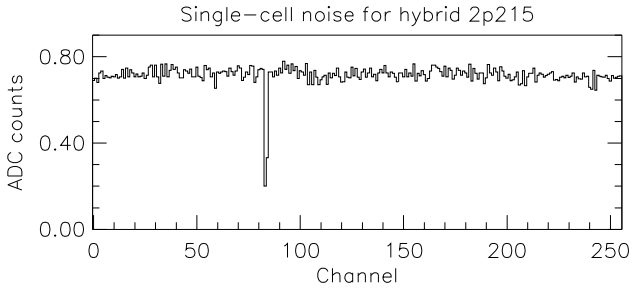
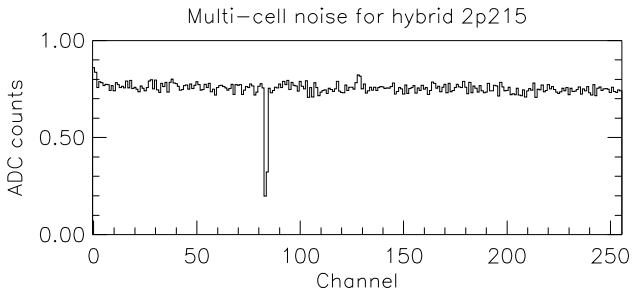
RMS Noise

The following plots show the single-cell and multi-cell RMS noise:

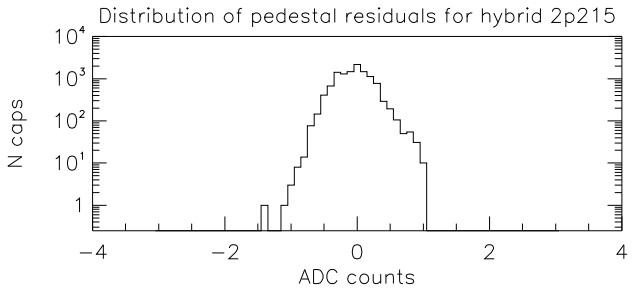
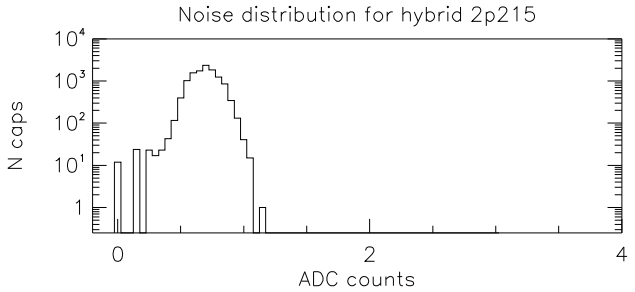
Distribution of Pedestals and Noise

The following are histograms of the pedestal of each pipeline capacitor relative to the chip average (top); and the RMS noise of each capacitor (bottom):

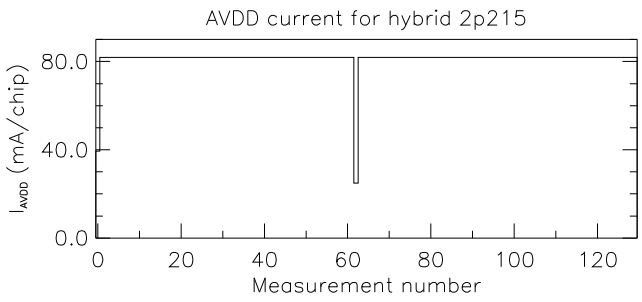
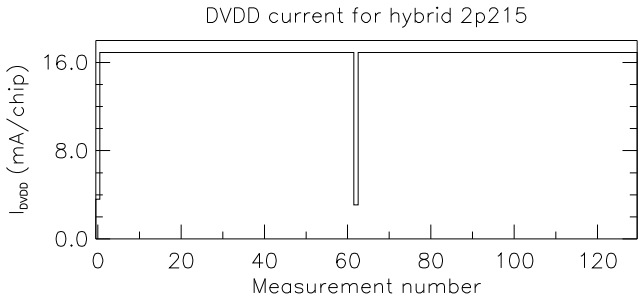
Supply Currents During Burn-in

The following plots show the supply currents per chip as a function of measurment number. Currents are measured approximately every 10 minutes:
