Hybrid 2p216 Traveler

April 4, 2000

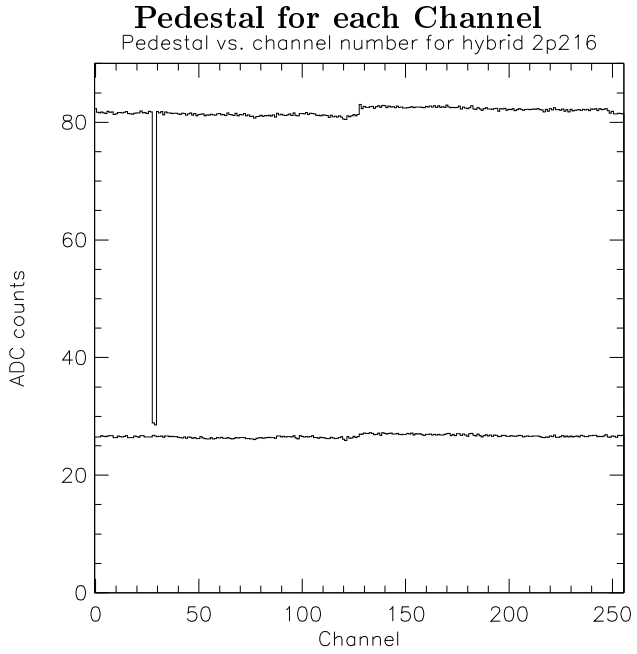
The following plot shows the pedestals vs. channel number with and without charge injection:

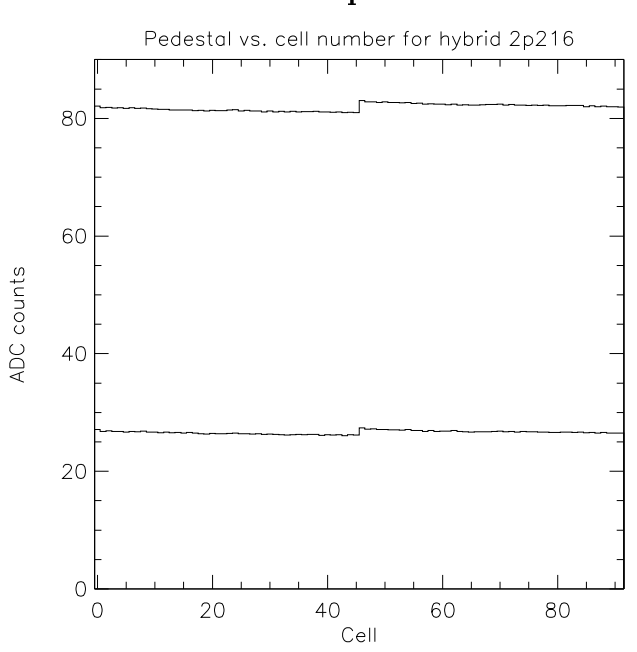
The following plot shows the average pedestal vs. pipeline cell ID with and without charge injection. The x-axis is cell ID offset by 46 for each chip. Thus cell ID 5 for chip 1 is at x=5, chip 2 at x=51, chip 3 at x=97, etc.

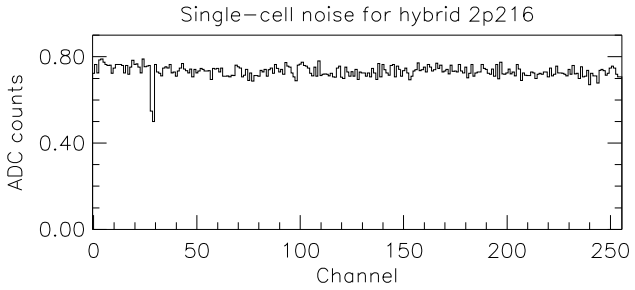
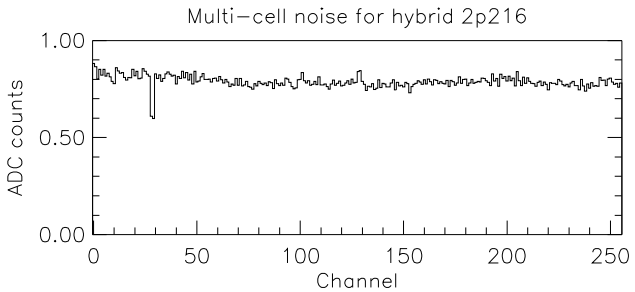
RMS Noise

The following plots show the single-cell and multi-cell RMS noise:

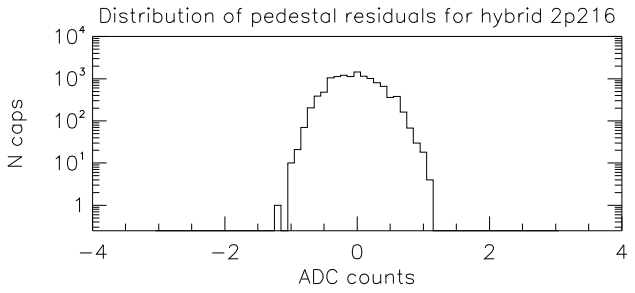
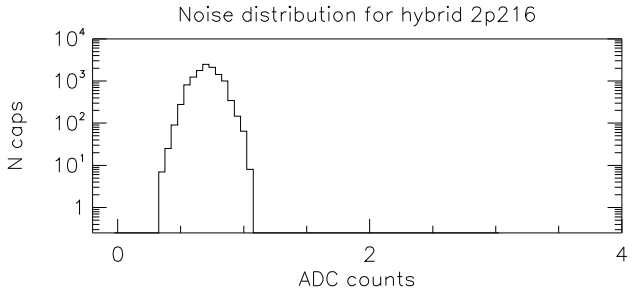
Distribution of Pedestals and Noise

The following are histograms of the pedestal of each pipeline capacitor relative to the chip average (top); and the RMS noise of each capacitor (bottom):

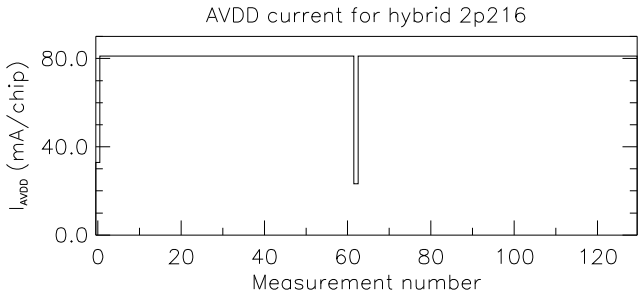
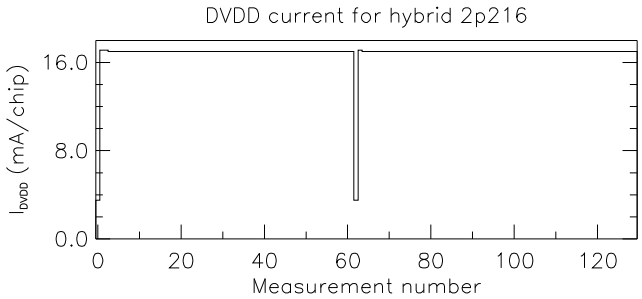
Supply Currents During Burn-in

The following plots show the supply currents per chip as a function of measurment number. Currents are measured approximately every 10 minutes:
