Hybrid 2p31 Traveler

October 19, 1999

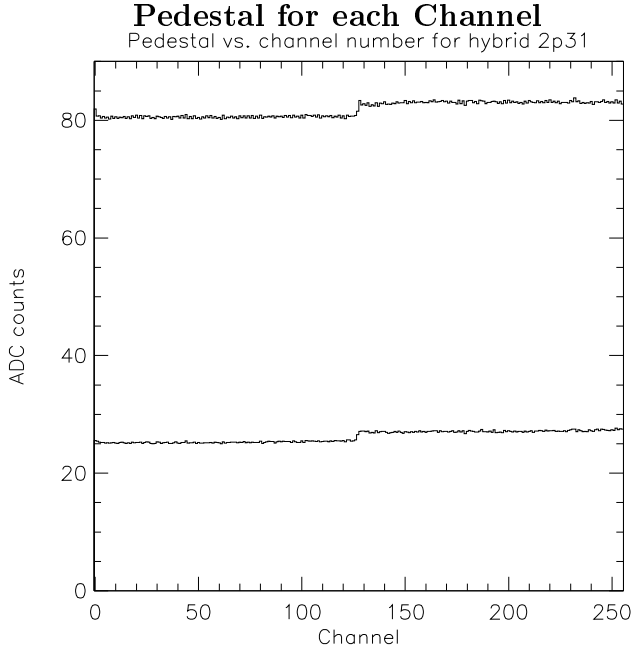
Pedestal for each Channel

The following plot shows the pedestals vs. channel number with and without charge injection:

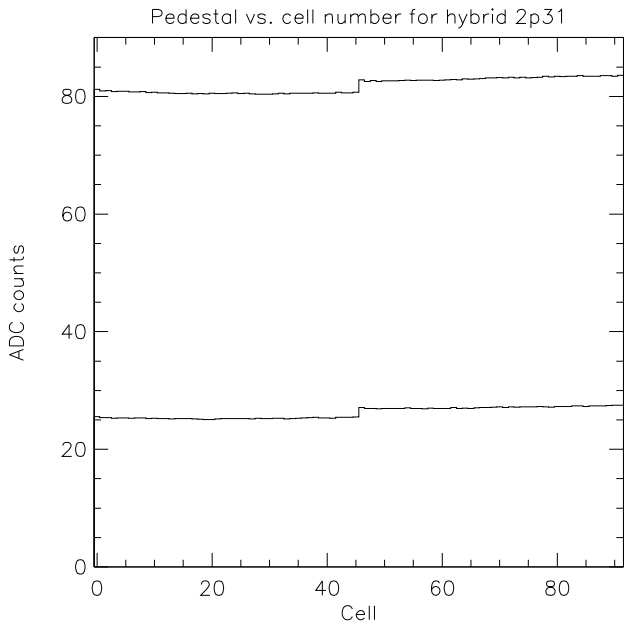
Pedestal vs. Pipeline Cell ID

The following plot shows the average pedestal vs. pipeline cell ID with and without charge injection. The x-axis is cell ID offset by 46 for each chip. Thus cell ID 5 for chip 1 is at x=5, chip 2 at x=51, chip 3 at x=97, etc.

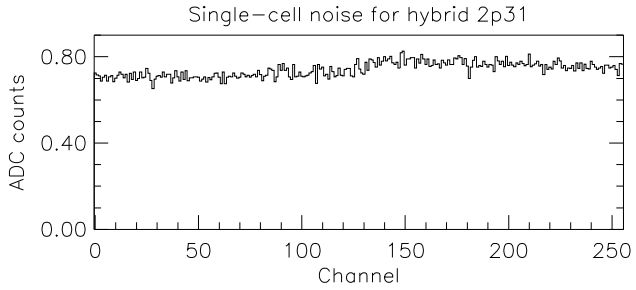
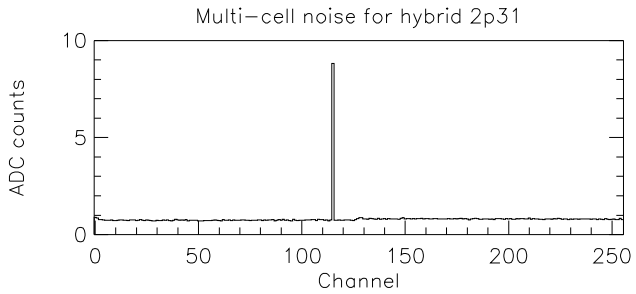
RMS Noise

The following plots show the single-cell and multi-cell RMS noise:

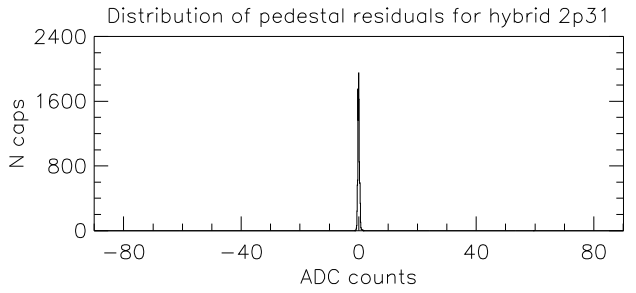
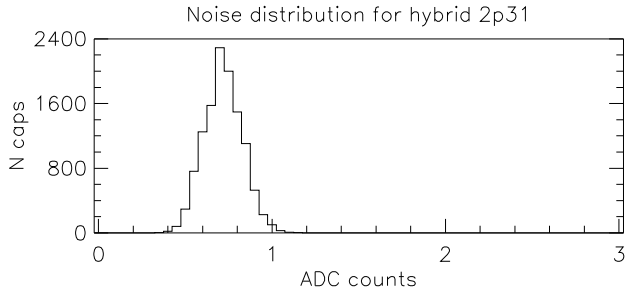
Distribution of Pedestals and Noise

The following are histograms of the pedestal of each pipeline capacitor relative to the chip average (top); and the RMS noise of each capacitor (bottom):

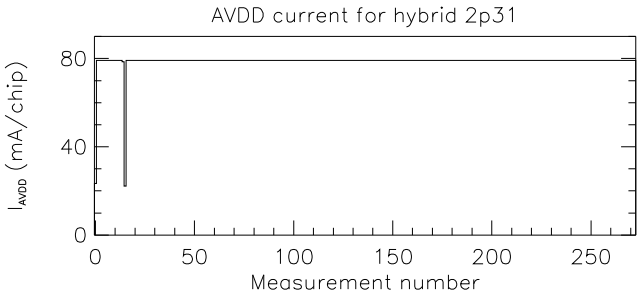
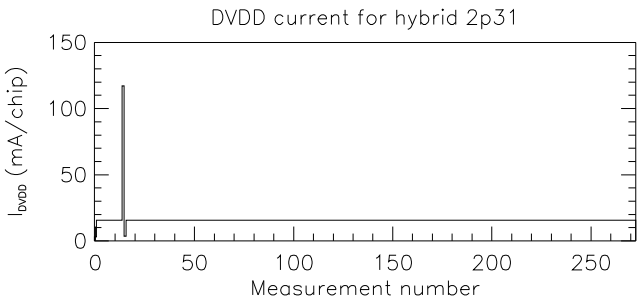
Supply Currents During Burn-in

The following plots show the supply currents per chip as a function of measurment number. Currents are measured approximately every 10 minutes:
