Hybrid 2p51 Traveler

December 2, 1999

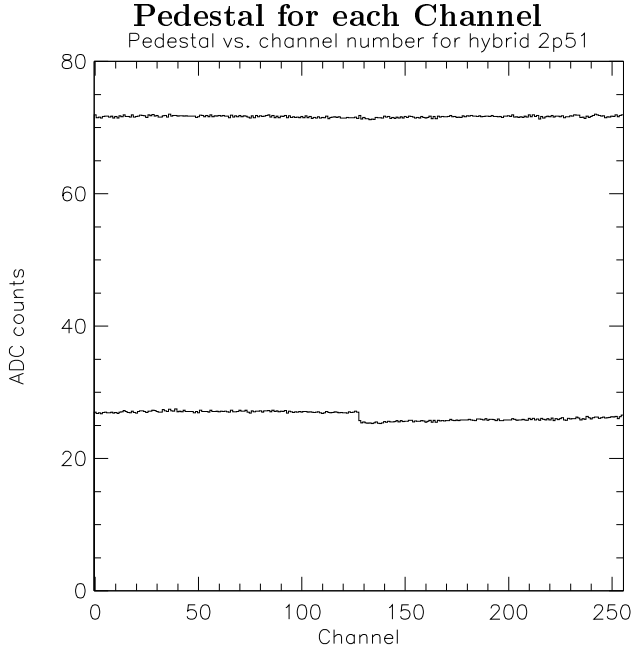
Pedestal for each Channel

The following plot shows the pedestals vs. channel number with and without charge injection:

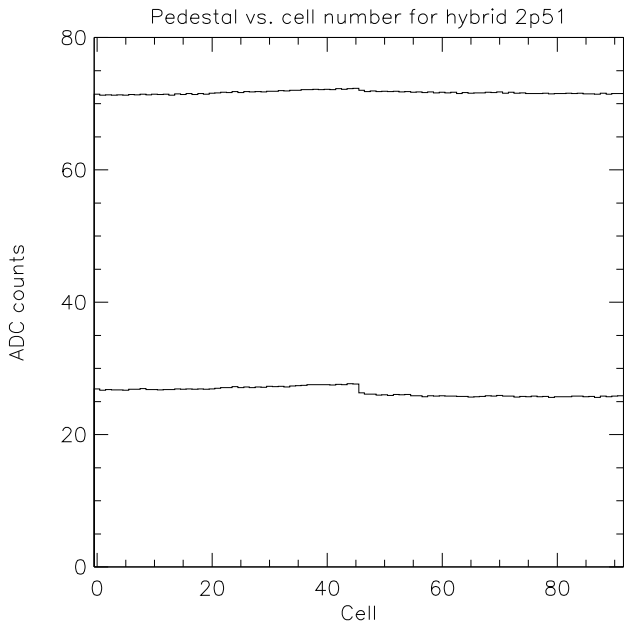
Pedestal vs. Pipeline Cell ID

The following plot shows the average pedestal vs. pipeline cell ID with and without charge injection. The x-axis is cell ID offset by 46 for each chip. Thus cell ID 5 for chip 1 is at x=5, chip 2 at x=51, chip 3 at x=97, etc.

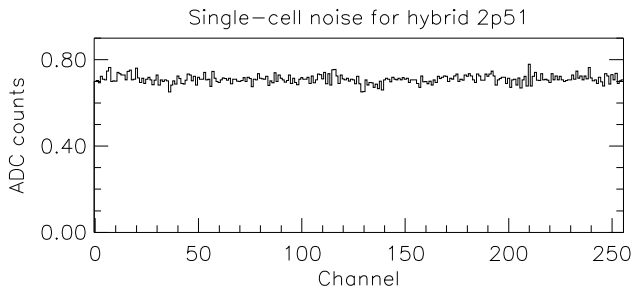
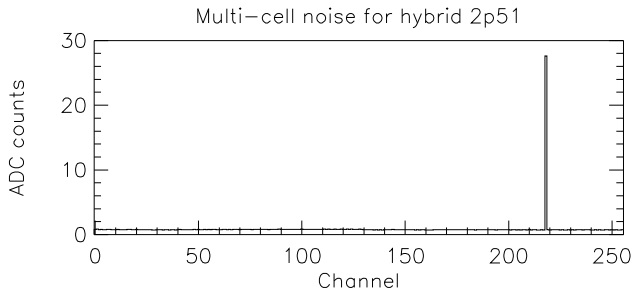
RMS Noise

The following plots show the single-cell and multi-cell RMS noise:

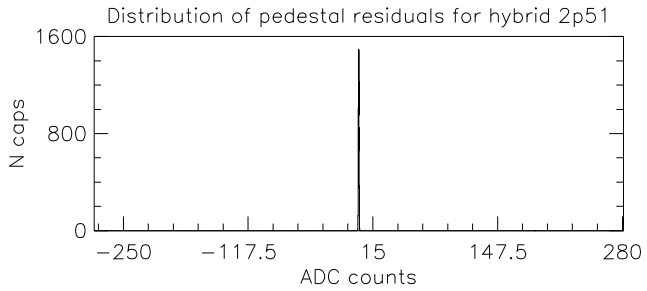
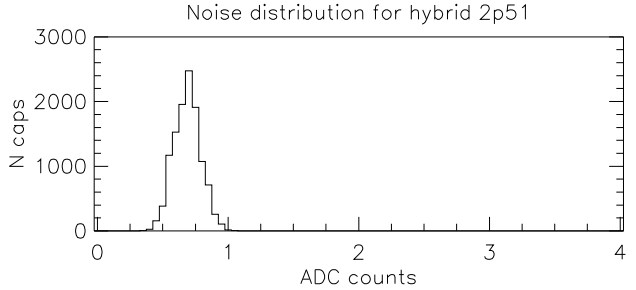
Distribution of Pedestals and Noise

The following are histograms of the pedestal of each pipeline capacitor relative to the chip average (top); and the RMS noise of each capacitor (bottom):

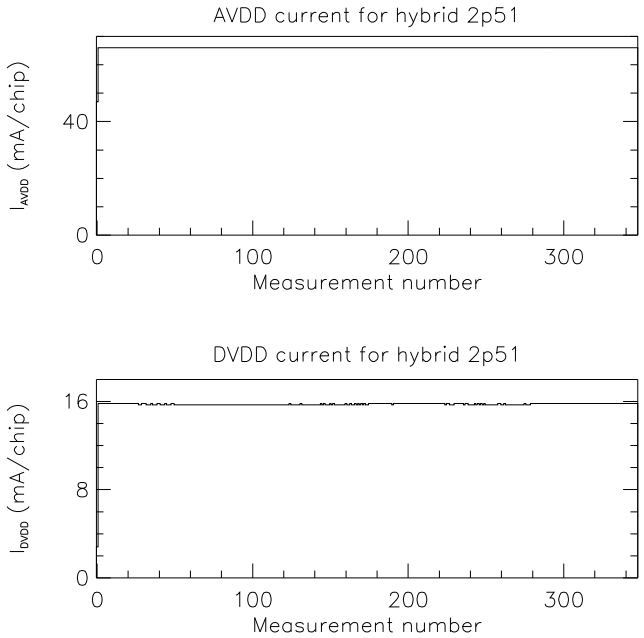
Supply Currents During Burn-in

The following plots show the supply currents per chip as a function of measurment number. Currents are measured approximately every 10 minutes:
