Hybrid 2p83 Traveler

November 17, 1999

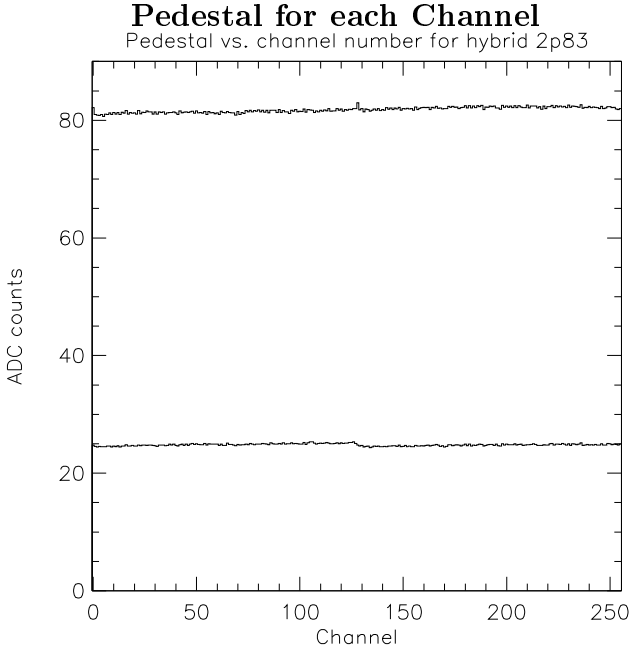
Pedestal for each Channel

The following plot shows the pedestals vs. channel number with and without charge injection:

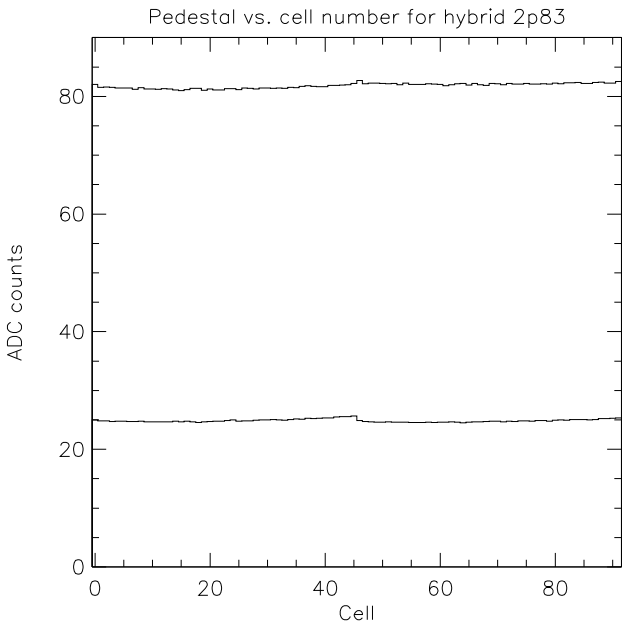
Pedestal vs. Pipeline Cell ID

The following plot shows the average pedestal vs. pipeline cell ID with and without charge injection. The x-axis is cell ID offset by 46 for each chip. Thus cell ID 5 for chip 1 is at x=5, chip 2 at x=51, chip 3 at x=97, etc.

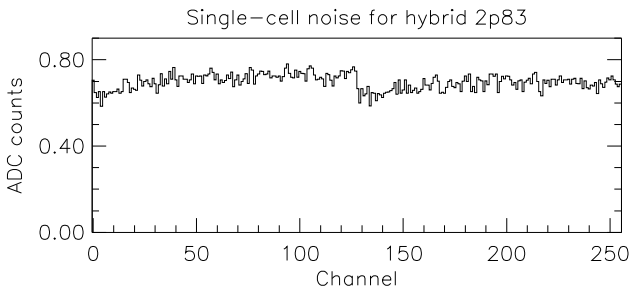
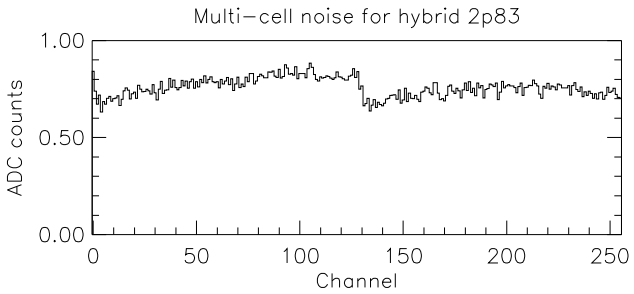
RMS Noise

The following plots show the single-cell and multi-cell RMS noise:

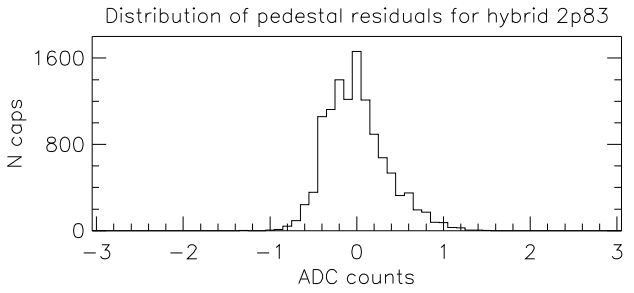
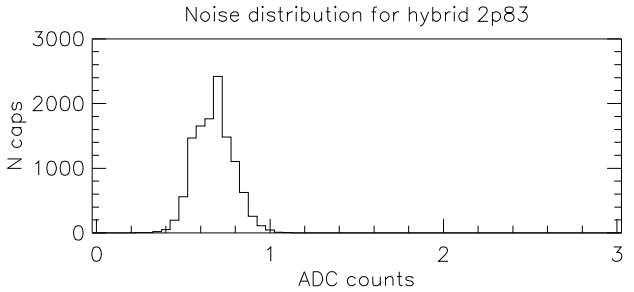
Distribution of Pedestals and Noise

The following are histograms of the pedestal of each pipeline capacitor relative to the chip average (top); and the RMS noise of each capacitor (bottom):

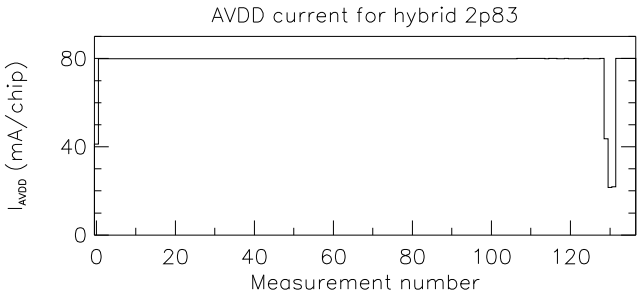
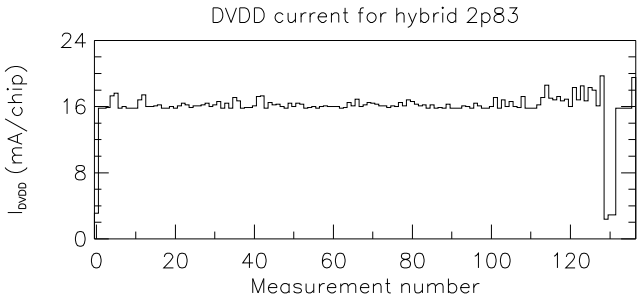
Supply Currents During Burn-in

The following plots show the supply currents per chip as a function of measurment number. Currents are measured approximately every 10 minutes:
