Hybrid 2p87 Traveler

October 21, 1999

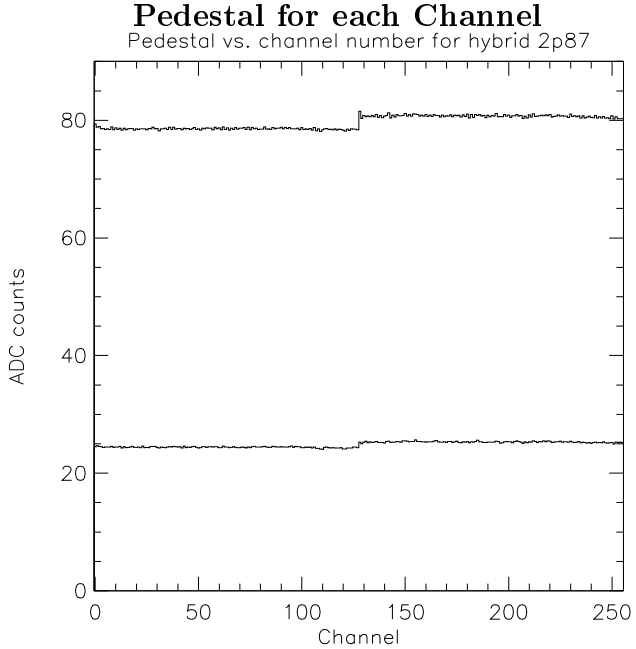
Pedestal for each Channel

The following plot shows the pedestals vs. channel number with and without charge injection:

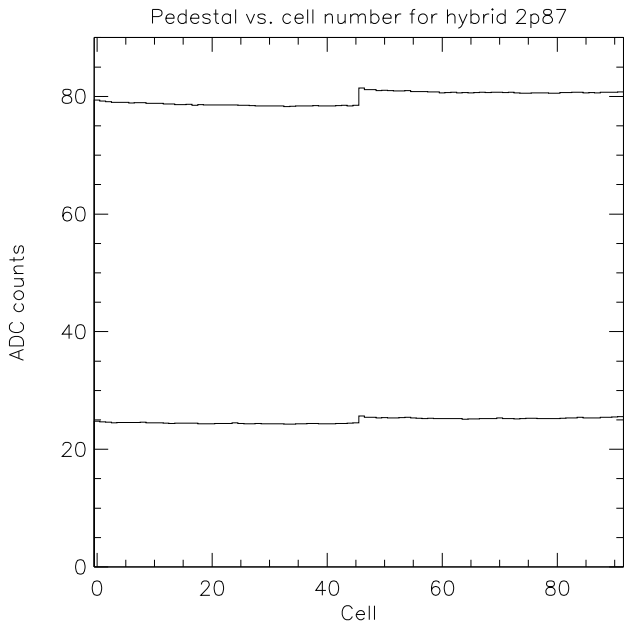
Pedestal vs. Pipeline Cell ID

The following plot shows the average pedestal vs. pipeline cell ID with and without charge injection. The x-axis is cell ID offset by 46 for each chip. Thus cell ID 5 for chip 1 is at x=5, chip 2 at x=51, chip 3 at x=97, etc.

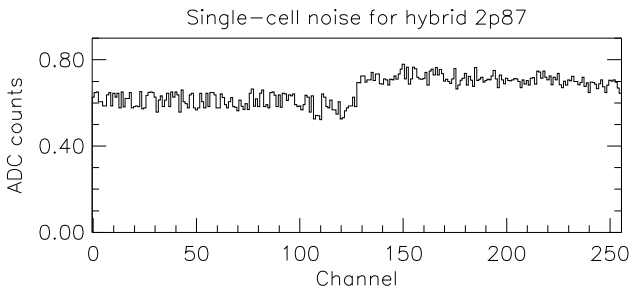
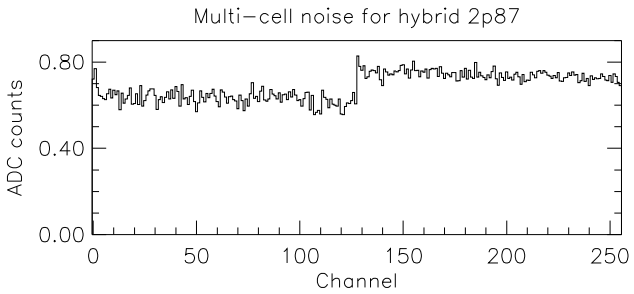
RMS Noise

The following plots show the single-cell and multi-cell RMS noise:

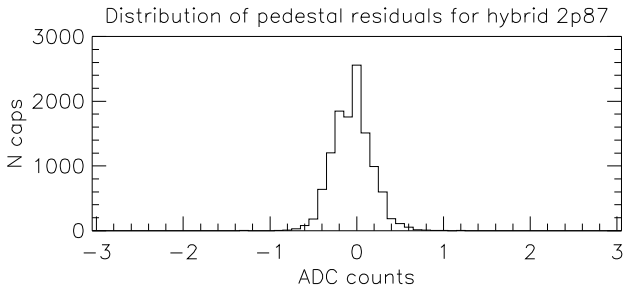
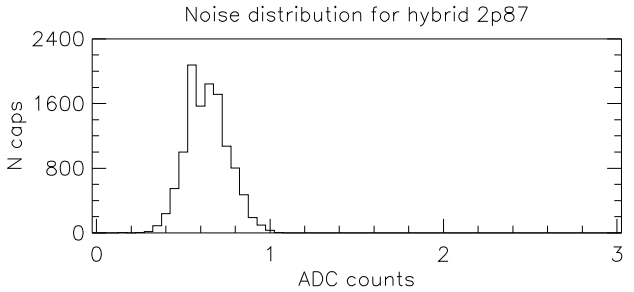
Distribution of Pedestals and Noise

The following are histograms of the pedestal of each pipeline capacitor relative to the chip average (top); and the RMS noise of each capacitor (bottom):

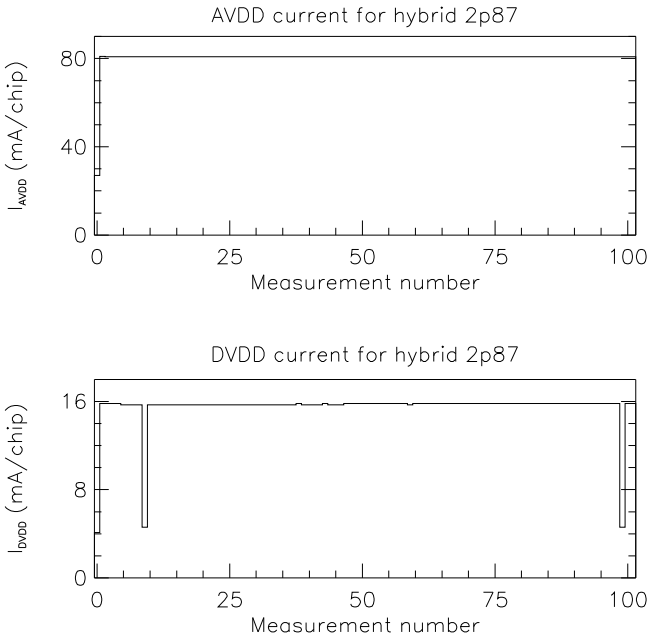
Supply Currents During Burn-in

The following plots show the supply currents per chip as a function of measurment number. Currents are measured approximately every 10 minutes:
